1769 CompactLogix Packaged Controllers, Revision 19

Catalog Numbers 1769-L23E-QB1B, 1769-L23E-QBFC1B, 1769-L23-QBFC1B

This publication describes enhancements, anomalies (known and corrected), and restrictions for 1769-L2x CompactLogix[™] packaged controllers, revision 19.13.

Publication 1769-RN014C-EN-P - February 2012

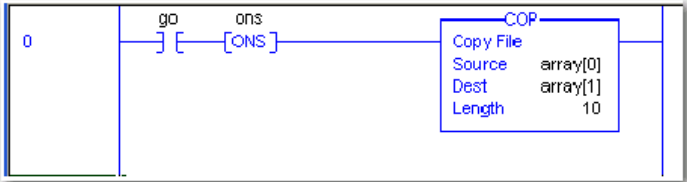
Cat. No.	Description																																																
1769-L23E-QB1B, 1769-L23-QB1BFC, 1769-L23E-QB1BFC	<p>CORRECTED: The Copy File (COP) Synchronous Copy File (CPS) instruction use may result in Unexpected Execution. If the COP or CPS instructions are configured so that the source and destination tags overlap, the instruction has unexpected execution. For example, these graphics show an example COP instruction and its tag values before execution.</p>

<table border="1" data-bbox="349 688 857 1039"><thead><tr><th>Name</th><th>Value</th></tr></thead><tbody><tr><td>array</td><td>{...}</td></tr><tr><td>array[0]</td><td>0</td></tr><tr><td>array[1]</td><td>1</td></tr><tr><td>array[2]</td><td>2</td></tr><tr><td>array[3]</td><td>3</td></tr><tr><td>array[4]</td><td>4</td></tr><tr><td>array[5]</td><td>5</td></tr><tr><td>array[6]</td><td>6</td></tr><tr><td>array[7]</td><td>7</td></tr><tr><td>array[8]</td><td>8</td></tr><tr><td>array[9]</td><td>9</td></tr></tbody></table> <p>The result should be an array that contains all zeros. Instead, the result is an array that contains the values shown in this graphic.</p> <table border="1" data-bbox="349 1138 857 1488"><thead><tr><th>Name</th><th>Value</th></tr></thead><tbody><tr><td>array</td><td>{...}</td></tr><tr><td>array[0]</td><td>0</td></tr><tr><td>array[1]</td><td>0</td></tr><tr><td>array[2]</td><td>1</td></tr><tr><td>array[3]</td><td>2</td></tr><tr><td>array[4]</td><td>3</td></tr><tr><td>array[5]</td><td>3</td></tr><tr><td>array[6]</td><td>5</td></tr><tr><td>array[7]</td><td>6</td></tr><tr><td>array[8]</td><td>7</td></tr><tr><td>array[9]</td><td>7</td></tr></tbody></table>	Name	Value	array	{...}	array[0]	0	array[1]	1	array[2]	2	array[3]	3	array[4]	4	array[5]	5	array[6]	6	array[7]	7	array[8]	8	array[9]	9	Name	Value	array	{...}	array[0]	0	array[1]	0	array[2]	1	array[3]	2	array[4]	3	array[5]	3	array[6]	5	array[7]	6	array[8]	7	array[9]	7
