1769 CompactLogix Controllers, Revision 18

Catalog Numbers 1769-L31, 1769-L32C, 1769-L32E, 1769-L35CR, 1769-L35E

Publication 1769-RN018A-EN-P - February 2010

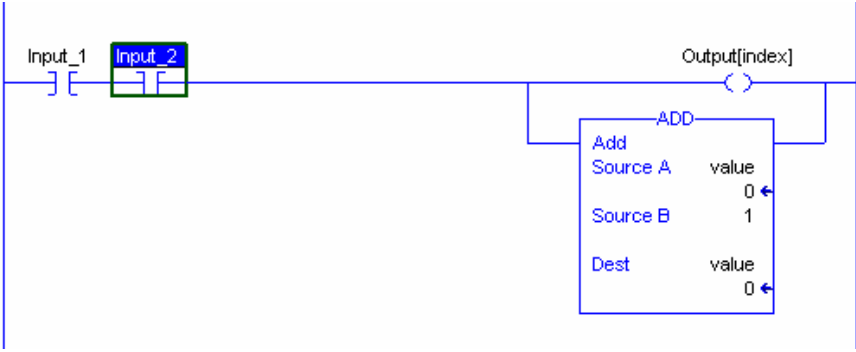
Catalog No.	Description
1769-L31, 1769-L32C, 1769-L32E, 1769-L35CR, 1769-L35E	<p>Fault handlers can be defined at the controller and program scope levels. These fault handlers are typically used to handle major recoverable faults that can occur during runtime execution of an application due to programming errors. A typical example of this would be handling indirect addressing that has gone out of range; <code>MyTag[index]</code>, where <code>index</code> is larger than the size of the array.</p> <p>Faults can also be handled by the controller during pre-scan of the controller program on the transition to Run mode. Again, for example, the handling of indirect addressing that has gone out of range.</p> <p>There is an anomaly when these methods attempt to handle a fault.</p> <p>These are the possible ways the anomaly can manifest itself:</p> <ul style="list-style-type: none"> • The controller will experience a major non-recoverable fault. I/O goes to their configured safe state, and the user application is cleared from memory. At this point, a Code 1 Type 60 or 61 major recoverable fault will be logged in the controller. This requires you to redownload the application. • Tag data corruption. • Online saving or uploading failures. • Anomalous program execution. <p>For example, if a rung is being scanned false and there is an instruction that has false execution, the fault handler executes so the remainder of the rung will scan true. In the example below, the OTE instruction has an index out of range. After returning from the fault handler, the ADD instruction will execute, even though the rung input conditions are false.</p>
