ControlLogix Controllers Revision 12

Cat. No. 1756-L1, -L1M1, -L1M2, -L1M3, -L55, -L55M12, -L55M13, -L55M14, -L55M16, -L55M22, -L55M23, -L55M24, -L61, -L62, -L63

Publication 1756-RN601H-EN-E - September 2005

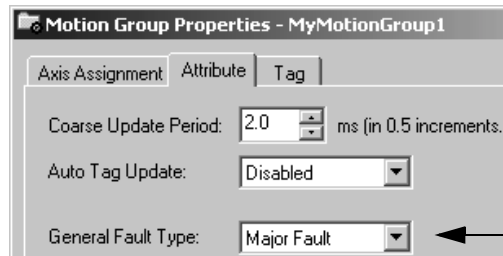
Change:	Description:
While in Program Mode, a Motion Group Fault No Longer Produces a Major Fault	As an option, you can configure a motion group to produce a <i>major fault</i> any time the group detects a motion fault.

With this revision, a motion group that is configured to produce a major fault produces a major fault *only* if the controller is in run/remote run mode.

In previous revision, the motion group could produce a major fault while the controller was in program/remote program mode. For example, a store to nonvolatile memory interrupts the execution of the motion planner, which produces a fault.

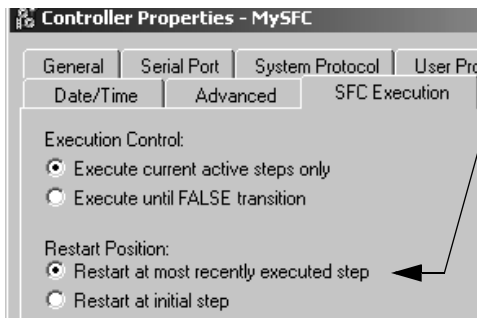
Improvements in How an SFC Restarts After Its Execution Is Aborted	<p>This revision provides better handling of situations where the execution of a sequential function chart (SFC) was aborted due:</p> <ul style="list-style-type: none">• loss of power• controller entered the faulted mode (flashing red OK LED) <p>The changes include the following:</p>
--	---

Regardless of this setting, the SFC *always restarts at the initial step* after a change from faulted mode (flashing red OK LED) to run/remote run mode.
