1769 CompactLogix Packaged Controllers, Revision 17

Catalog Numbers 1769-L23E-QB1B, 1769-L23E-QBFC1B,
1769-L23-QBFC1B

Publication 1769-RN012D-EN-E - February 2010

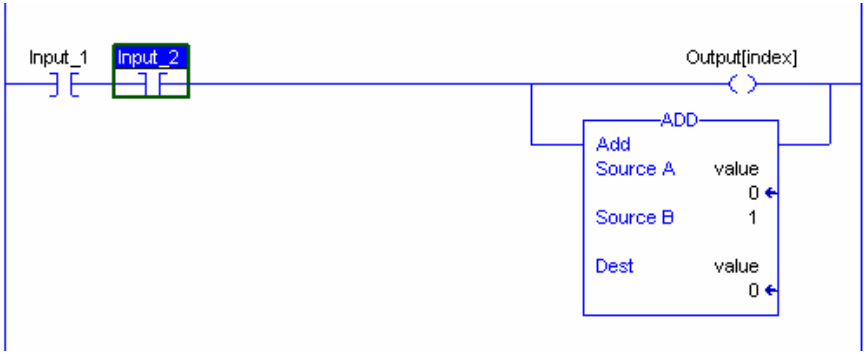
Firmware Revision	Description
17.05	<p>Fault handlers can be defined at the controller and program scope levels. These fault handlers are typically used to handle major recoverable faults that can occur during runtime execution of an application due to programming errors. A typical example of this would be handling indirect addressing that has gone out of range; <code>MyTag[index]</code>, where <code>index</code> is larger than the size of the array.</p> <p>Faults can also be handled by the controller during pre-scan of the controller program on the transition to Run mode. Again, for example, the handling of indirect addressing that has gone out of range.</p> <p>There is an anomaly when these methods attempt to handle a fault.</p> <p>These are the possible ways the anomaly can manifest itself:</p> <ul style="list-style-type: none">• The controller will experience a major non-recoverable fault. I/O goes to their configured safe state, and the user application is cleared from memory. At this point, a Code 1 Type 60 or 61 major recoverable fault will be logged in the controller. This requires you to redownload the application.• Tag data corruption.• Online saving or uploading failures.• Anomalous program execution. <p>For example, if a rung is being scanned false and there is an instruction that has false execution, the fault handler executes so the remainder of the rung will scan true. In the example below, the OTE instruction has an index out of range. After returning from the fault handler, the ADD instruction will execute, even though the rung input conditions are false.</p>
