ControlLogix Combination Controller and SERCOS Interface Card, Firmware Revision 17

Catalog Number 1756-L60M03SE

Publication 1756-RN655B-EN-E - July 2009

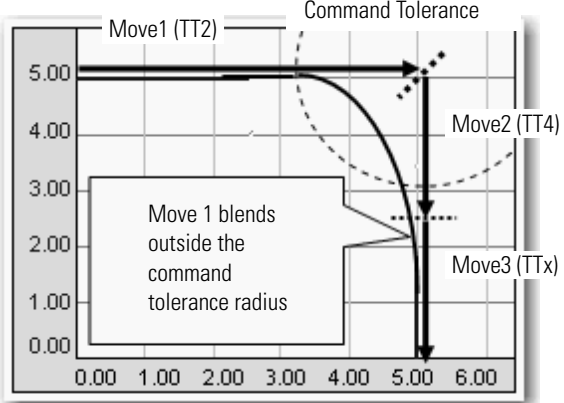
Firmware Revision	Anomaly	Description
17.02	Combination of Termination Types may cause you to miss the target position	<p>You may have missed hitting the end point of a move with Termination Type 4 or 5 (TT4/5) when it was preceded by another move with Termination Type 2 or 3 (TT2/3). See figure below as one possible combination:</p>
