1768 CompactLogix Controllers, Revision 19

CompactLogix Catalog Numbers 1768-L43, 1768-L45

Compact GuardLogix Catalog Numbers 1768-L43S, 1768-L45S

Publication 1768-RN019A-EN-P - September 2010

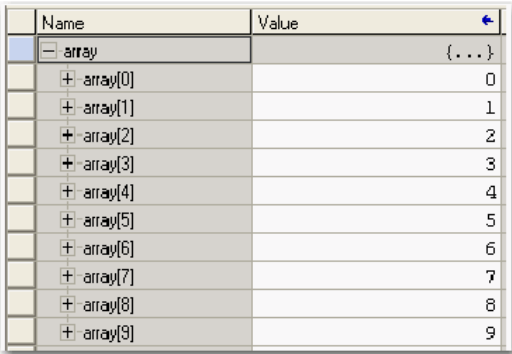
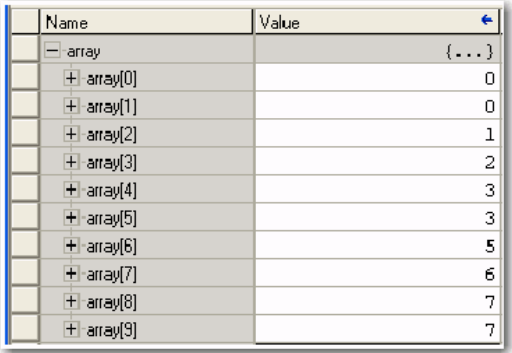
Cat. No.	Description
1768-L43, 1768-L45, 1768-L43S, 1768-L45S	<p>The Copy File (COP) Synchronous Copy File (CPS) instruction use may result in Unexpected Execution</p> <p>If the COP or CPS instructions are configured so that the source and destination tags overlap, the instruction has unexpected execution.</p> <p>For example, these graphics show an example COP instruction and its tag values before execution.</p>

<p>The result should be an array that contains all zeros. Instead, the result is an array that contains the values shown in this graphic.</p>
