FlexLogix Controller Revision 13 Release Notes

Cat. No. 1794-L33, 1794-L34

These release notes should be used with FlexLogix™ controller firmware **major revision 13, minor revision 33**. Use this firmware with:

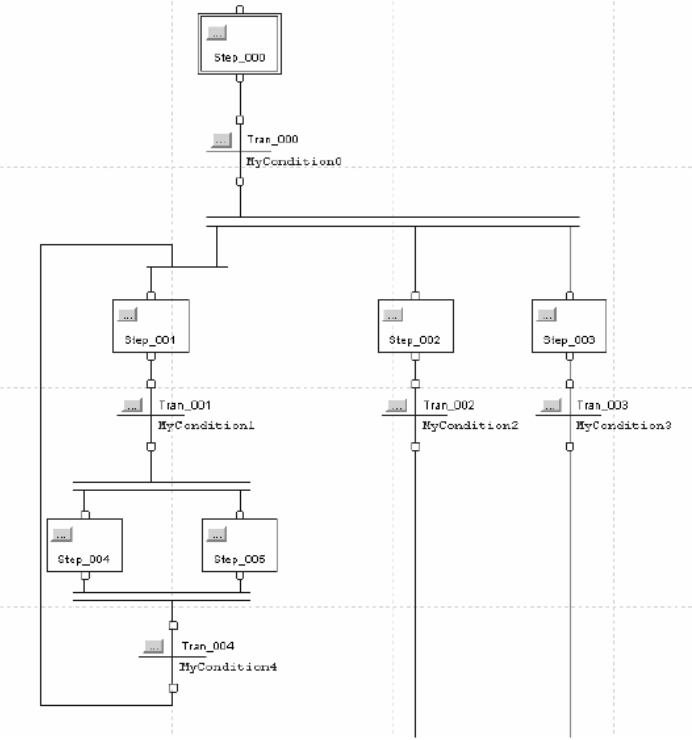
<p>An SFC Could Execute the Wrong Step</p>	<p>If you had an SFC with nested simultaneous branches, the controller could begin execution at an unexpected step. Following the convergence of a nested simultaneous branch, if the SFC looped back to the initial step of the parent branch, instead of executing that step, the SFC could jump to a step of another path in the nested simultaneous branch. For example:</p>

<p>Execution starts at Step_000. When Tran_000 becomes true, Step_001, Step_002 and Step_003 should become active. However, because the nested simultaneous branch in the left path converged and looped back to its parent step (Step_001), the active steps were actually Step_005, Step_002 and Step_003.</p> <p style="text-align: right;">Lgx00054785</p>
<p>The File Search Compare (FSC) Instruction Caused a Non-Recoverable Fault</p>	<p>The FSC instruction caused a non-recoverable fault if both these conditions occurred:</p> <ul style="list-style-type: none"> • a major fault was declared from within the expression of an FSC instruction • the user fault routine cleared the fault <p>When the user fault routine attempted to recover, information previously saved was not properly restored, which resulted in corrupted system registers and a non-recoverable fault.</p> <p style="text-align: right;">Lgx00055522</p>
