# 1769 CompactLogix Controllers, Revision 20

Catalog Numbers 1769-L31, 1769-L32C, 1769-L32E, 1769-L35CR, 1769-L35E

Publication 1769-RN021B-EN-P - May 2012

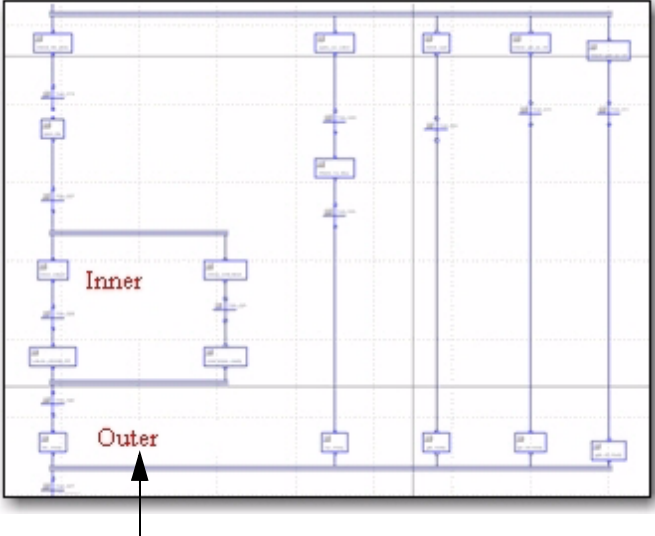
Cat. No.	Description
1769-L31 1769-L32C 1769-L32E 1769-L35CR 1769-L35E	<p><b>CORRECTED:</b> An anomaly can occur when you nest simultaneous branches in a Sequential Function Chart (SFC) routine as shown below.</p>

<p style="text-align: center;">Bottom-most Steps</p> <p>During normal operations, the logic does not step out of a simultaneous branch until all of the incoming legs have reached their bottom-most step. In the example shown, the logic does not step out of the Outer simultaneous branch until the leftmost leg has stepped out of the Inner simultaneous branch. The first time through the SFC routine, the application works as expected. On subsequent scans, however, the chart steps out of the Outer simultaneous branch even though the left leg has not reached the Inner simultaneous branch yet.</p> <p>This behavior occurs because the information in the bottom step, that is, the step next to the word Outer, remains from the previous scan. This stale information incorrectly causes the transition to move on as if the left leg is at the bottom step when it actually is not.</p> <p>To work around this anomaly, confirm all of the incoming legs have reached their bottom steps in the transition. You can check the .x bits to make sure the bottom-most step of each converging leg is active before allowing the chart to advance. This check can be added to the transition logic already present.</p> <p>For example, the steps in the following expression are the bottom steps (see graphic above) of the incoming legs. Each step has a timer. The transition does not move on until all of the step timers have reached their preset value.</p> <p>The expression can be modified to be sure those steps are truly active. This is the <b>original expression</b>:</p> <pre>// Unit is ready to Transition Step1_ready.dn and Step2_ready.dn and Step3_ready.dn and Step4_ready.dn and Step5_ready.dn</pre> <p>This is the <b>modified expression</b> to work around this anomaly.</p> <pre>// Unit is ready to Transition Step1_ready.x and Step2_ready.x and Step3_ready.x and Step4_ready.x and Step5_ready.x and Step1_ready.dn and Step2_ready.dn and Step3_ready.dn and Step4_ready.dn and Step5_ready.dn</pre> <p><b>IMPORTANT:</b> The .x bit is cleared when the chart transitions out of a step.</p> <p>Adding this check to the condition forces the engine to wait until all of those steps are genuinely active before advancing out of the simultaneous branch.</p> <p style="text-align: right;">Lgx00118188, Lgx00116506</p> <p><b>CORRECTED:</b> Applications that have a large quantity of HMI tags on scan in the controller can experience a non-recoverable major fault when doing online edits.</p> <p style="text-align: right;">Lgx00118192, Lgx00115817</p> <p><b>CORRECTED:</b> Even though the message path is incorrect, messages to the CompactBus will complete.</p> <p>For example, a path of 1,3,10,3 would go to the Compact I/O™ module in slot 3 when it should error. The path should have been 1,3,1,3.</p> <p style="text-align: right;">Lgx00122439, Lgx00120959</p>

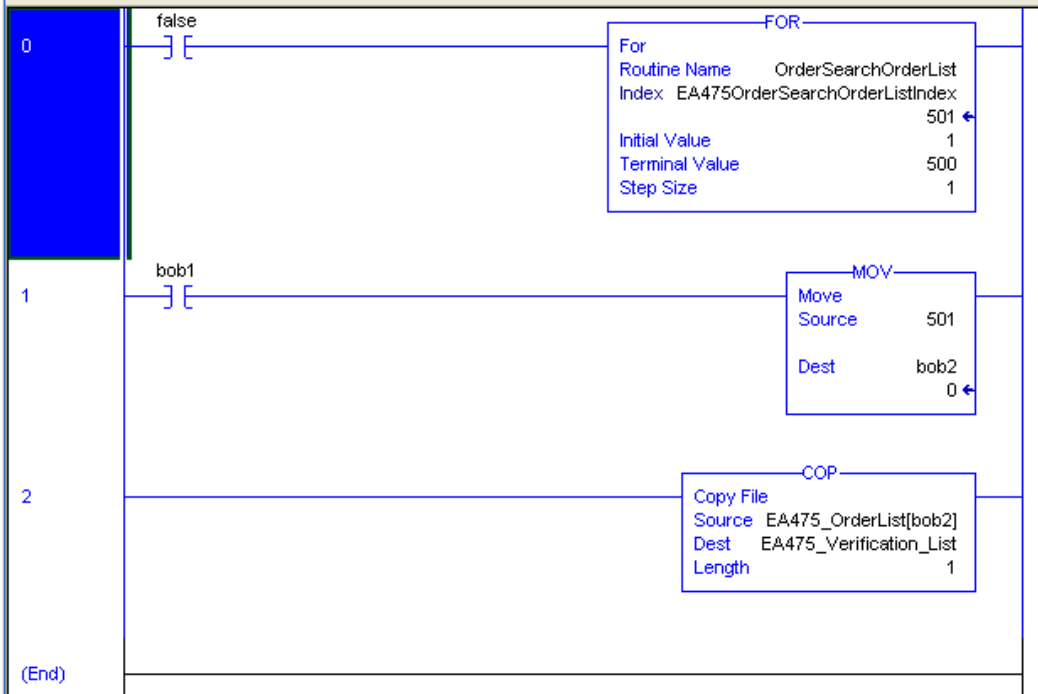
Cat. No.	Description																														
1769-L31 1769-L32C 1769-L32E 1769-L35CR 1769-L35E	<p><b>CORRECTED:</b> If a FOR instruction is scanned true and an instruction has an index out of range that references a UDT or multi-dimensional array, the controller will fault. Clearing the fault and returning to run mode will cause a nonrecoverable major fault.</p>
