Table of Contents

1. Preparing and Upgrading

3. Before you update

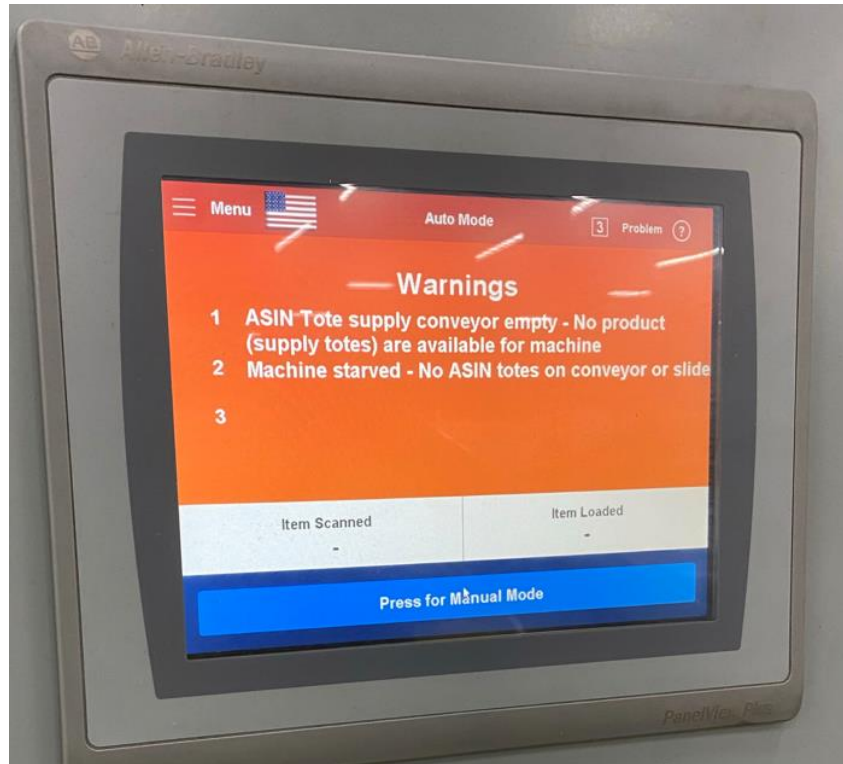
4.1. ASIN Tote Supply conveyor empty and/or Machine Starved warnings on HMI

This is likely due to sensors being light activated vs dark activated.

- gPar.7 and gPar.8 allow inverting the sensor if needed.
https://w.amazon.com/index.php/FCShip/SmartPac#g_Par_Definitions_.28Machine_Option_Settings.29
- Setup Information
https://w.amazon.com/index.php/FCShip/SmartPac#OEE_Starved_Condition_Definition

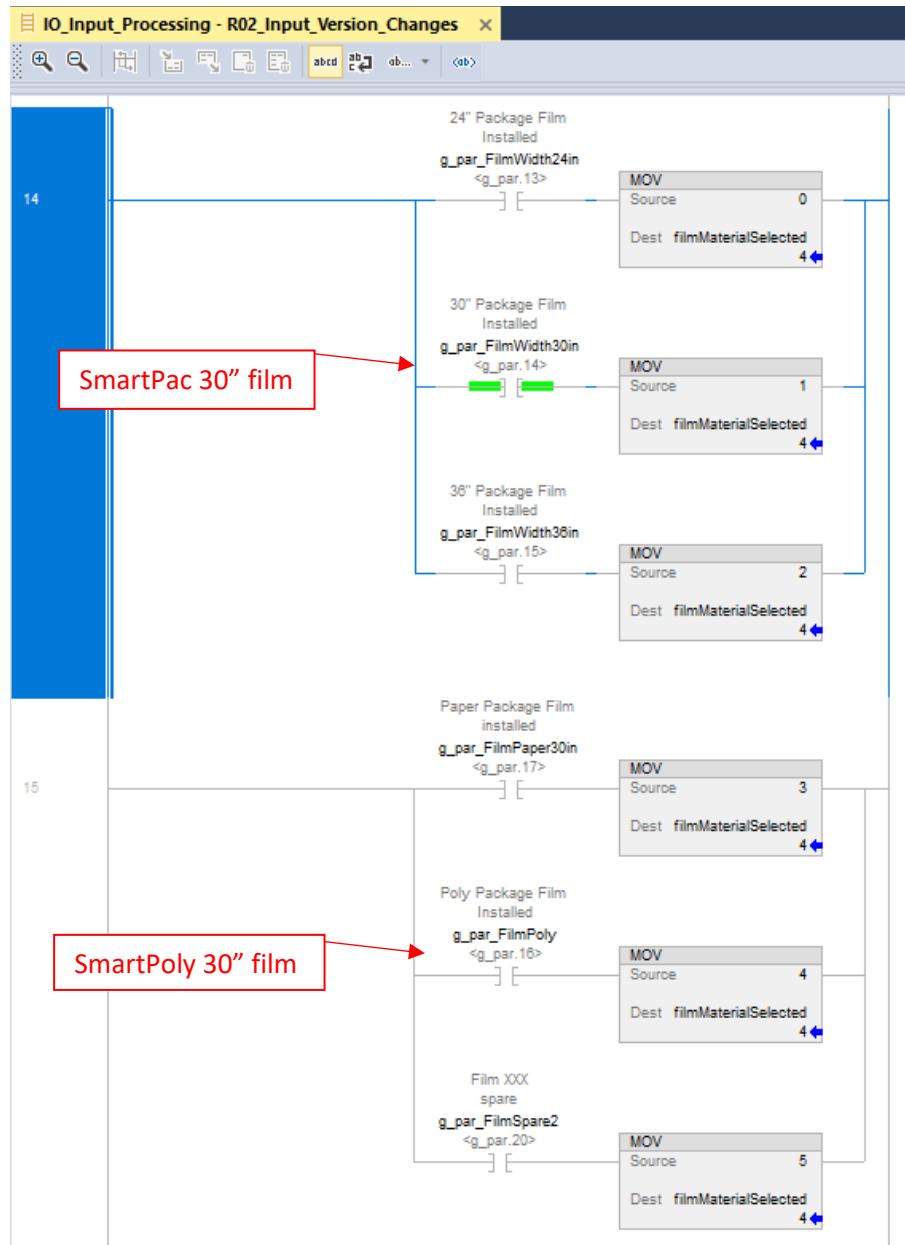
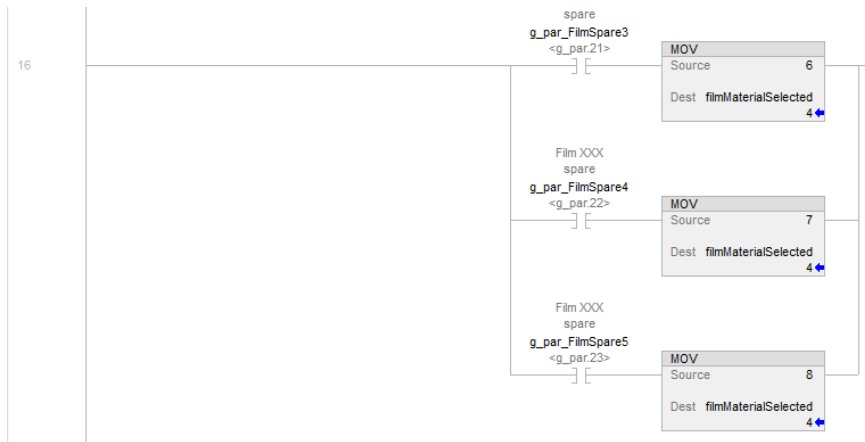
5.3. PLC g_par's to adjust material type setting

Only the config for the material you are running should be active (ON). Typically, this is g_par_FilmWidth30in as shown in the screen shot below or Poly Film g_par_FilmPoly (g_par.16).

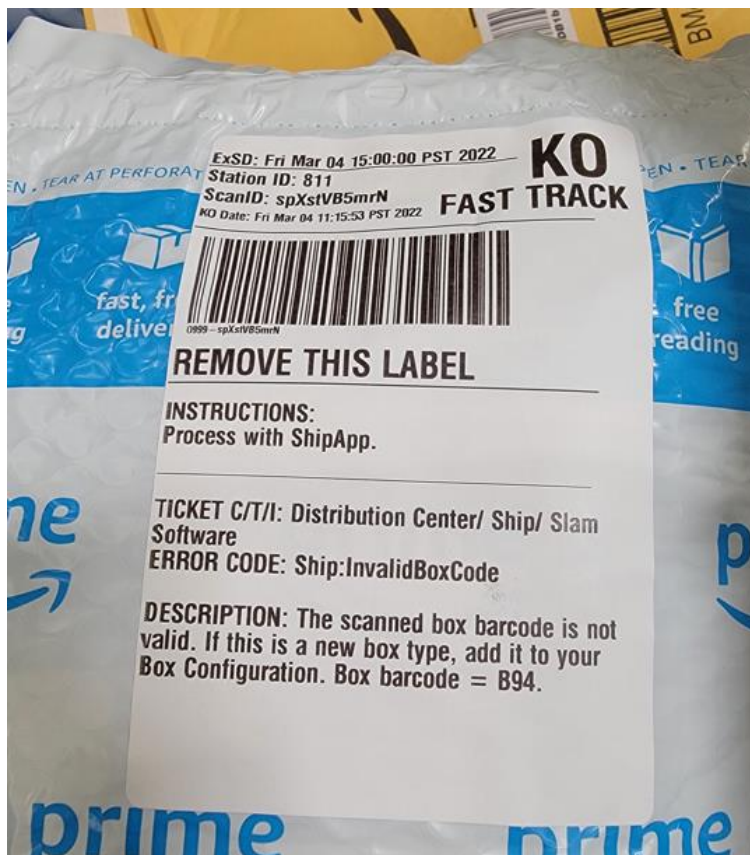
5.4. Kickout “The scanned box barcode is not valid”

The following kick out can occur if the material type is not properly setup

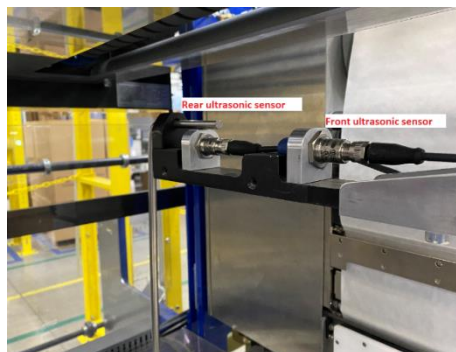
6.2. Ultrasonic sensor version (for 3.x machines)

Front sensor model number (close to operator) : Pico+25/WK/F Rear sensor model number (away from operator): Pico+35/WK/F - IO Link version 1.0 (**g_par.18 ON**)

Front sensor model number (close to operator): Pico+25/WK/F/A Rear sensor model number (away from operator): Pico+35/WK/F/A – IO Link version 1.1 (**g_par.18 OFF**)

Note sensors have to be either both IO Link version 1.0 or both IO Link version 1.1.

Toggle the g_par bit to indicate the IO Link version of ultrasonic sensor installed on the machine (g_par.18)
