ControlLogix Controllers, Revision 16

About Publication 1756-RN016E-EN-P

This revision of the firmware release notes, 1756-RN016E, provides updated information specific to firmware revision 16.22 for all ControlLogix controllers.

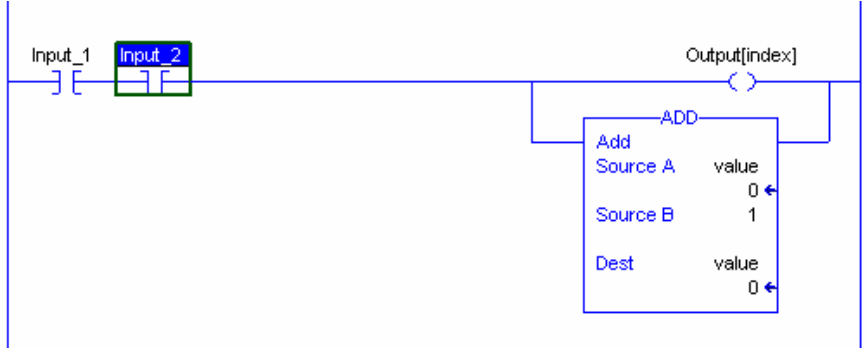
Cat. No.	Firmware Revision	Description
1756-L55Mxx, 1756-L61, 1756-L61S, 1756-L62, 1756-L62S, 1756-L63, and 1756-L64	16.22	<p>Fault handlers can be defined at the controller and program scope levels. These fault handlers are typically used to handle major recoverable faults that can occur during runtime execution of an application due to programming errors. A typical example of this would be handling indirect addressing that has gone out of range; MyTag[index], where <code>index</code> is larger than the size of the array.</p> <p>Faults can also be handled by the controller during pre-scan of the controller program on the transition to Run mode. Again, for example, the handling of indirect addressing that has gone out of range.</p> <p>There is an anomaly when these methods attempt to handle a fault.</p> <p>These are the possible ways the anomaly can manifest itself:</p> <ul style="list-style-type: none"> • The controller will experience a major non-recoverable fault. I/O goes to their configured safe state, and the user application is cleared from memory. At this point, a Code 1 Type 60 or 61 major recoverable fault will be logged in the controller. This requires you to redownload the application. • Tag data corruption. • Online saving or uploading failures. • Anomalous program execution. <p>For example, if a rung is being scanned false and there is an instruction that has false execution, the fault handler executes so the remainder of the rung will scan true. In the example below, the OTE instruction has an index out of range. After returning from the fault handler, the ADD instruction will execute, even though the rung input conditions are false.</p>

<p>Lgx00106481, Lgx00107423, Lgx00100766, Lgx00106478</p>
