# 1769 CompactLogix Packaged Controllers, Revision 18

Catalog Numbers 1769-L23E-QB1B, 1769-L23E-QBFC1B,  
1769-L23-QBFC1B

Publication 1769-RN013A-EN-P - February 2010

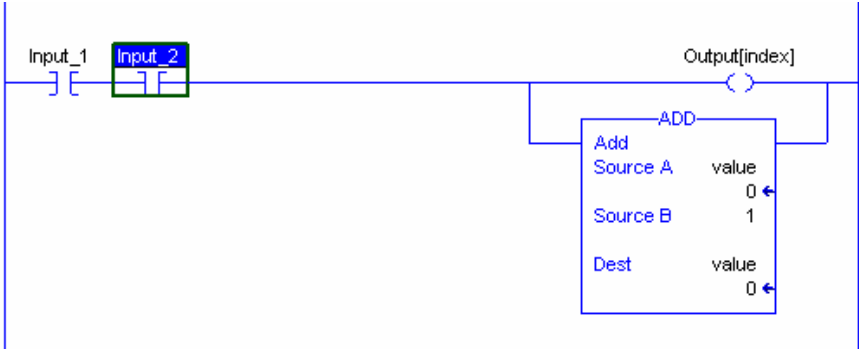
Catalog No.	Description
1769-L23-QBFC1, 1769-L23E-QB1B, 1769-L23E-QBFC1B	<p>Fault handlers can be defined at the controller and program scope levels. These fault handlers are typically used to handle major recoverable faults that can occur during runtime execution of an application due to programming errors. A typical example of this would be handling indirect addressing that has gone out of range; <code>MyTag[index]</code>, where <code>index</code> is larger than the size of the array.</p> <p>Faults can also be handled by the controller during pre-scan of the controller program on the transition to Run mode. Again, for example, the handling of indirect addressing that has gone out of range.</p> <p>There is an anomaly when these methods attempt to handle a fault.</p> <p>These are the possible ways the anomaly can manifest itself:</p> <ul style="list-style-type: none"> <li>• The controller will experience a major non-recoverable fault. I/O goes to their configured safe state, and the user application is cleared from memory. At this point, a Code 1 Type 60 or 61 major recoverable fault will be logged in the controller. This requires you to redownload the application.</li> <li>• Tag data corruption.</li> <li>• Online saving or uploading failures.</li> <li>• Anomalous program execution.</li> </ul> <p>For example, if a rung is being scanned false and there is an instruction that has false execution, the fault handler executes so the remainder of the rung will scan true. In the example below, the OTE instruction has an index out of range. After returning from the fault handler, the ADD instruction will execute, even though the rung input conditions are false.</p>
