ControlLogix Controllers, Revision 19

This publication describes enhancements, anomalies (known and corrected), and restrictions for ControlLogix and GuardLogix controllers, firmware revision 19.11.

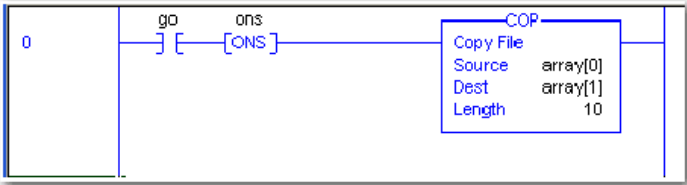
Cat. No.	Description																																																
1756-L61, 1756-L62, 1756-L63, 1756-L64, 1756-L65, 1756-L61S, 1756-L62S, 1756-L63S, 1756-L63XT, 1756-L72, 1756-L73, 1756-L74, 1756-L75	<p>The Copy File (COP) Synchronous Copy File (CPS) instruction use may result in Unexpected Execution</p> <p>If the COP or CPS instructions are configured so that the source and destination tags overlap, the instruction has unexpected execution.</p> <p>For example, these graphics show an example COP instruction and its tag values before execution.</p> <div>

</div> <div><table><tr><th>Name</th><th>Value</th></tr><tr><td>array</td><td>{...}</td></tr><tr><td>array[0]</td><td>0</td></tr><tr><td>array[1]</td><td>1</td></tr><tr><td>array[2]</td><td>2</td></tr><tr><td>array[3]</td><td>3</td></tr><tr><td>array[4]</td><td>4</td></tr><tr><td>array[5]</td><td>5</td></tr><tr><td>array[6]</td><td>6</td></tr><tr><td>array[7]</td><td>7</td></tr><tr><td>array[8]</td><td>8</td></tr><tr><td>array[9]</td><td>9</td></tr></table></div> <p>The result should be an array that contains all zeros. Instead, the result is an array that contains the values shown in this graphic.</p> <div><table><tr><th>Name</th><th>Value</th></tr><tr><td>array</td><td>{...}</td></tr><tr><td>array[0]</td><td>0</td></tr><tr><td>array[1]</td><td>0</td></tr><tr><td>array[2]</td><td>1</td></tr><tr><td>array[3]</td><td>2</td></tr><tr><td>array[4]</td><td>3</td></tr><tr><td>array[5]</td><td>3</td></tr><tr><td>array[6]</td><td>5</td></tr><tr><td>array[7]</td><td>6</td></tr><tr><td>array[8]</td><td>7</td></tr><tr><td>array[9]</td><td>7</td></tr></table></div> <p>Lgx00114495, Lgx00114576</p>	Name	Value	array	{...}	array[0]	0	array[1]	1	array[2]	2	array[3]	3	array[4]	4	array[5]	5	array[6]	6	array[7]	7	array[8]	8	array[9]	9	Name	Value	array	{...}	array[0]	0	array[1]	0	array[2]	1	array[3]	2	array[4]	3	array[5]	3	array[6]	5	array[7]	6	array[8]	7	array[9]	7
