ControlLogix Controllers, Revision 20

ControlLogix Controllers Catalog Numbers

This publication describes enhancements, anomalies (corrected and known), restrictions for ControlLogix controllers, firmware revisions 20.012 and 20.011, and GuardLogix™ controllers, firmware revision 20.012 and 20.011.

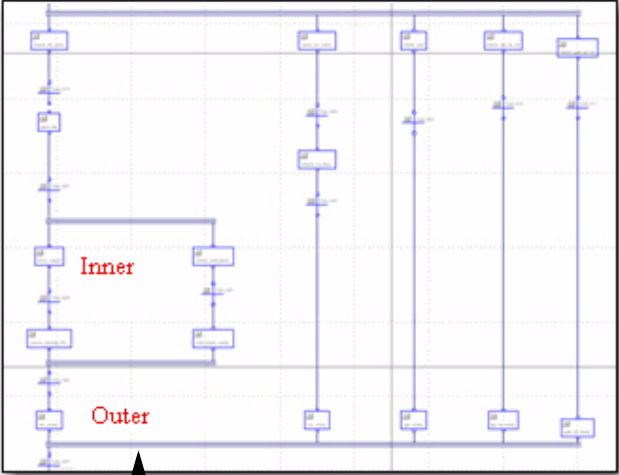
Cat. No.	Description
1756-L61 1756-L62 1756-L63 1756-L64 1756-L65 1756-L61S 1756-L62S 1756-L63S 1756-L63XT 1756-L72 1756-L73 1756-L74 1756-L75	<p>CORRECTED: An anomaly can occur when you nest simultaneous branches in a Sequential Function Chart (SFC) routine as shown below.</p>

<p>Bottom-most Steps</p> <p>During normal operations, the logic does not step out of a simultaneous branch until all of the incoming legs have reached their bottom-most step. In the example shown, the logic does not step out of the Outer simultaneous branch until the leftmost leg has stepped out of the Inner simultaneous branch. The first time through the SFC routine, the application works as expected. On subsequent scans, however, the chart steps out of the Outer simultaneous branch even though the left leg has not reached the Inner simultaneous branch yet.</p> <p>This behavior occurs because the information in the bottom step, that is, the step next to the word Outer, remains from the previous scan. This stale information incorrectly causes the transition to move on as if the left leg is at the bottom step when it actually is not.</p> <p>To work around this anomaly, confirm all of the incoming legs have reached their bottom steps in the transition. You can check the .x bits to make sure the bottom-most step of each converging leg is active before allowing the chart to advance. This check can be added to the transition logic already present.</p> <p>For example, the steps in the following expression are the bottom steps (see graphic above) of the incoming legs. Each step has a timer. The transition does not move on until all of the step timers have reached their preset value.</p> <p>The expression can be modified to be sure those steps are truly active. This is the original expression:</p> <pre>// Unit is ready to Transition Step1_ready.dn and Step2_ready.dn and Step3_ready.dn and Step4_ready.dn and Step5_ready.dn</pre> <p>This is the modified expression to work around this anomaly.</p> <pre>// Unit is ready to Transition Step1_ready.x and Step2_ready.x and Step3_ready.x and Step4_ready.x and Step5_ready.x and Step1_ready.dn and Step2_ready.dn and Step3_ready.dn and Step4_ready.dn and Step5_ready.dn</pre> <p>IMPORTANT: The x bit is cleared when the chart transitions out of a step.</p> <p>Adding this check to the condition forces the engine to wait until all of those steps are genuinely active before advancing out of the simultaneous branch.</p> <p style="text-align: right;">Lgx00118188, Lgx00116506</p> <p>CORRECTED: Applications that have a large quantity of HMI tags on scan in the controller can experience a non-recoverable major fault when doing online edits.</p> <p style="text-align: right;">Lgx00118192, Lgx00115817</p>

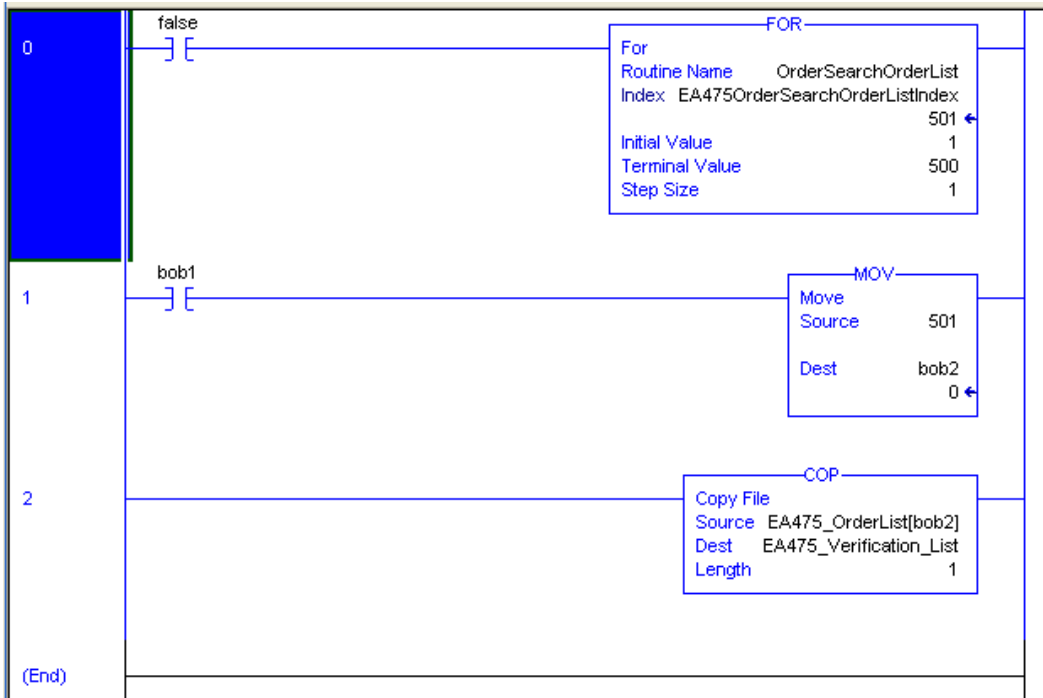
Cat. No.	Description
1756-L61 1756-L62 1756-L63 1756-L64 1756-L65 1756-L61S 1756-L62S 1756-L63S 1756-L63XT 1756-L72 1756-L73 1756-L74 1756-L75	<p>CORRECTED: If a FOR instruction is scanned true and an instruction has an index out of range that references a UDT or multi-dimensional array, the controller will fault. Clearing the fault and returning to run mode will cause a nonrecoverable major fault.</p>
