ControlLogix Controllers, Revision 18

ControlLogix Controllers Catalog Numbers

Publication 1756-RN018A-EN-P - February 2010

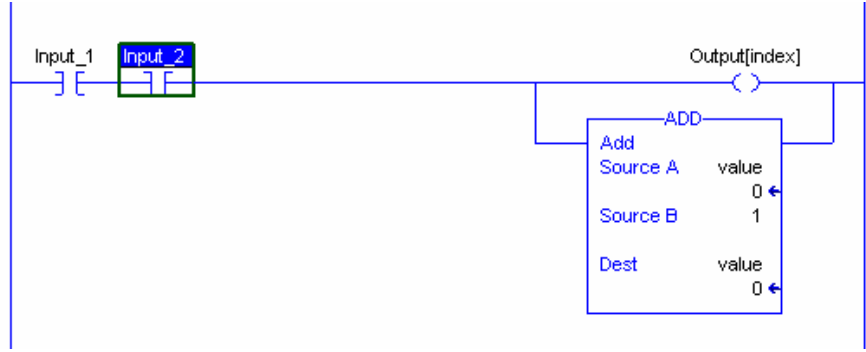
Catalog No.	Description
1756-L61, 1756-L62, 1756-L63, 1756-L64, 1756-L65 1756-L61S, 1756-L62S, 1756-L63S, 1756-L63XT	<p>Fault handlers can be defined at the controller and program scope levels. These fault handlers are typically used to handle major recoverable faults that can occur during runtime execution of an application due to programming errors. A typical example of this would be handling indirect addressing that has gone out of range; <code>MyTag[index]</code>, where <code>index</code> is larger than the size of the array.</p> <p>Faults can also be handled by the controller during pre-scan of the controller program on the transition to Run mode. Again, for example, the handling of indirect addressing that has gone out of range.</p> <p>There is an anomaly when these methods attempt to handle a fault.</p> <p>These are the possible ways the anomaly can manifest itself:</p> <ul style="list-style-type: none"> • The controller will experience a major non-recoverable fault. I/O goes to their configured safe state, and the user application is cleared from memory. At this point, a Code 1 Type 60 or 61 major recoverable fault will be logged in the controller. This requires you to redownload the application. • Tag data corruption. • Online saving or uploading failures. • Anomalous program execution. <p>For example, if a rung is being scanned false and there is an instruction that has false execution, the fault handler executes so the remainder of the rung will scan true. In the example below, the OTE instruction has an index out of range. After returning from the fault handler, the ADD instruction will execute, even though the rung input conditions are false.</p>
