CompactLogix Controllers, Revision 16

Catalog Numbers 1769-L31, 1769-L32C, 1769-L32E, 1769-L35CR, 1769-L35E

These release notes, 1769-RN016E, are specific to firmware revision 16.22 for all CompactLogix controllers.

Publication 1769-RN016E-EN-E - February 2010

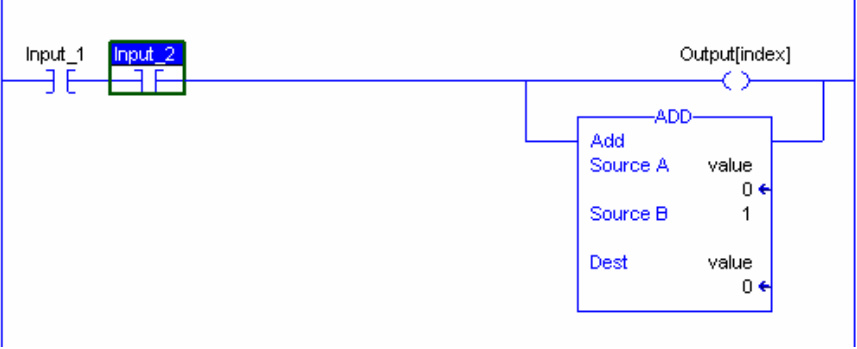
Firmware Revision	Description
16.22	<p>Fault handlers can be defined at the controller and program scope levels. These fault handlers are typically used to handle major recoverable faults that can occur during runtime execution of an application due to programming errors. A typical example of this would be handling indirect addressing that has gone out of range; MyTag[index], where index is larger than the size of the array.</p> <p>Faults can also be handled by the controller during pre-scan of the controller program on the transition to Run mode. Again, for example, the handling of indirect addressing that has gone out of range.</p> <p>There is an anomaly when these methods attempt to handle a fault.</p> <p>These are the possible ways the anomaly can manifest itself:</p> <ul style="list-style-type: none"> • The controller will experience a major non-recoverable fault. I/O goes to their configured safe state, and the user application is cleared from memory. At this point, a Code 1 Type 60 or 61 major recoverable fault will be logged in the controller. This requires you to redownload the application. • Tag data corruption. • Online saving or uploading failures. • Anomalous program execution. <p>For example, if a rung is being scanned false and there is an instruction that has false execution, the fault handler executes so the remainder of the rung will scan true. In the example below, the OTE instruction has an index out of range. After returning from the fault handler, the ADD instruction will execute, even though the rung input conditions are false.</p>
