ControlLogix Controllers Revision 13

Cat. No. 1756-L1, -L1M1, -L1M2, -L1M3, -L55, -L55M12, -L55M13, -L55M14, -L55M16, -L55M22, -L55M23, -L55M24, -L61, -L62, -L63

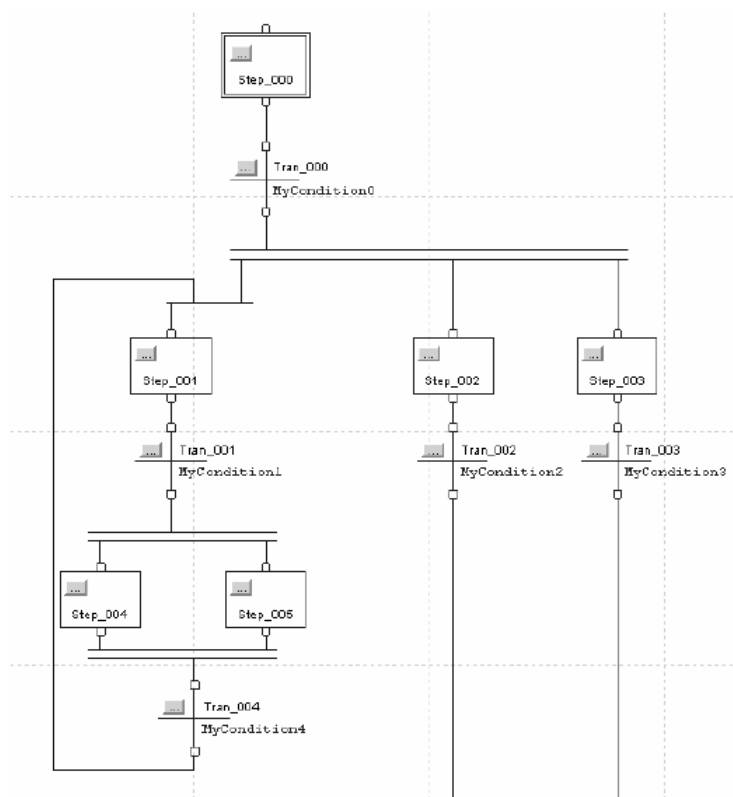
An SFC Could Execute the Wrong Step

If you had an SFC with nested simultaneous branches, the controller could begin execution at an unexpected step. Following the convergence of a nested simultaneous branch, if the SFC looped back to the initial step of the parent branch, instead of executing that step, the SFC could jump to a step of another path in the nested simultaneous branch. For example:

Execution starts at Step_000. When Tran_000 becomes true, Step_001, Step_002 and Step_003 should become active. However, because the nested simultaneous branch in the left path converged and looped back to its parent step (Step_001), the active steps were actually **Step_005**, Step_002 and Step_003.

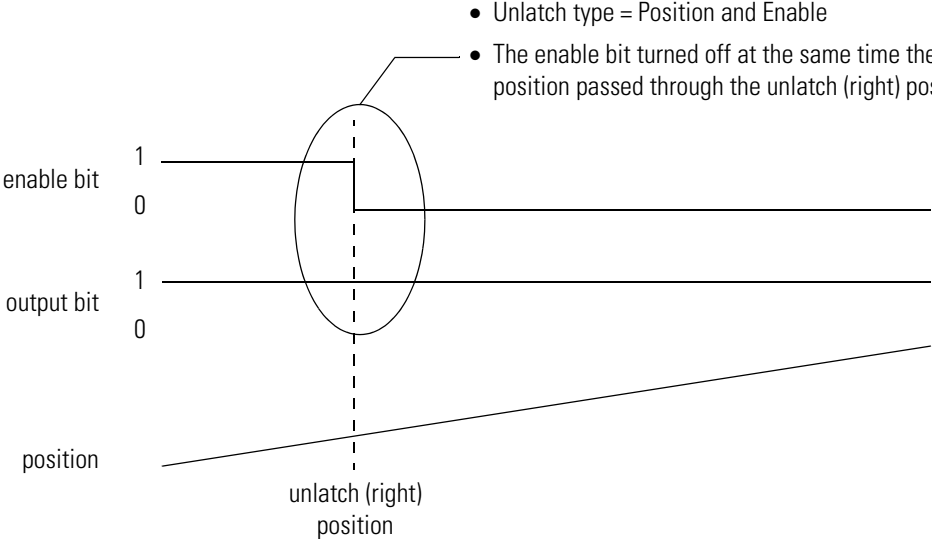
Corrected anomaly:	Description:
MAOC Instruction Left Output Bit On When Enable Bit Turned Off	<p>Under the following conditions, the Motion Arm Output Cam (MAOC) instruction left the output bit on when the bit should have turned off.</p> <div><ul style="list-style-type: none">• Unlatch type = Position and Enable• The enable bit turned off at the same time the position passed through the unlatch (right) position.

<p>enable bit</p><p>output bit</p><p>position</p><p>unlatch (right) position</p></div>
Lgx00048145

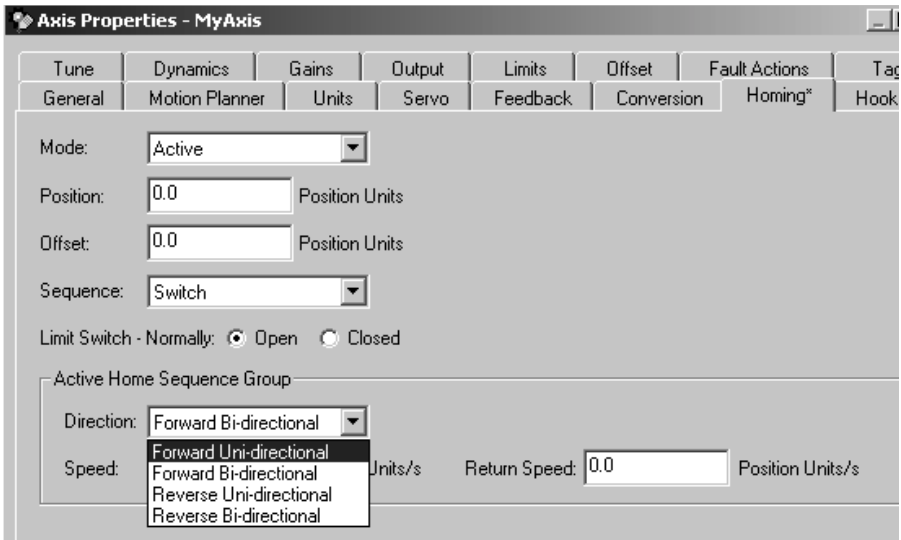
Corrected anomaly:	Description:
Uni-Directional Homing Failed to Complete	<p>A Motion Axis Home (MAH) instruction sometime failed to complete (IP bit remained on) under the following axis configuration:</p> <ul style="list-style-type: none">Return Speed = 0uni-directional homing (forward or reverse)

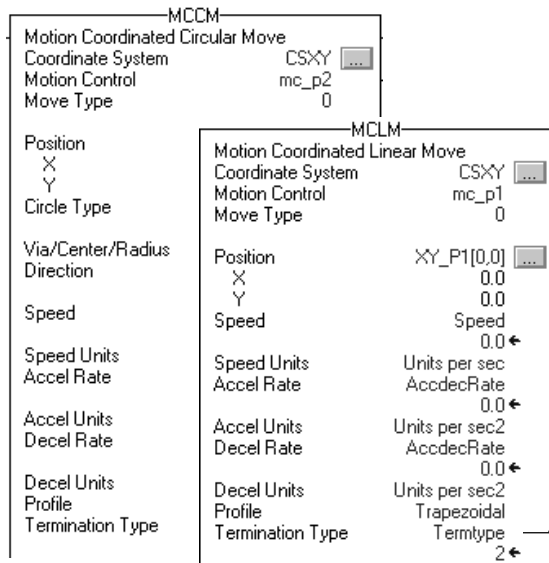
Corrected anomaly:	Description:
Blended Moves Produce Smoother, More Accurate Motion	This revision improves the response of the axes when you blend the execution of Motion Coordinated Linear Move (MCLM) and Motion Coordinated Circular Move (MCCM) instructions.

- If the Termination Type = command tolerance (2) or no decel (3), axes change more smoothly and follow the intended path more closely.
- If the Termination Type = command tolerance (2) or no decel (3) and the program path direction is reversed, the instruction will exceed the specified acceleration/deceleration for the MCLM or MCCM instruction.
