1769 CompactLogix Packaged Controllers, Revision 19

Catalog Numbers 1769-L23E-QB1B, 1769-L23E-QBFC1B, 1769-L23-QBFC1B

This publication describes enhancements, anomalies (known and corrected), and restrictions for 1769-L2x CompactLogix packaged controllers, revision 19.11.

Publication 1769-RN014A-EN-P - September 2010

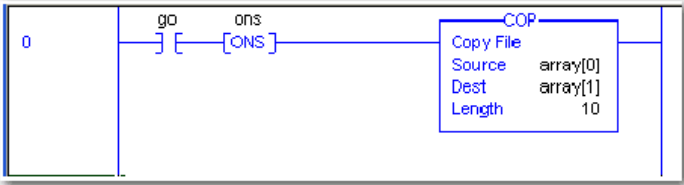
Cat. No.	Description																																																
1769-L23E-QB1B, 1769-L23-QB1BFC, 1769-L23E-QB1BFC	<p>The Copy File (COP) Synchronous Copy File (CPS) instruction use may result in Unexpected Execution</p> <p>If the COP or CPS instructions are configured so that the source and destination tags overlap, the instruction has unexpected execution.</p> <p>For example, these graphics show an example COP instruction and its tag values before execution.</p> <div>

</div> <div><table><thead><tr><th>Name</th><th>Value</th></tr></thead><tbody><tr><td>array</td><td>{ ... }</td></tr><tr><td>+ array[0]</td><td>0</td></tr><tr><td>+ array[1]</td><td>1</td></tr><tr><td>+ array[2]</td><td>2</td></tr><tr><td>+ array[3]</td><td>3</td></tr><tr><td>+ array[4]</td><td>4</td></tr><tr><td>+ array[5]</td><td>5</td></tr><tr><td>+ array[6]</td><td>6</td></tr><tr><td>+ array[7]</td><td>7</td></tr><tr><td>+ array[8]</td><td>8</td></tr><tr><td>+ array[9]</td><td>9</td></tr></tbody></table></div> <p>The result should be an array that contains all zeros. Instead, the result is an array that contains the values shown in this graphic.</p> <div><table><thead><tr><th>Name</th><th>Value</th></tr></thead><tbody><tr><td>array</td><td>{ ... }</td></tr><tr><td>+ array[0]</td><td>0</td></tr><tr><td>+ array[1]</td><td>0</td></tr><tr><td>+ array[2]</td><td>1</td></tr><tr><td>+ array[3]</td><td>2</td></tr><tr><td>+ array[4]</td><td>3</td></tr><tr><td>+ array[5]</td><td>3</td></tr><tr><td>+ array[6]</td><td>5</td></tr><tr><td>+ array[7]</td><td>6</td></tr><tr><td>+ array[8]</td><td>7</td></tr><tr><td>+ array[9]</td><td>7</td></tr></tbody></table></div> <p>Lgx00114495, Lgx00114576</p>	Name	Value	array	{ ... }	+ array[0]	0	+ array[1]	1	+ array[2]	2	+ array[3]	3	+ array[4]	4	+ array[5]	5	+ array[6]	6	+ array[7]	7	+ array[8]	8	+ array[9]	9	Name	Value	array	{ ... }	+ array[0]	0	+ array[1]	0	+ array[2]	1	+ array[3]	2	+ array[4]	3	+ array[5]	3	+ array[6]	5	+ array[7]	6	+ array[8]	7	+ array[9]	7
