STM32h7hxi Embassy UART Issues

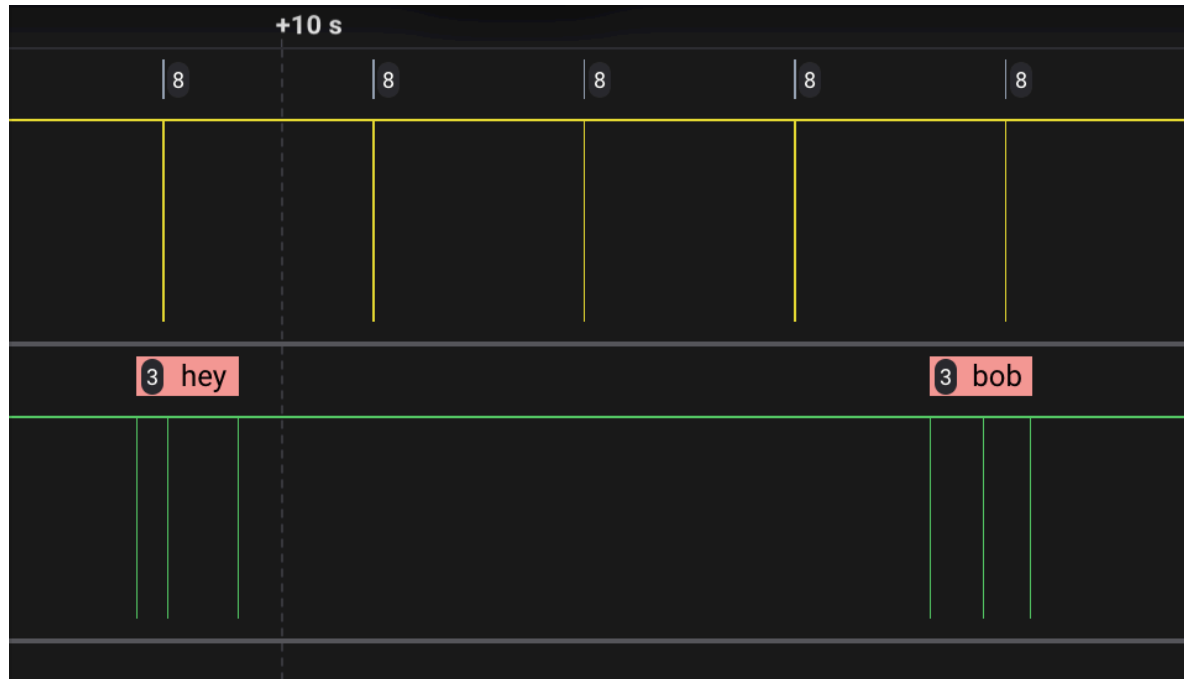
Screen connected to Arduino UNO Wifi Rev2 at 9600baud

Bottom in green: text sent from the screen session, and in yellow response from the UNO saying "Got: h\r\n" etc. It repeats for every character.

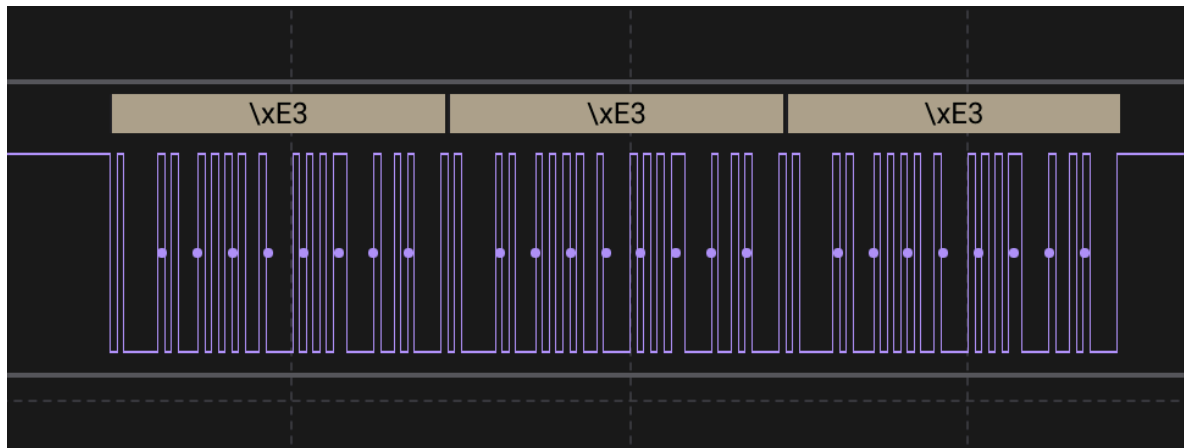
stm32h747_slow

Connecting the STM32h7hxi (Arduino Portenta H7) with Embassy UART blocking write of text "ATB\r\n" appears as 3-bytes of 0xE3.

This is with the power stage config called "slow".

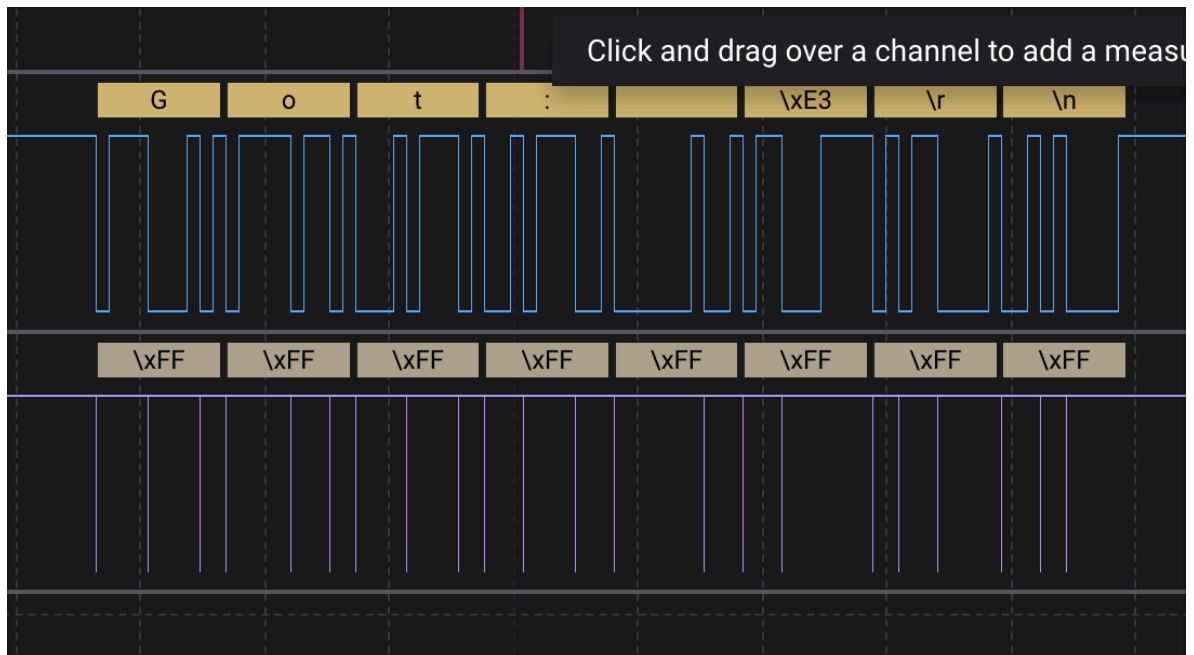
The UNO's response is seen below in blue

I'm also not sure why it's responding with 0xFF for every response byte from the UNO. This is strange.

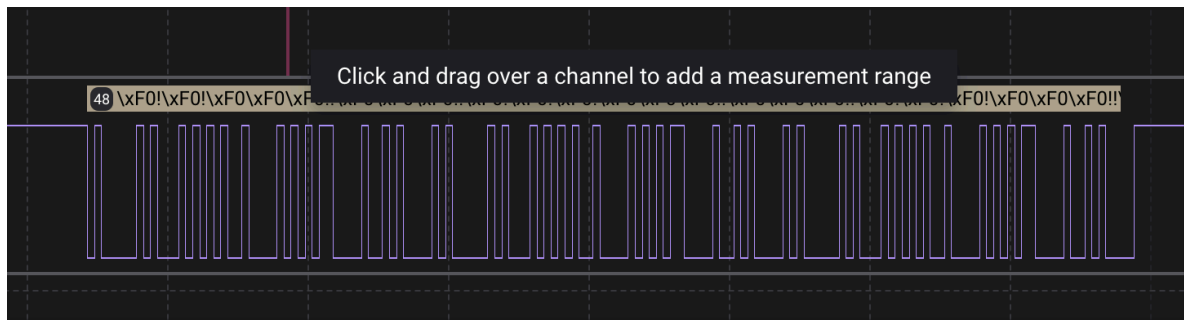
stm32h747_480

Changing to power stage `stm32h747_480`

UART blocking write of text "ATB\r\n" now changes to

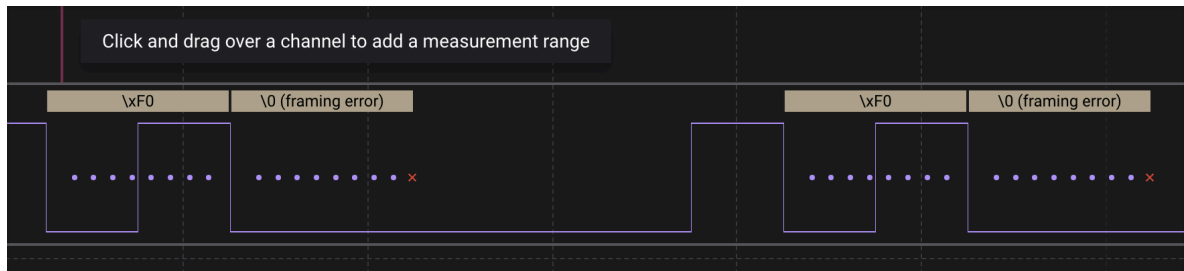
Notice the framing errors
