ABBA firmware status

Alessandra Camplani – Università degli Studi di Milano

06/06/2016

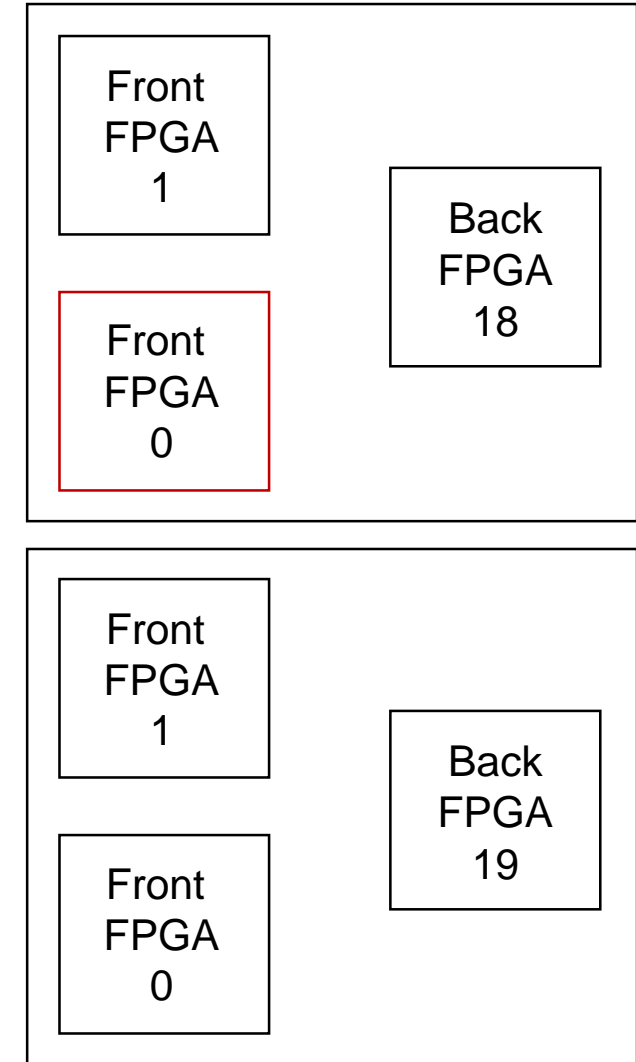
Known issue with FPGA 18:0 in USA15 (part 1)

➤ **only one not responding** (FPGA 18:0)

- FPGA 0 from ABBA 91.18 was sending some random data that affect FPGA 1 on the same board, but also the other board
 - v0.68a: length check in UDP and IP module now avoids transmission of garbage!
 - Stabilized readout with 3 remaining FPGAs

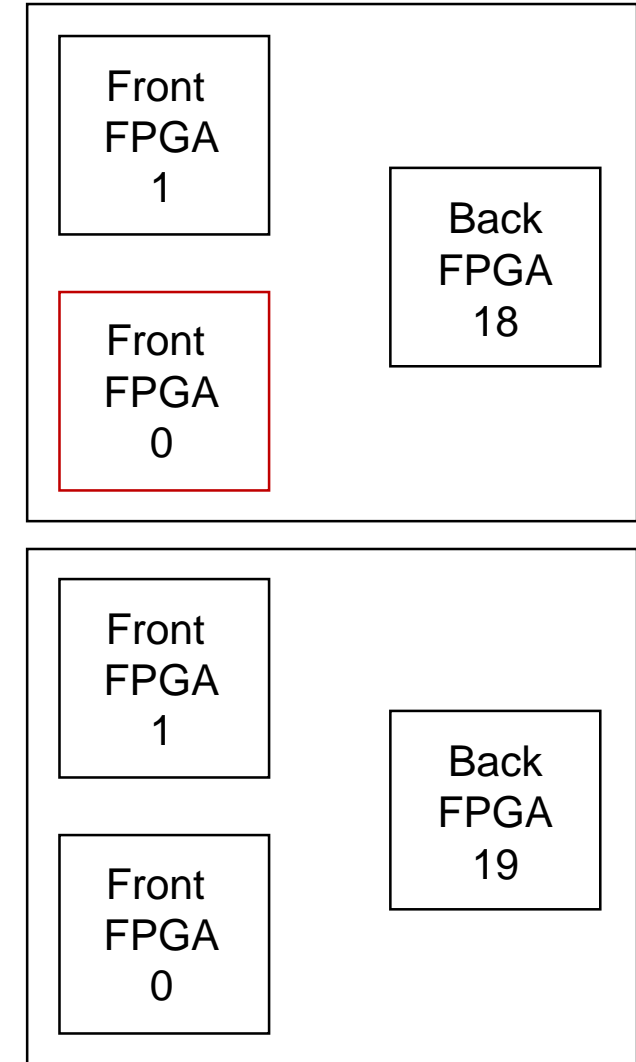
Known issue with FPGA 18:0 in USA15 (part 2)

Issue hidden but not solved ...

Looking with **Signal Tap** Altera tool in front FPGA:

- the signal which is blocking if the FPGA is *aligned_status*:
 - coming from the ALTERA XAUI CORE
 - connected to *channelaligned* signal in the back FPGA interface

The issue is coming from the **communication between front and back** FPGA.

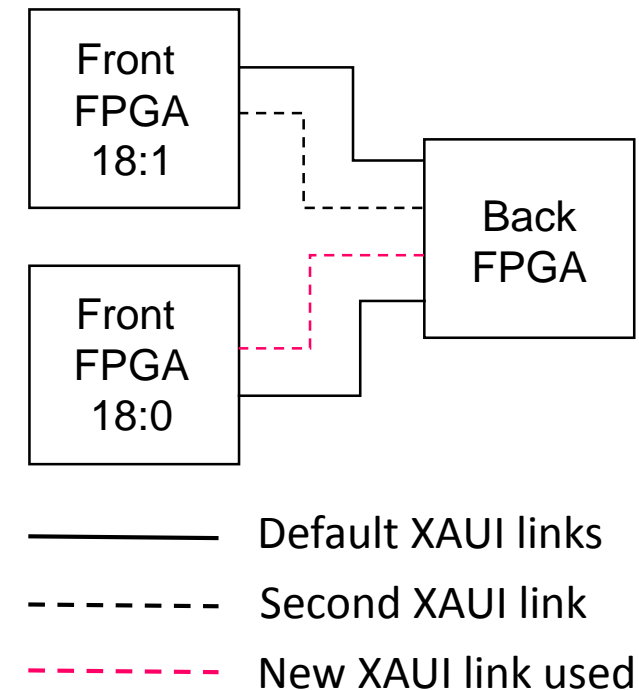
Known issue with FPGA 18:0 in USA15 (part 3)

➤ **All these attempts didn't solve the issue.**

Neither this solution recovered the FPGA.

- **Conclusion:** hardware issue (also the TTC is behaving differently here!)

To solved this issue **different strategies** have been adopted:

- Solved timing critical warnings
- Used a different (better) clock source: oscillator
- Improved reset structure
- Changing reset in most important processes from asynchronous to synchronous

- Tried the second XAUI transceiver

- **Finally (27/05/2016):** added a new ABBA in USA15 to substitute FPGA 18:0
