# LMX9838 Firmware Release Note

National Semiconductor  
Application Note 1706  
Markus Roemer  
September 2007

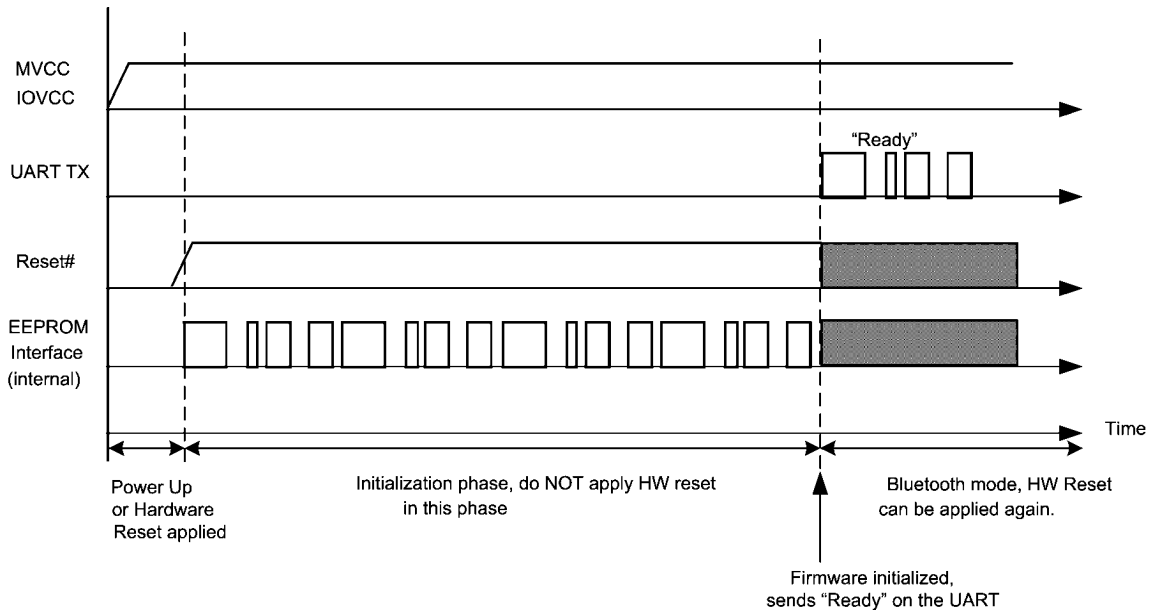
30036303

In case the Hardware Reset is applied while the EEPROM is accessed by the baseband controller, it may occur that the EEPROM locks up on the serial interface and

can not be accessed from the baseband controller anymore. The result of this is, that the LMX9838 will respond with

the “Await initialization” Event, which indicates, that the bluetooth address could not be read from the EEPROM.

**FIGURE 3. Safe Reset Timing on Power-up or After Hardware Reset**

To avoid this scenario, the LMX9838 RESET# must not be pulled low between one of the following events and the device sending the “Ready” Event on the UART interface:

- on power-up (after pulling Reset# high)
- after a hardware reset (using the pin Reset#)
- after a software reset (using the command “Reset”)

In case it is not possible to read back the “Ready” Event (e.g. it is not possible to parse the LMX9838 events), the workaround can be implemented by waiting for about 1 second, before re-applying the hardware reset again. The estimated maximum time for the firmware to initialize is about 900 milliseconds, so 1 second should give enough margin.

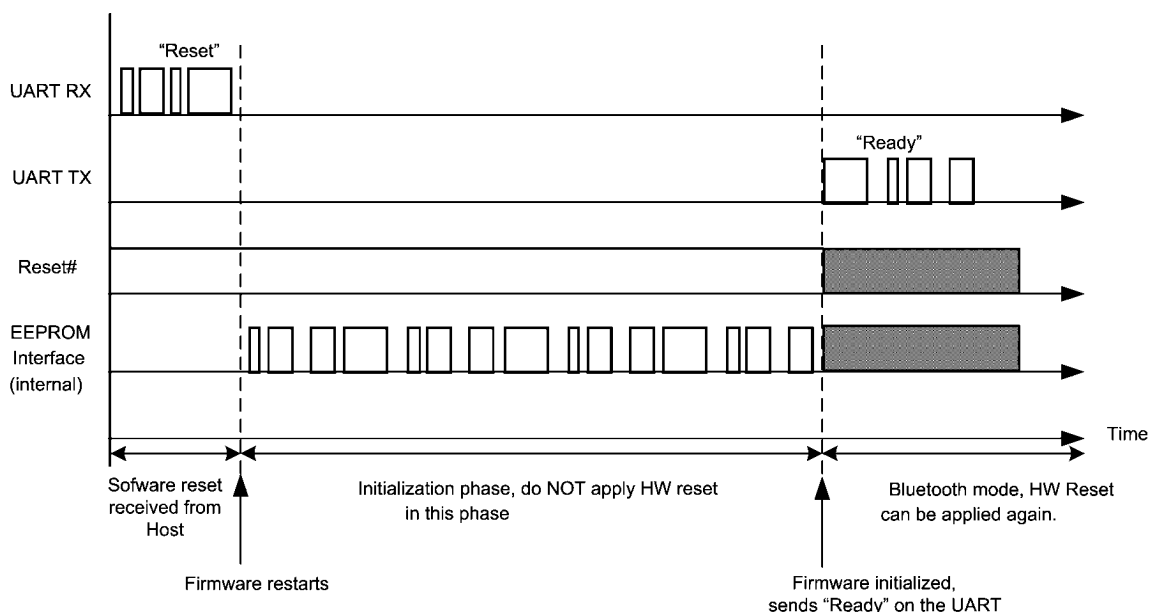
30036304

FIGURE 4. Safe Reset Timing on Software Reset

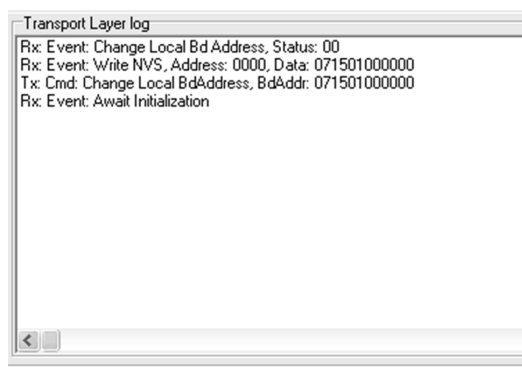
30036305

If a Hardware reset, Software reset or Power up occurs during the EEPROM initialization phase, the EEPROM might be unrecognized and might lock-up. If this situation happens, there is a way to recover and reset the module. On receiving the `AWAIT_INITIALIZATION_EVENT` perform the following steps:

FIGURE 5. Step 1, Write `BD_Addr`

1. Write `BD_ADDR`
2. Load the Patch 10
3. Send `ENTER_BLUETOOTH_MODE` command
4. Send `RESET` command

After sending the `BD_ADDR` write command, the SimplyBlue commander log window should look like the following.

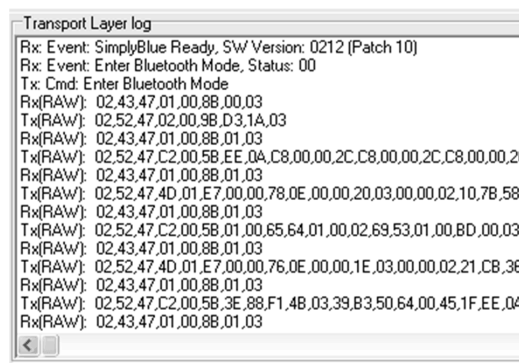
30036306

FIGURE 6. Step 2/3, Apply Patch 10 and Enter `BT_Mode`

After sending the Patch 10 and Enter Bluetooth Mode command, the log window should show:

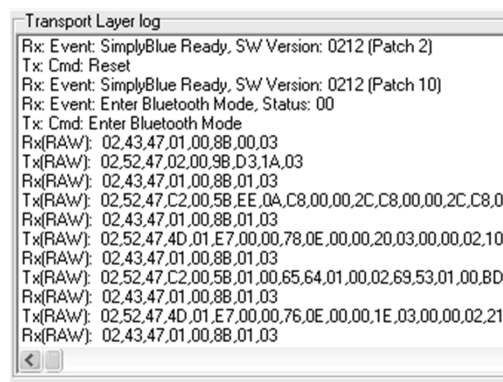
30036307

FIGURE 7. Step 4, Send Software Reset

Finally after software reset the module recovers and is back to its normal operation mode.
