3rdParty MCAL Integration

Technical Reference

Infineon TC3xx

Version 2.13.00

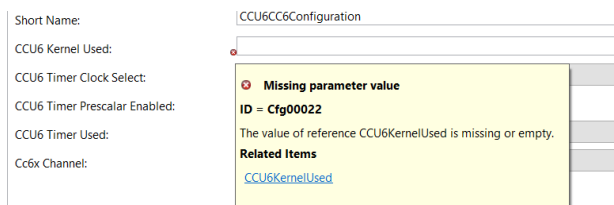
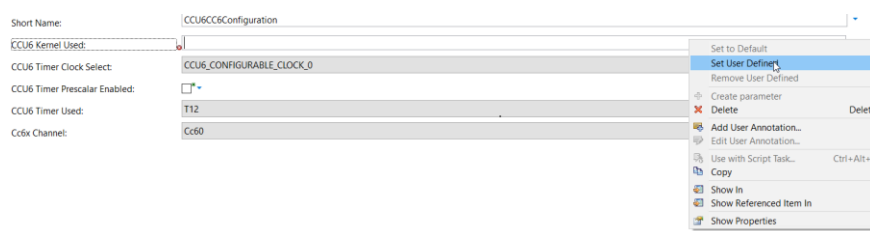
2.1.1.2 Inconsistency between Tresos and CFG5

There may be inconsistencies between parameters in Tresos and CFG5. This is because the parameter in Tresos is marked as optional while it is mandatory in CFG5.

To avoid that the parameter has to be configured in CFG5 and the configuration is changed, set the parameter to User Defined.

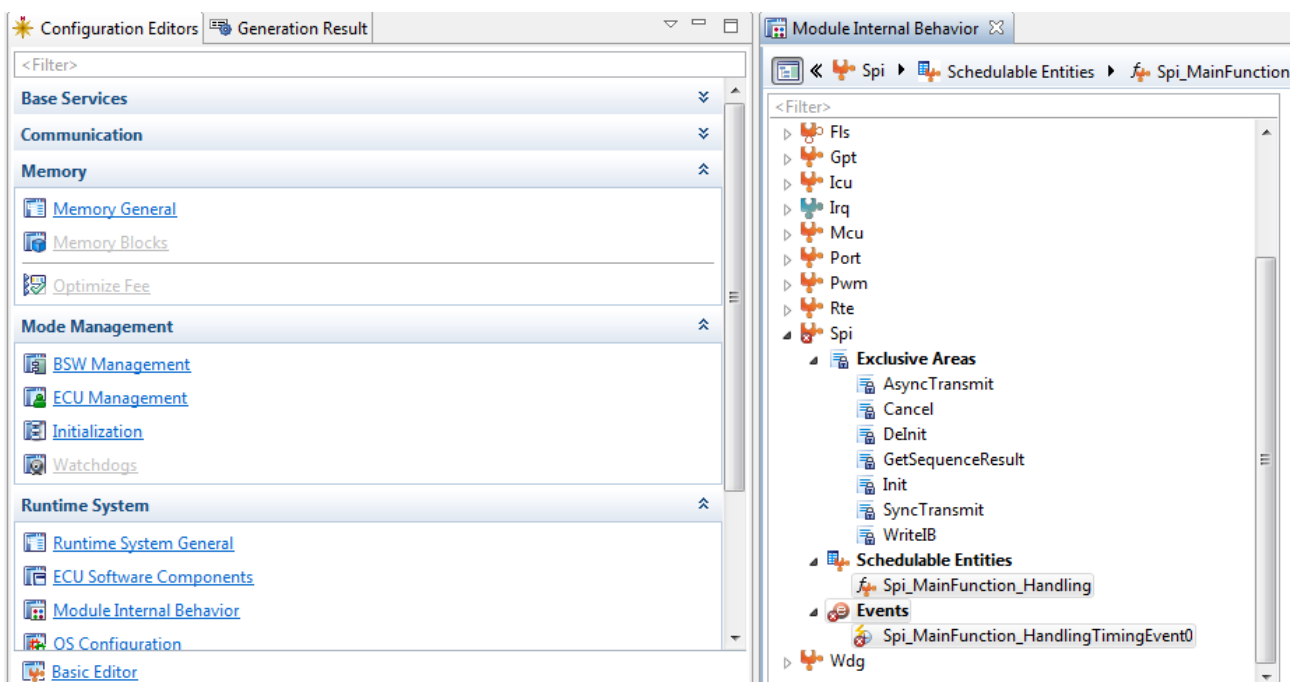
2.1.2.1.1 Extern Definition for the function Spi_MainFunction_Handling is defined with a compiler switch.

The function Spi_MainFunction_Handling is called unconditionally in the file SchM_Spi.h without any compiler switch but the extern definition of this function is defined in spi.h file with a compiler switch.

This leads to an error as below if Spi Level Delivered is different from 2:

Remove the configuration for Spi_MainFunction_Handling in
Runtime System → Module Internal Behavior → Spi → Schedulable Entities and Events

Please see the below image for some more information.

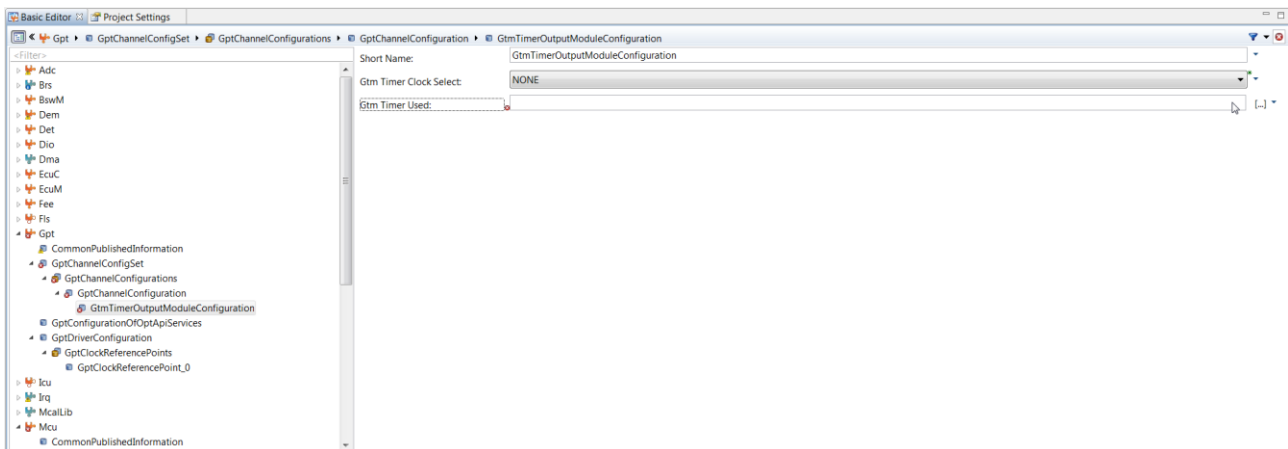
2.1.4.3.3 GPT modules cannot be generated in DaVinci configurator.

For the derivative TC35x generation of GPT is not possible in DaVinci Configurator.

Gpt/GptChannelConfigSet/GptChannelConfiguration/GtmTimerOutputModuleConfiguration/GtmTimerUsed

The tag GtmTimerUsed is a mandatory tag with multiplicity 1:1.

To configure this tag, we must give a reference to Mcu/McuHardwareResourceAllocationConf/McuGtmAllocationConfcontainer, but this container is not available for the derivative TC35x

GPT module must be generated with Tresos and the generated files has to be copied to GenData/Src and Gendata/inc folders respectively for the compilation.

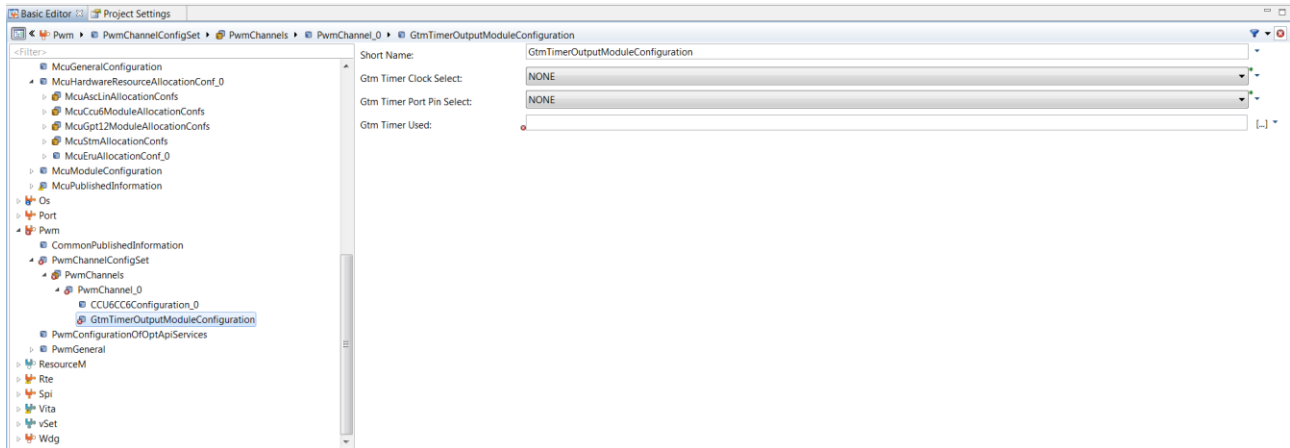
2.1.4.3.4 PWM modules cannot be generated in DaVinci configurator.

For the derivative TC35x generation of PWM is not possible in DaVinci Configurator.

Pwm/PwmChannelConfigSet/PwmChannel/GtmTimerOutputModuleConfiguration/GtmTimerUsed

The tag GtmTimerUsed is a mandatory tag with multiplicity 1:1.

To configure this tag, we must give a reference to Mcu/McuHardwareResourceAllocationConf/McuGtmAllocationConfcontainer, but this container is not available for the derivative TC35x

Pwm module must be generated with Tresos and the generated files has to be copied to GenData/Src and Gendata/inc folders respectively for the compilation.
