Starliner investigation finds numerous problems in Boeing software development process

by [Jeff Foust](#) — February 7, 2020

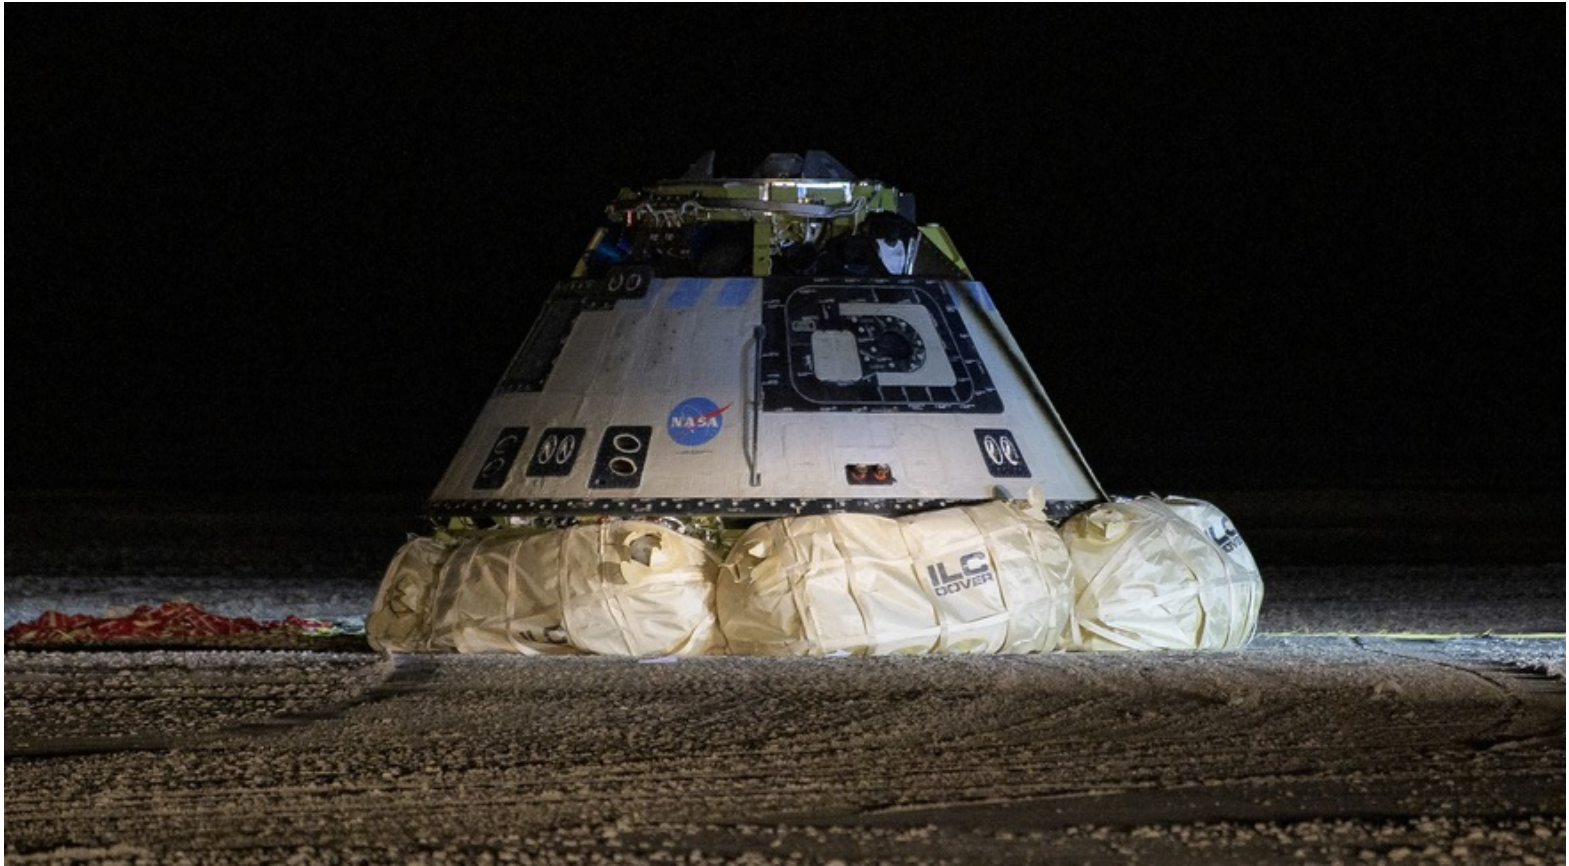
Boeing corrected a software flaw that could have caused the Starliner's service module to run into the crew capsule just a few hours before Starliner landed in New Mexico. Credit: NASA/Bill Ingalls

The second problem, revealed Feb. 6 at a meeting of the Aerospace Safety Advisory Panel (ASAP), was a “valve mapping error” for the thrusters in the vehicle’s service module. Those thrusters perform a “disposal burn” of the service module after separating from the crew module just before reentry.

Mulholland said the valves were configured for conditions in normal flight for that disposal burn, which, had it not been corrected, could have pushed the service module into the crew module. That could have caused the crew capsule to become unstable, requiring additional thruster firings to reorient itself, or have damaged the capsule’s heat shield.

The second error was detected during the review of the spacecraft software on the ground after the timer problem took place. Mulholland said engineers found the thruster software issue late Dec. 21, with the corrected and reverified code uploaded to the spacecraft around 5 a.m. Eastern Dec. 22, or about three hours before the spacecraft landed at White Sands Missile Range in New Mexico.
