TDC Documentation

Project Overview

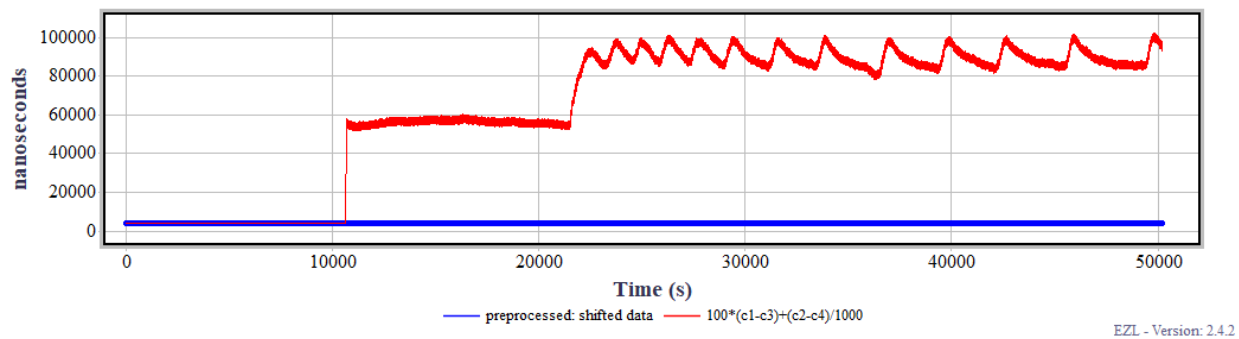
While testing the continuous polling feature, some unexpected behavior appeared. When a signal was disconnected and reconnected, the error would jump from 3500 (to 60000 when disconnected) to 100000 ns as shown in the diagram below. This issue seemed to have occurred more readily after the TDC board had been sending data for more than 3 hours, but it was still possible to recreate the behavior within a few seconds by disconnecting and reconnecting sporadically. It also more difficult to replicate in the lab, probably because the integrity of the PPS in the lab is higher than the Arduino sourced one.

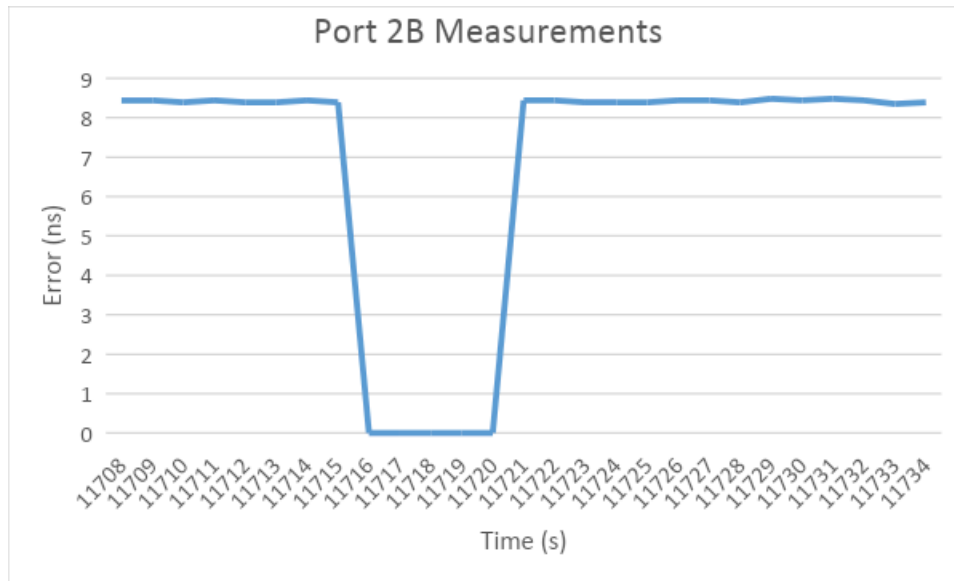
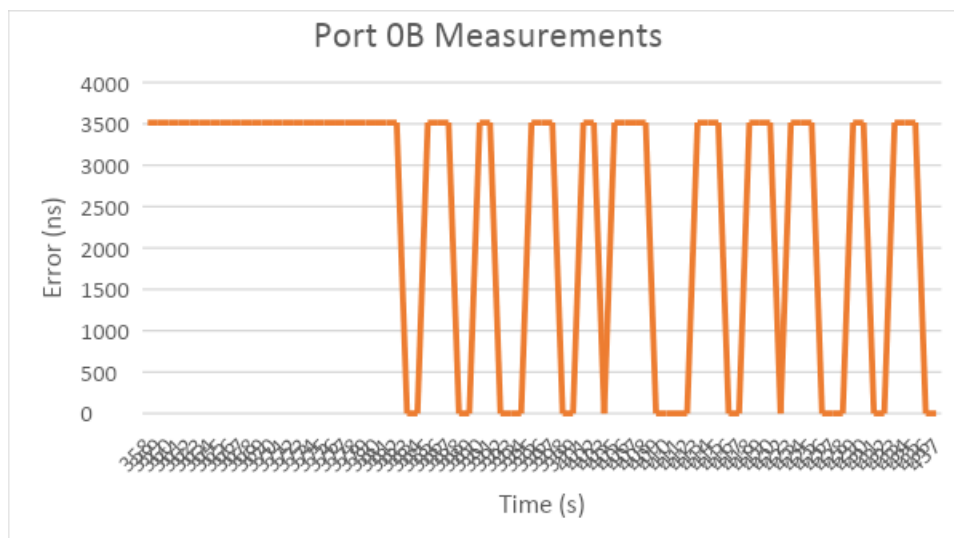
This problem seemed to have stemmed from some FIFO buffers being filled completely while others still have empty space. When a PPS signal is pulled off, that channel's FIFO is cleared, but then in order to restart it, 2 STOPS are needed. The other channels have already executed 2 STOPS at the beginning of the loop, so this discrepancy in time makes the data lag.

Now, the problem of disconnecting and reconnecting does not seem to appear. It was tested in lab and at home over several hours and multiple reconnections as shown below:

To prevent this from happening, the `COMMON_FIFO_READ` configuration was set to 0 so that all four channels are completely independent from one another. If there are any pending measurements/empty spaces in the FIFOs, the INTERRUPT pin will be held low (from the data sheet: "interrupt gets high when all FIFO are empty"). In `tdc_spi.cpp`, the code has been changed to make sure the measurements are all read through the buffers as long as there is at least one FIFO with valid data.

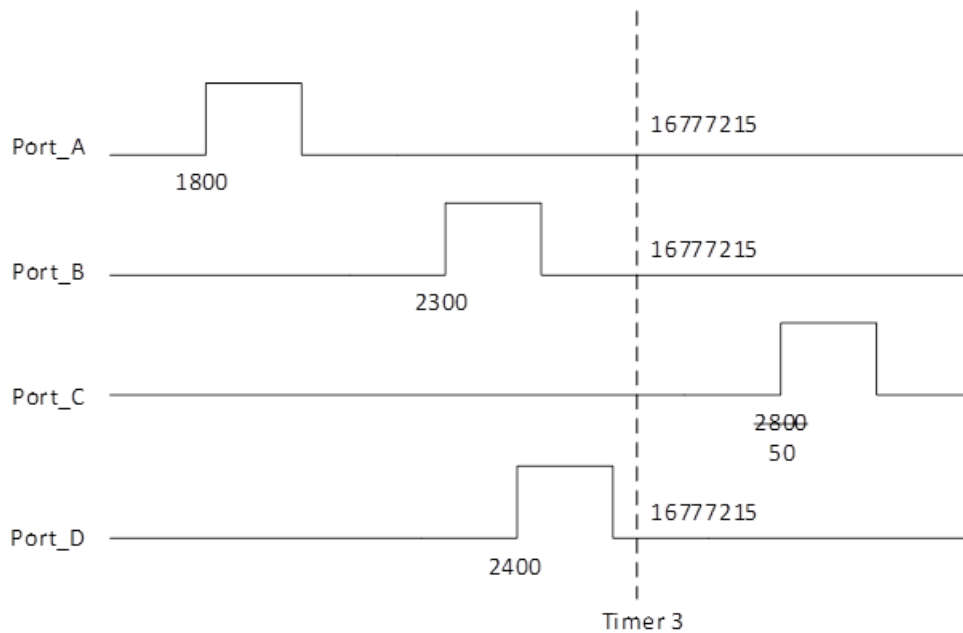
The placing of the interrupt will be something to think about as well. If the interrupt occurs somewhere between the reference pulse on Port A and a pulse on any other port, there is a potential misalignment of measurements.

In this drawing above the reported time difference between Port A and Port B will be 500. The difference between A and D will be 600. The difference between Port A and Port C *should* be 1000, but because the interrupt occurred, the buffers are cleared and the index is reset. Ports A, B, and D read out 0x00FFFFFF (overflow), but Port C is something else. This has not been an issue seen in the wild yet, but it is important to note in case it does in the future.
