JOURNEY RISK MANAGEMENT (JRM) STUDY

IOCL Coimbatore Terminal to Aadhithiya Krishnaa Fuels

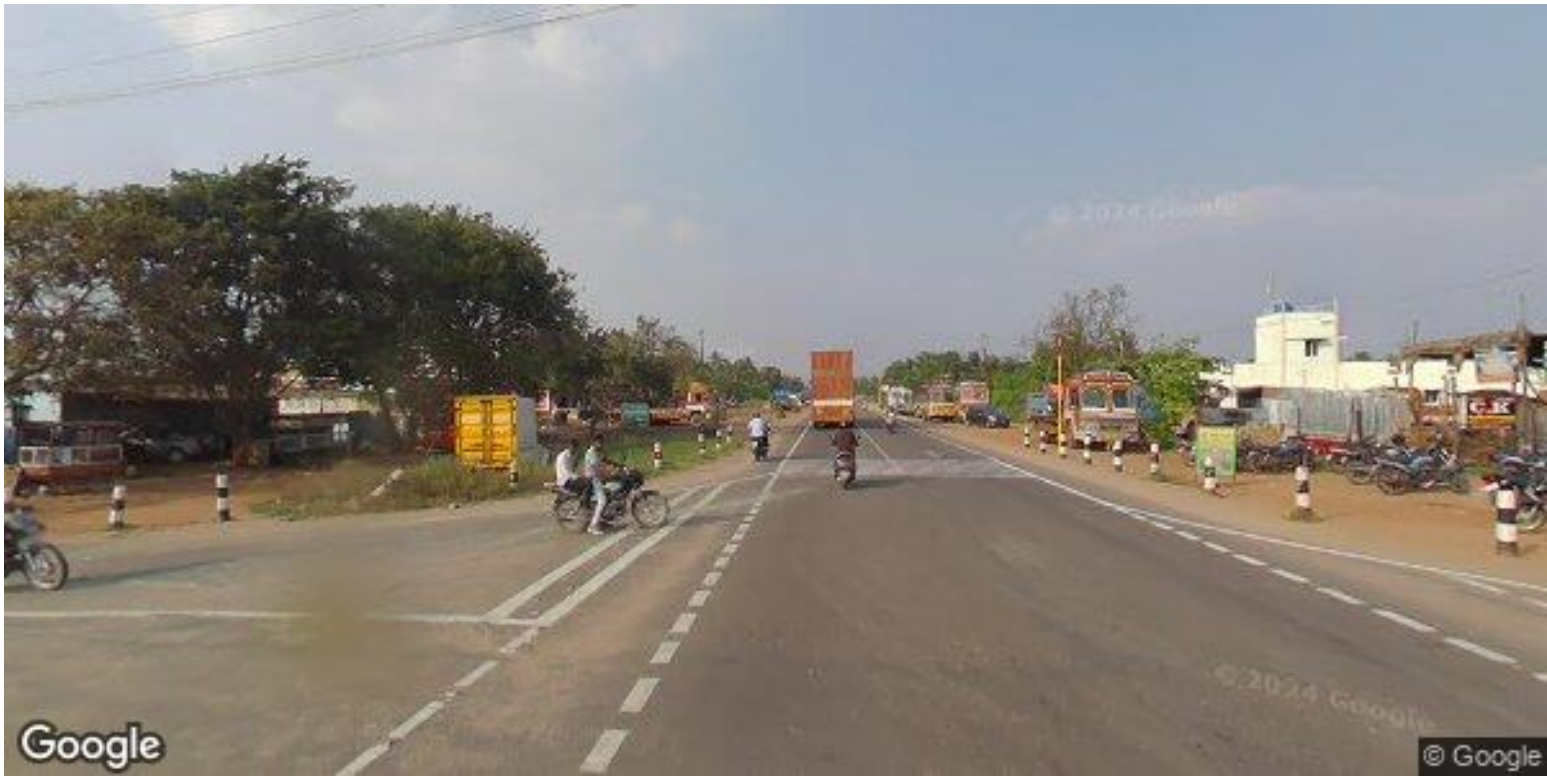
Speed Limit: 10 KM/Hr
Coordinates: 11.03211, 77.07640

Risk Type: Blind Spot
Risk Level: Blind Spot

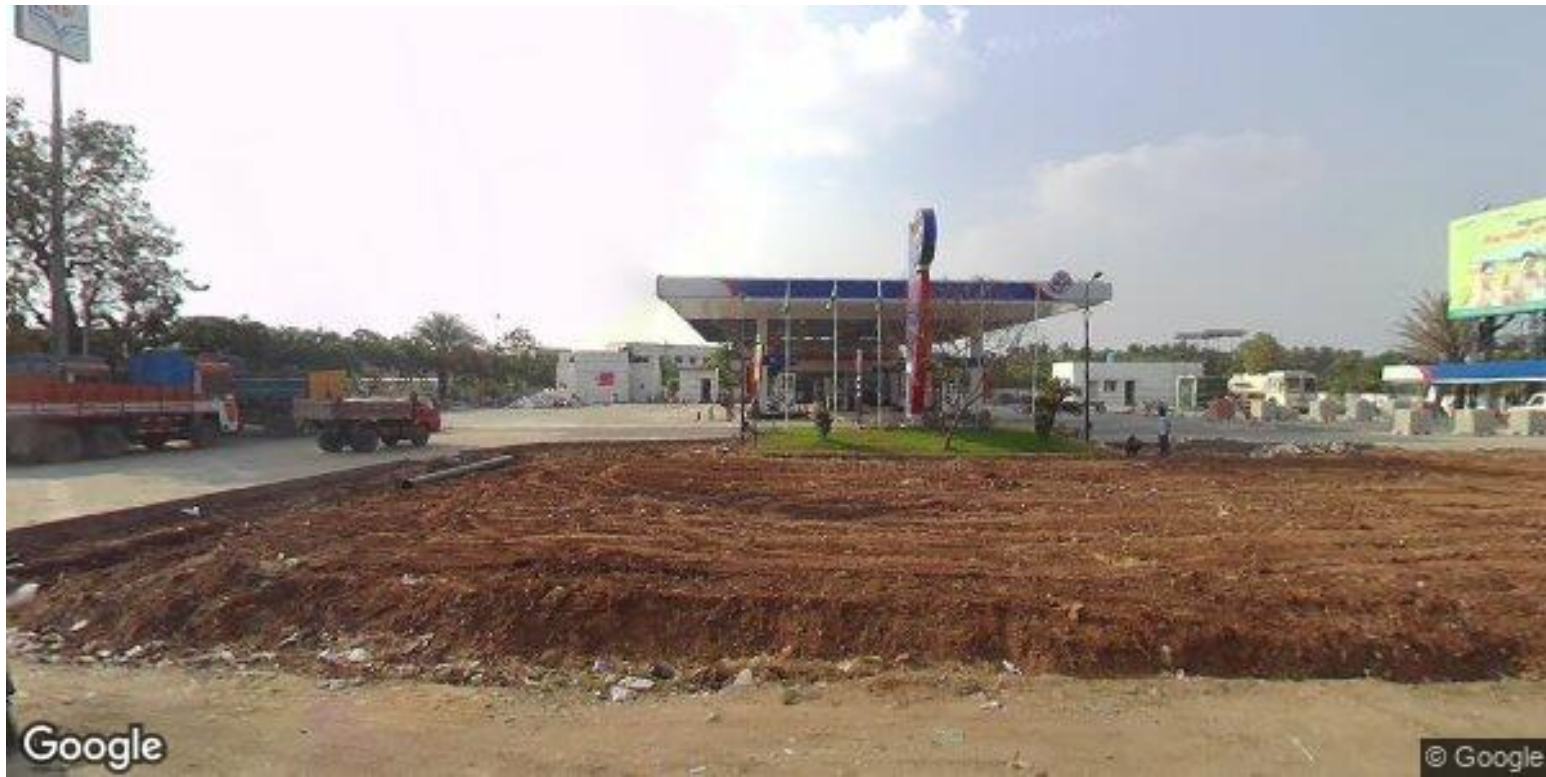
Risk Type: Turn
Risk Level: Medium
Speed Limit: 30 KM/Hr
Coordinates: 11.00873, 77.07114

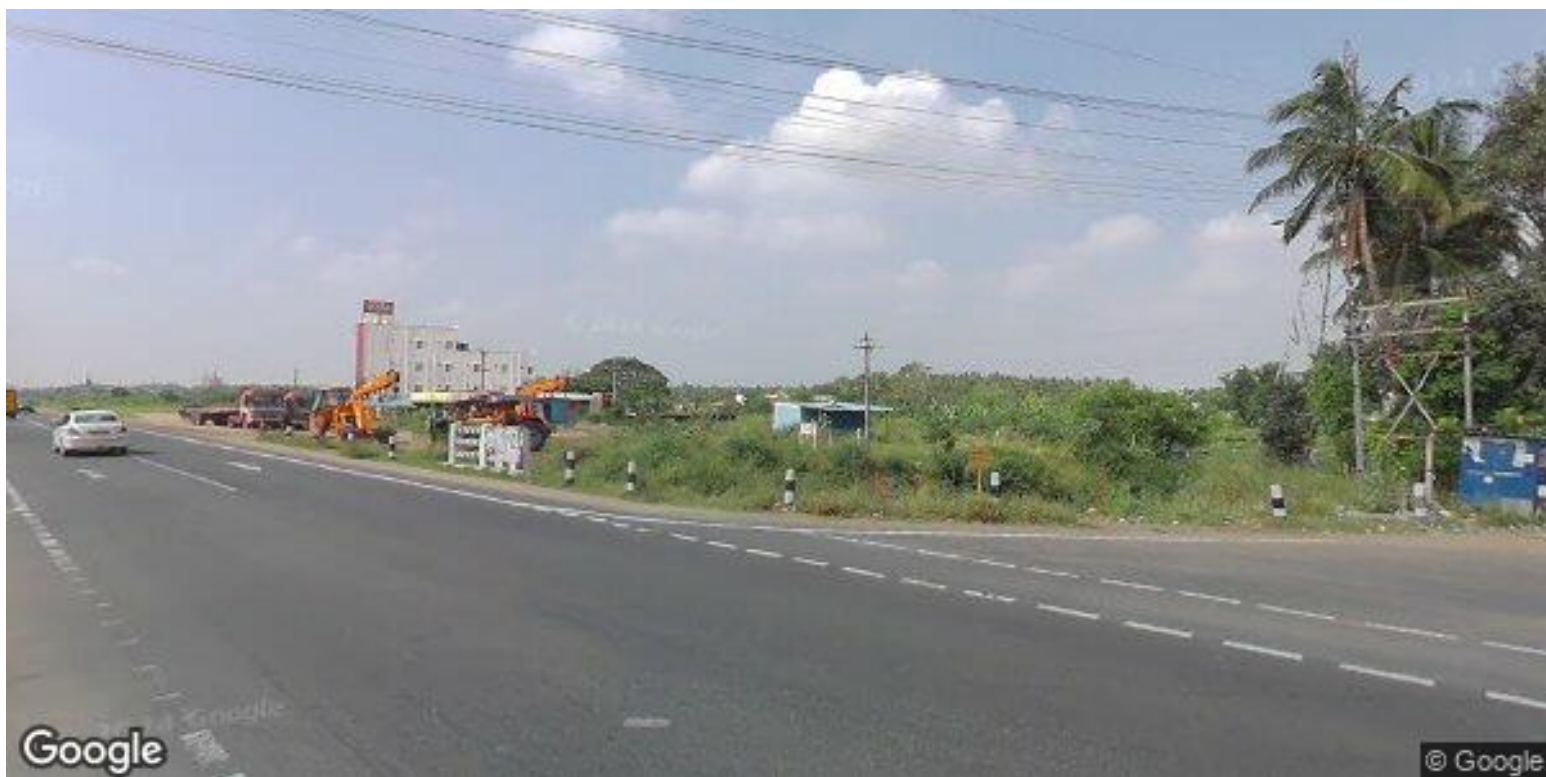
Risk Type: Turn
Risk Level: High
Speed Limit: 15 KM/Hr
Coordinates: 10.99307, 77.05866

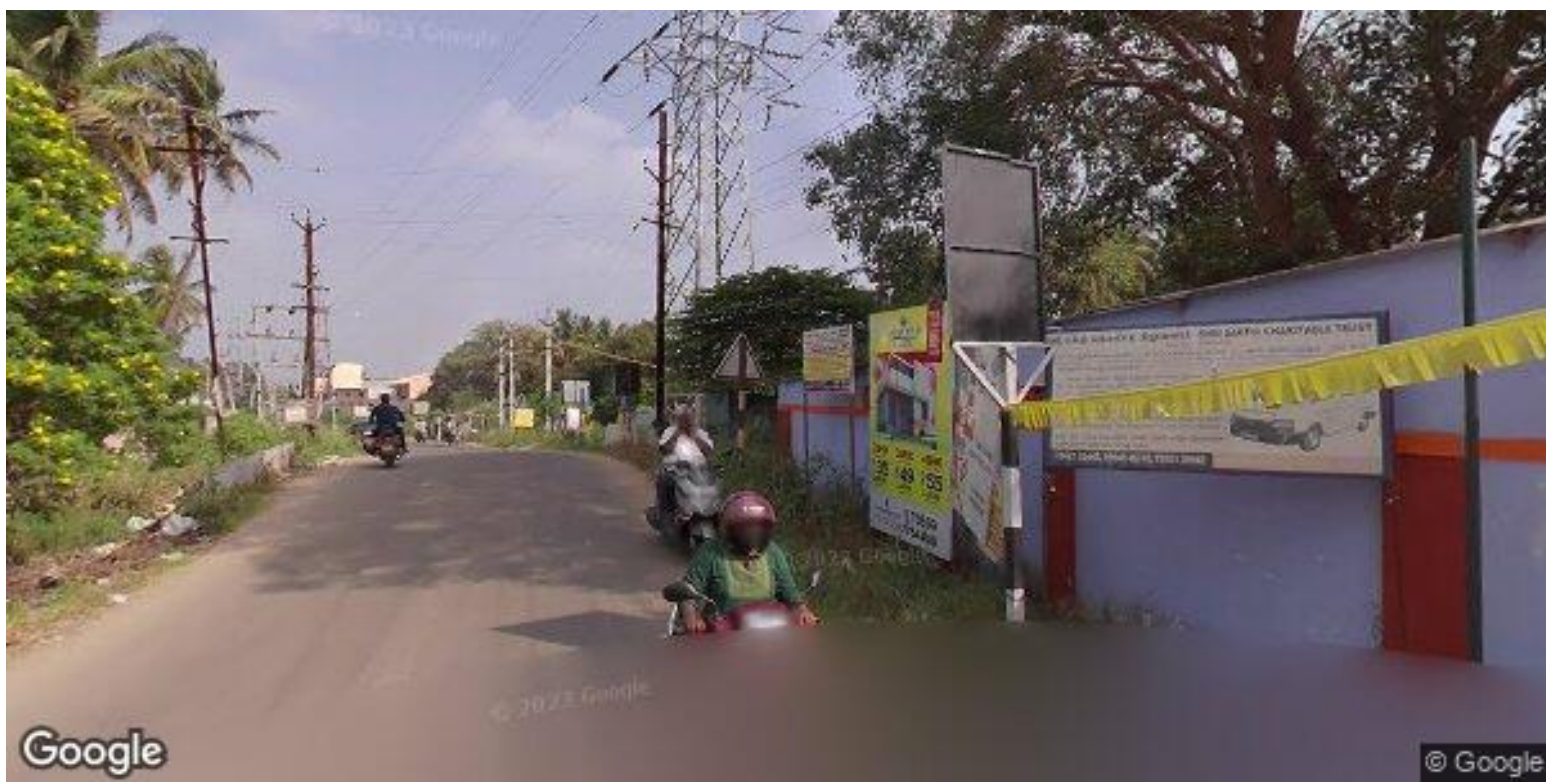
Coordinates: 10.99073, 77.05906

Risk Type: Turn

Risk Level: Medium

Speed Limit: 30 KM/Hr

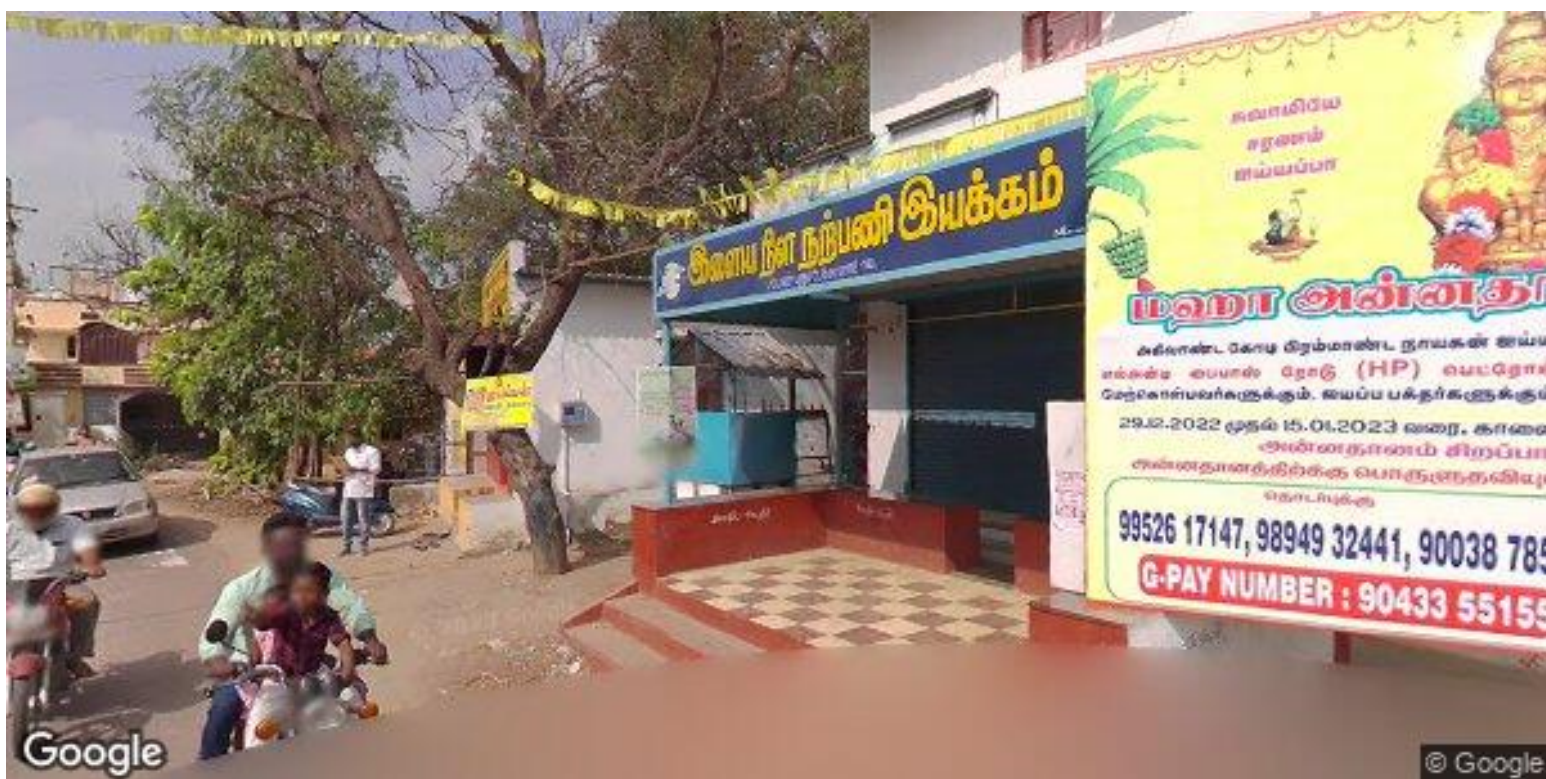
Coordinates: 10.99062, 77.05900

Risk Type: Blind Spot

Risk Level: Blind Spot

Speed Limit: 10 KM/Hr

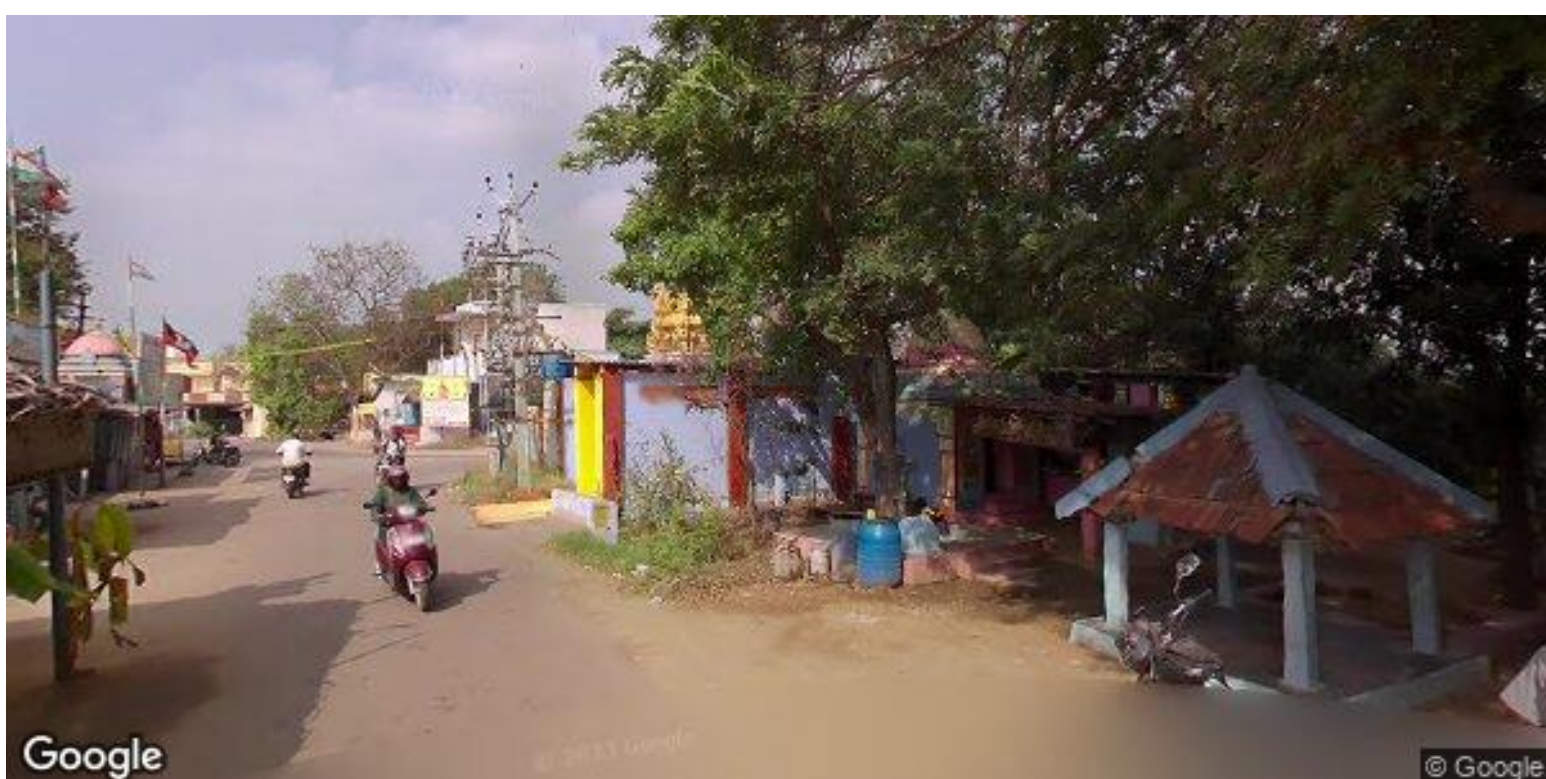
Coordinates: 10.99061, 77.05936

Risk Type: Turn

Risk Level: Medium

Speed Limit: 30 KM/Hr

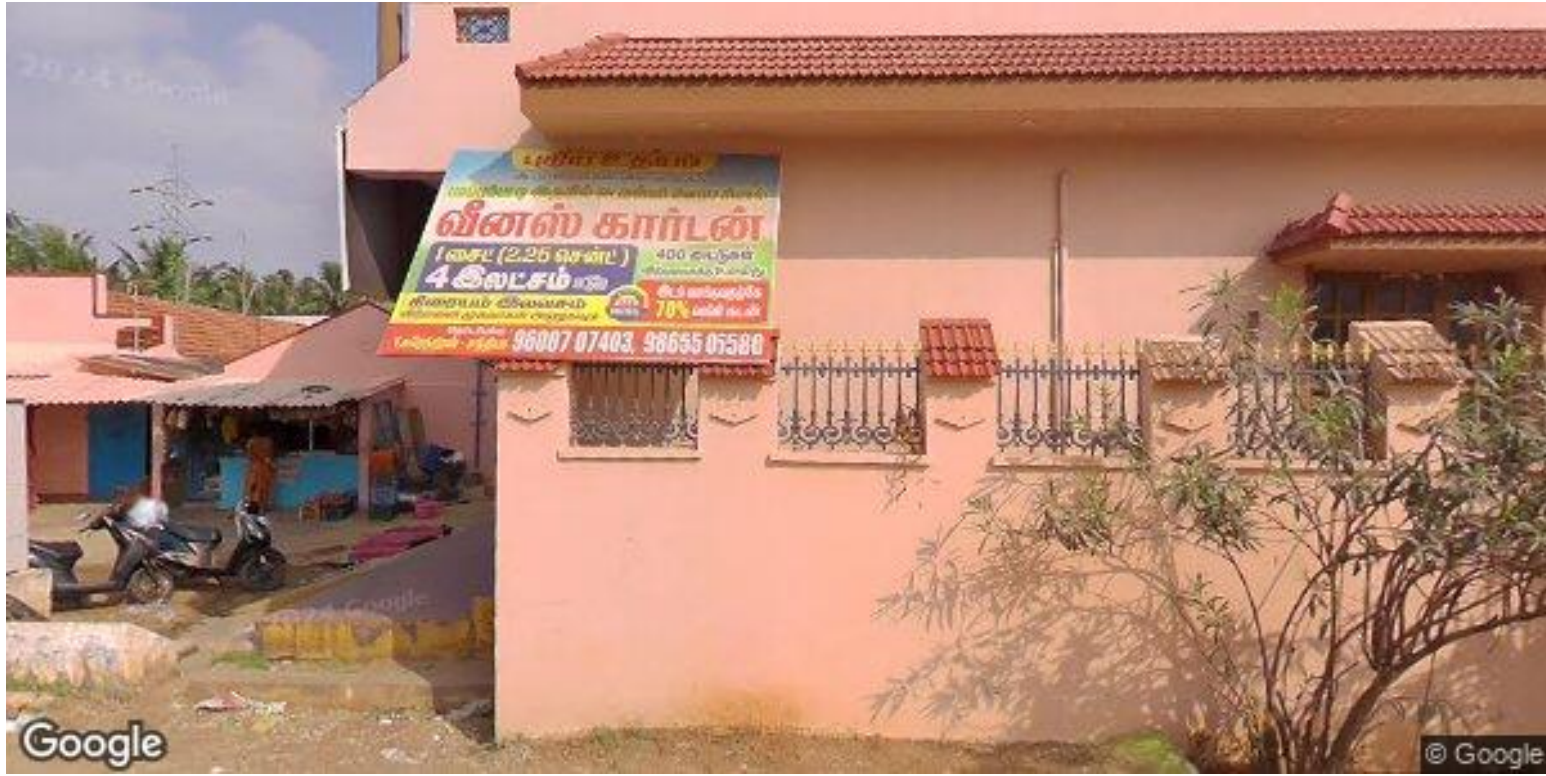
Coordinates: 10.98981, 77.06084

Risk Type: Turn

Risk Level: Medium

Speed Limit: 30 KM/Hr

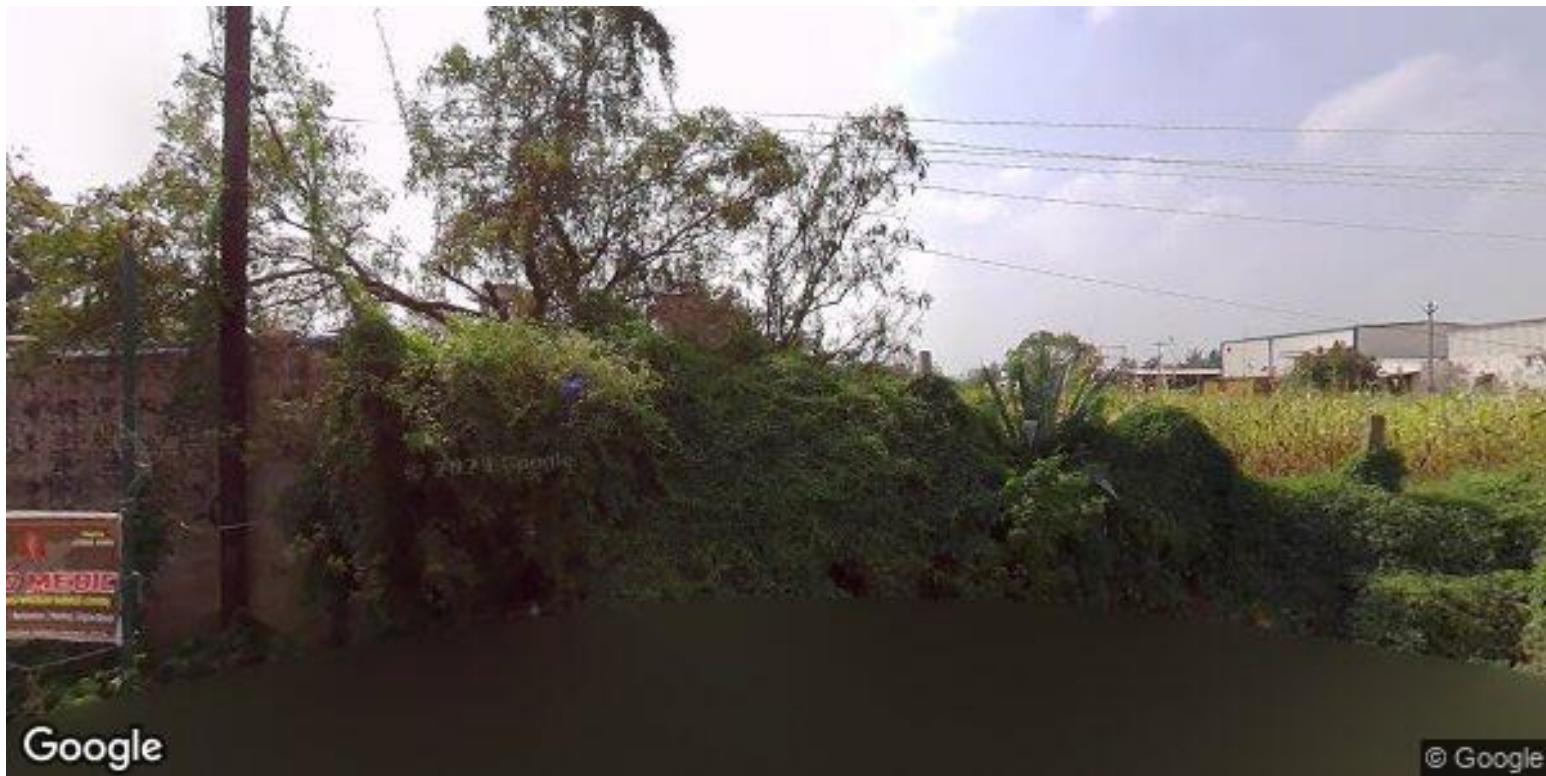
Coordinates: 10.98156, 77.06210

Risk Type: Turn

Risk Level: High

Speed Limit: 15 KM/Hr
