IndianOil

JOURNEY RISK MANAGEMENT (JRM) STUDY

Salem Terminal TO MARUDHAN AGENCIES

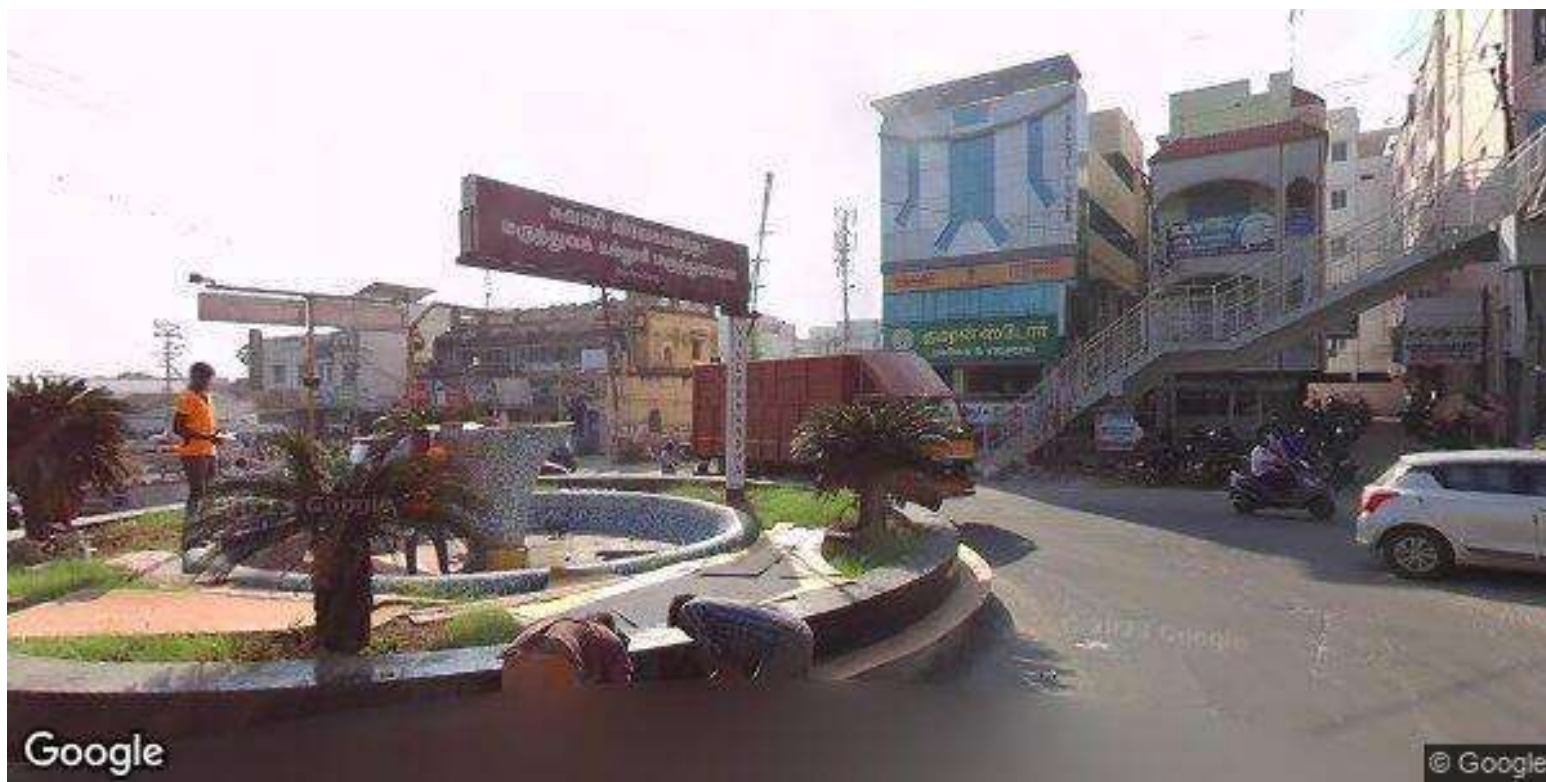
Coordinates: 11.38395, 77.89480

Risk Type: Roundabout

Risk Level: High

Speed Limit: 15 KM/Hr

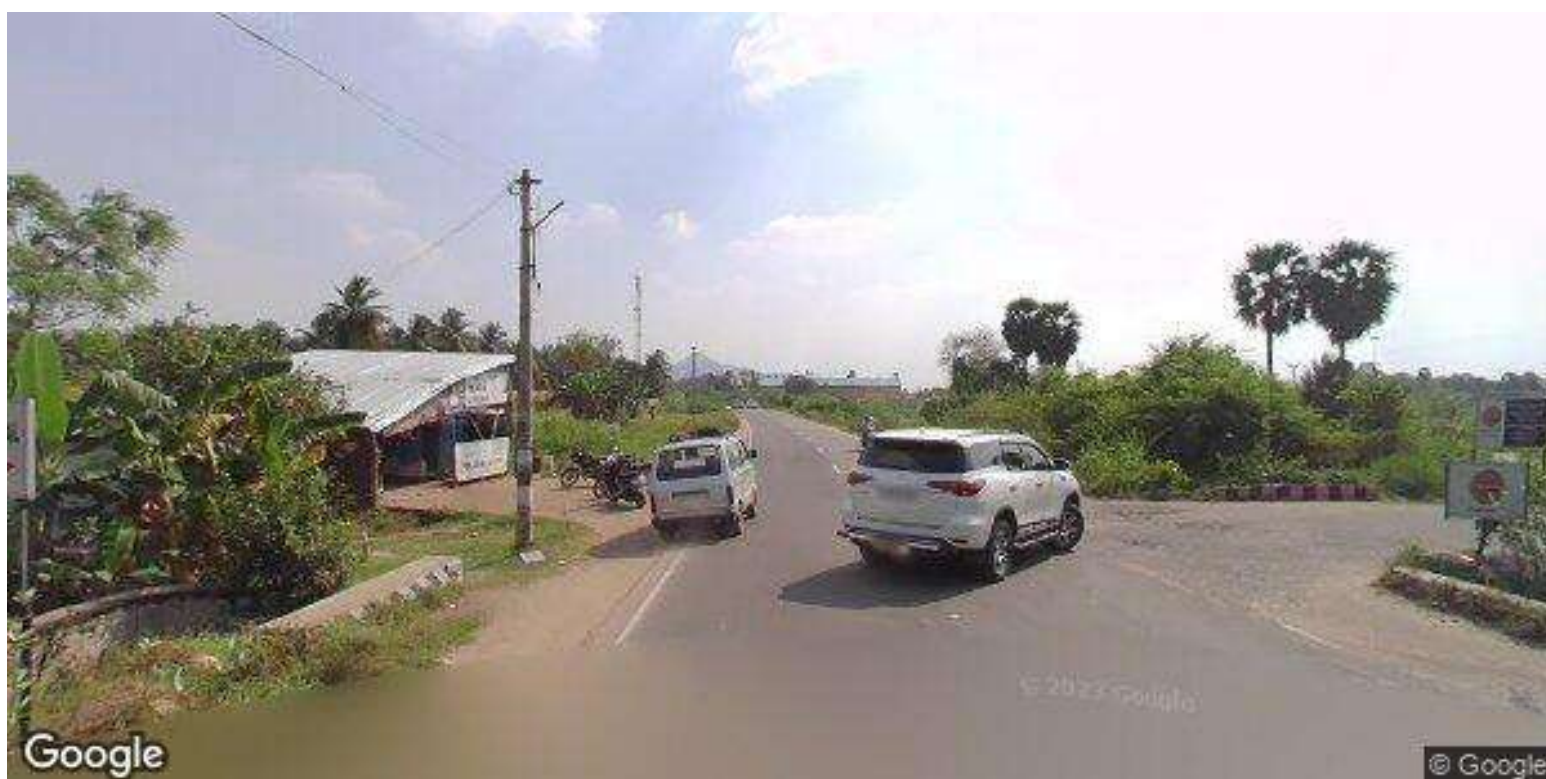
Coordinates: 11.44029, 77.87544

Risk Type: Blind Spot

Risk Level: Blind Spot

Speed Limit: 10 KM/Hr

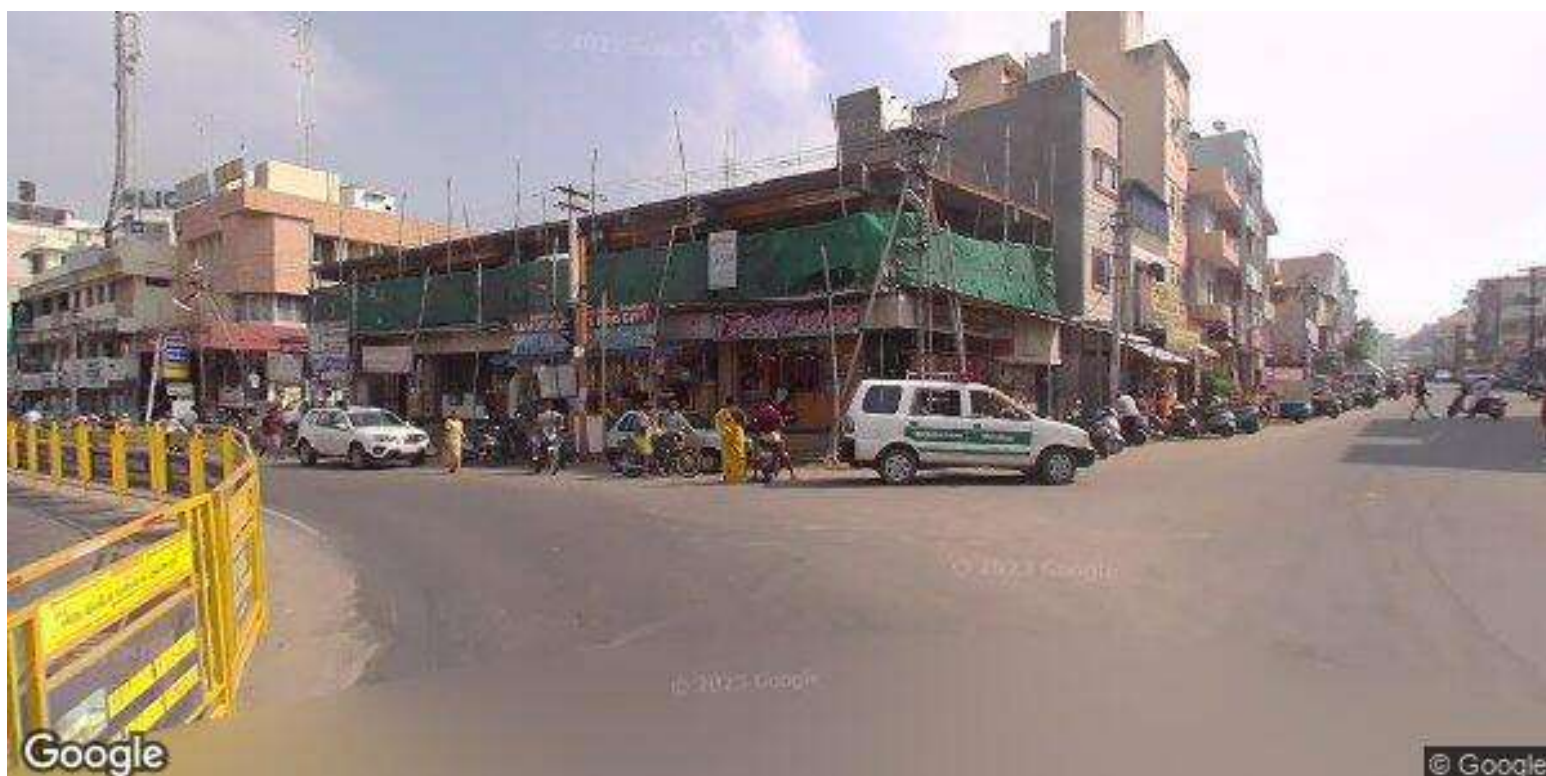
Coordinates: 11.37868, 77.89498

Risk Type: Turn

Risk Level: High

Speed Limit: 15 KM/Hr

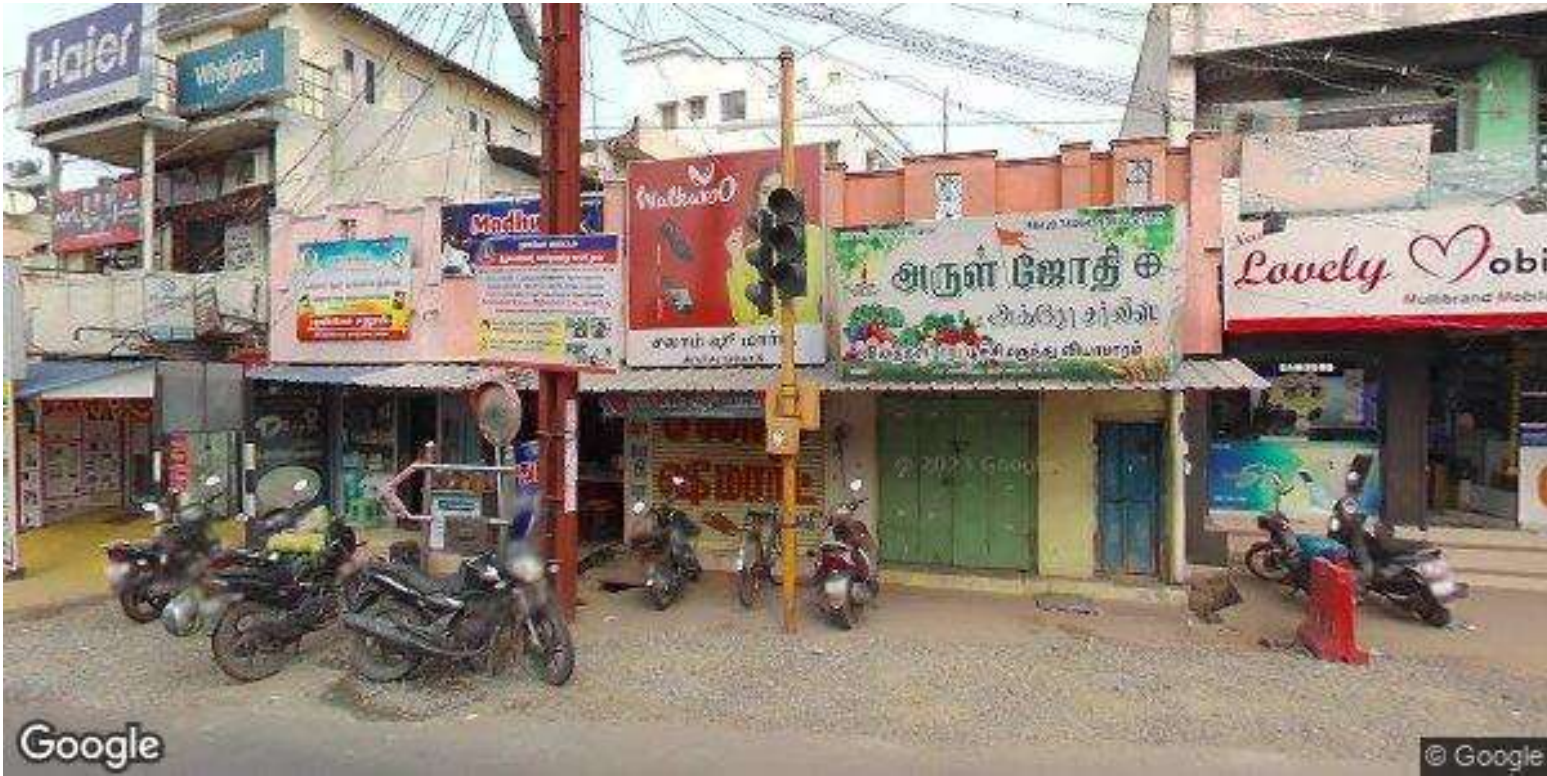
Coordinates: 11.37850, 77.89453

Risk Type: Turn

Risk Level: High

Speed Limit: 15 KM/Hr

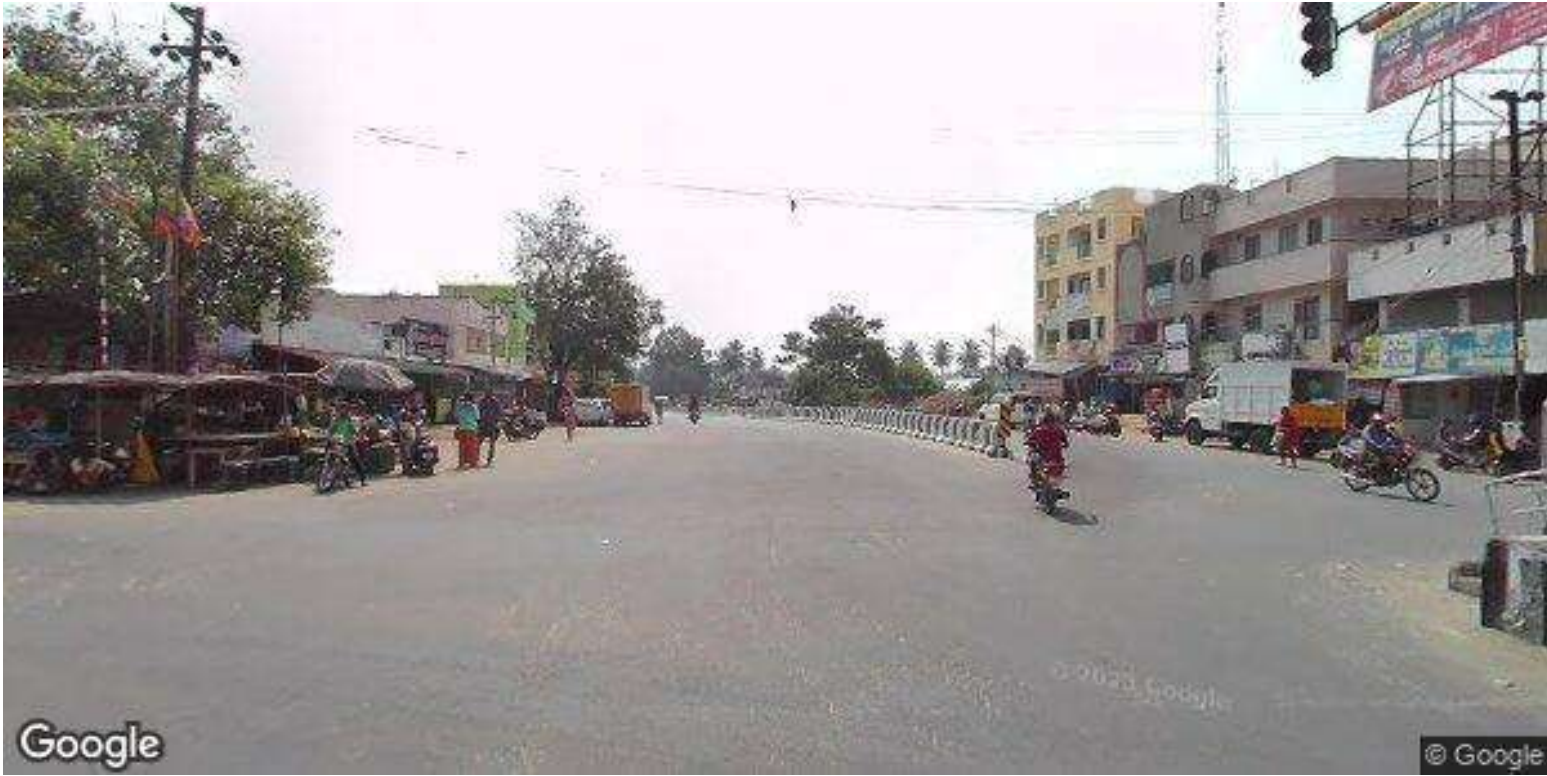
Coordinates: 11.36604, 77.88887

Risk Type: Turn

Risk Level: High

Speed Limit: 15 KM/Hr
