JOURNEY RISK MANAGEMENT (JRM) STUDY

Salem Terminal TO COCO BHAVANI BKLOA UNIT II

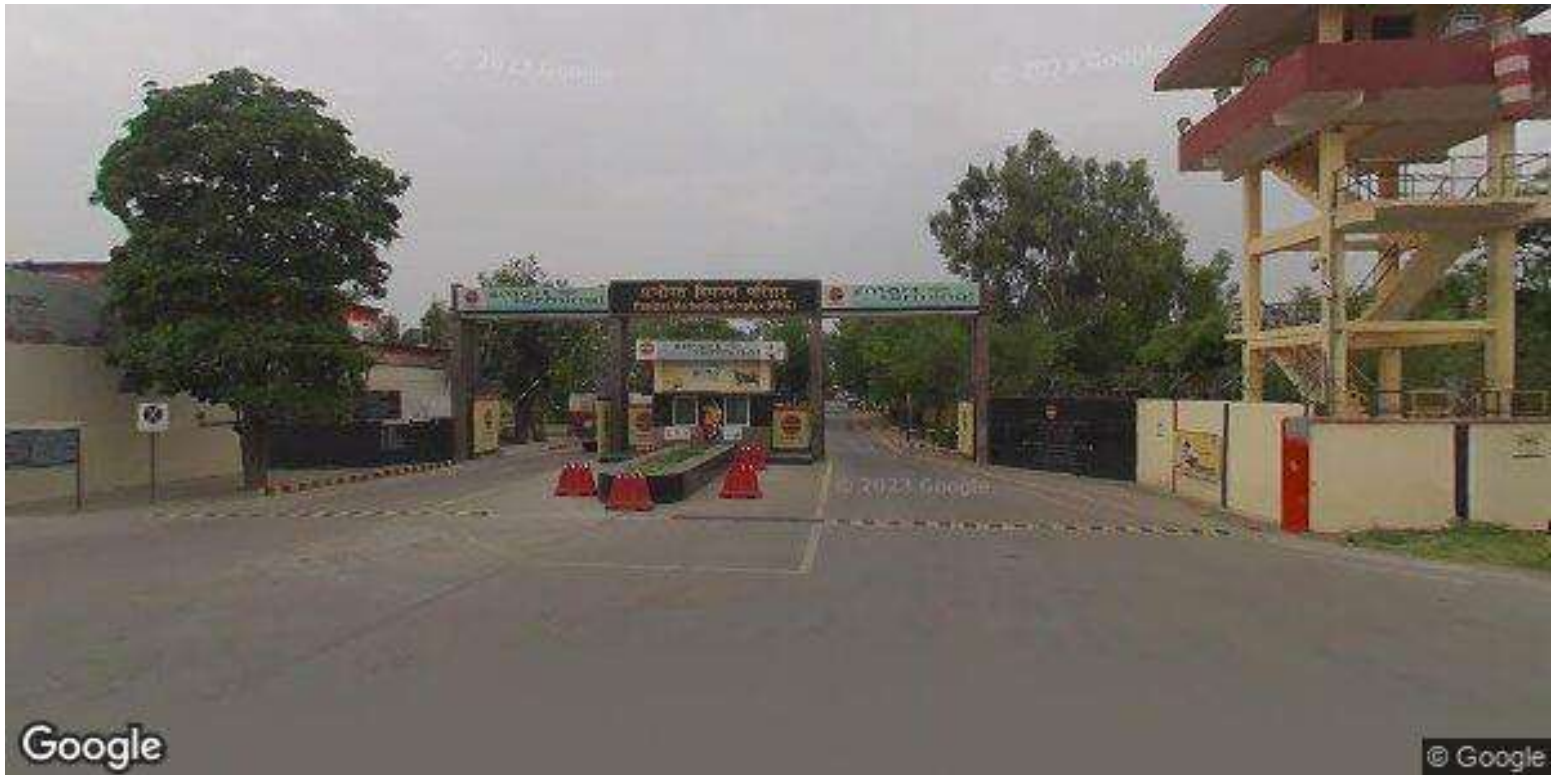
Risk Type: Ascent
Speed Limit: 15 KM/Hr
Distance from Start: 0.35 km
Coordinates: 29.48062, 76.88982

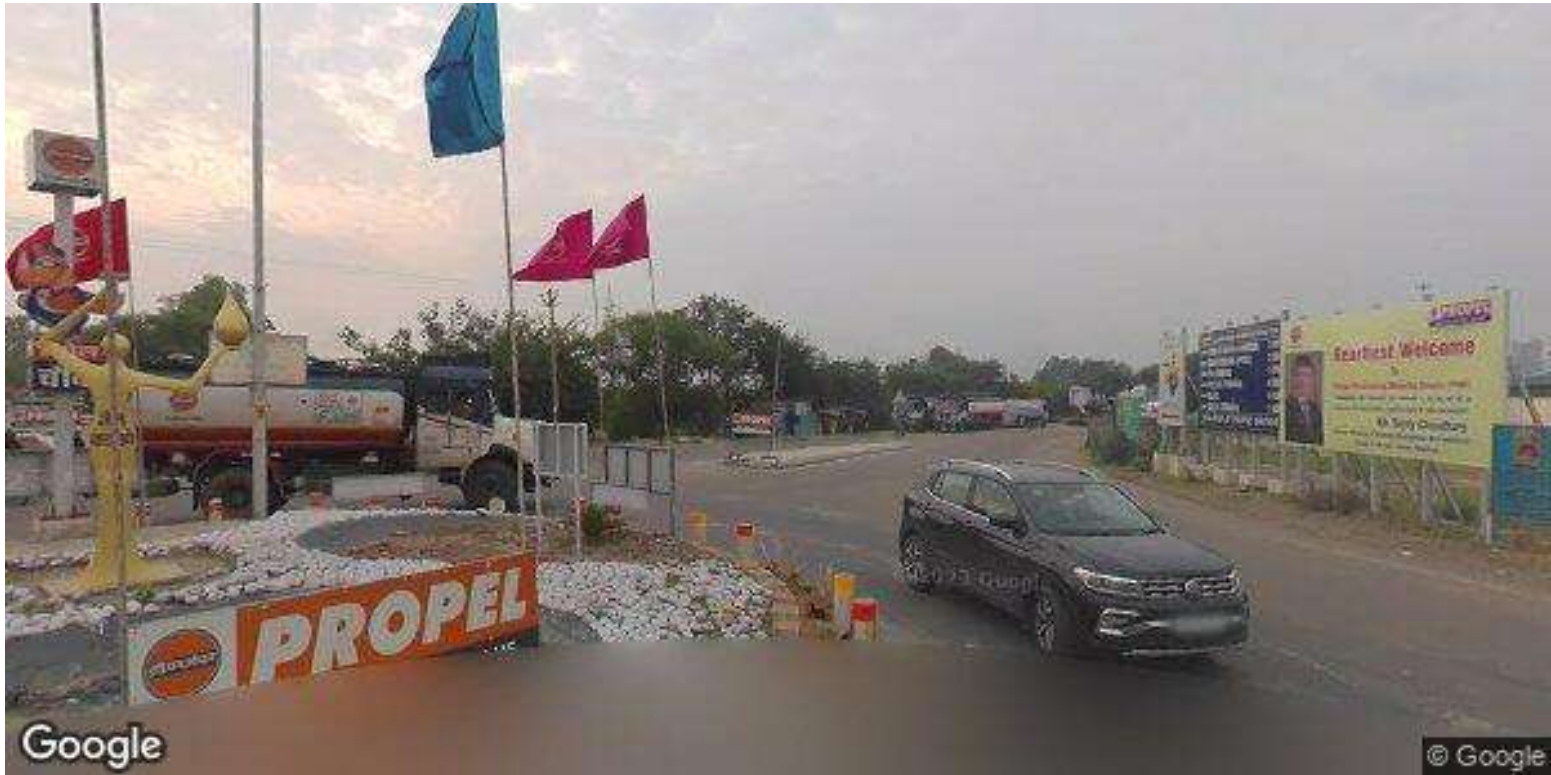
Risk Type: Roundabout
Speed Limit: 15 KM/Hr

Distance from Start: 0.71 km
Coordinates: 29.48076, 76.89217

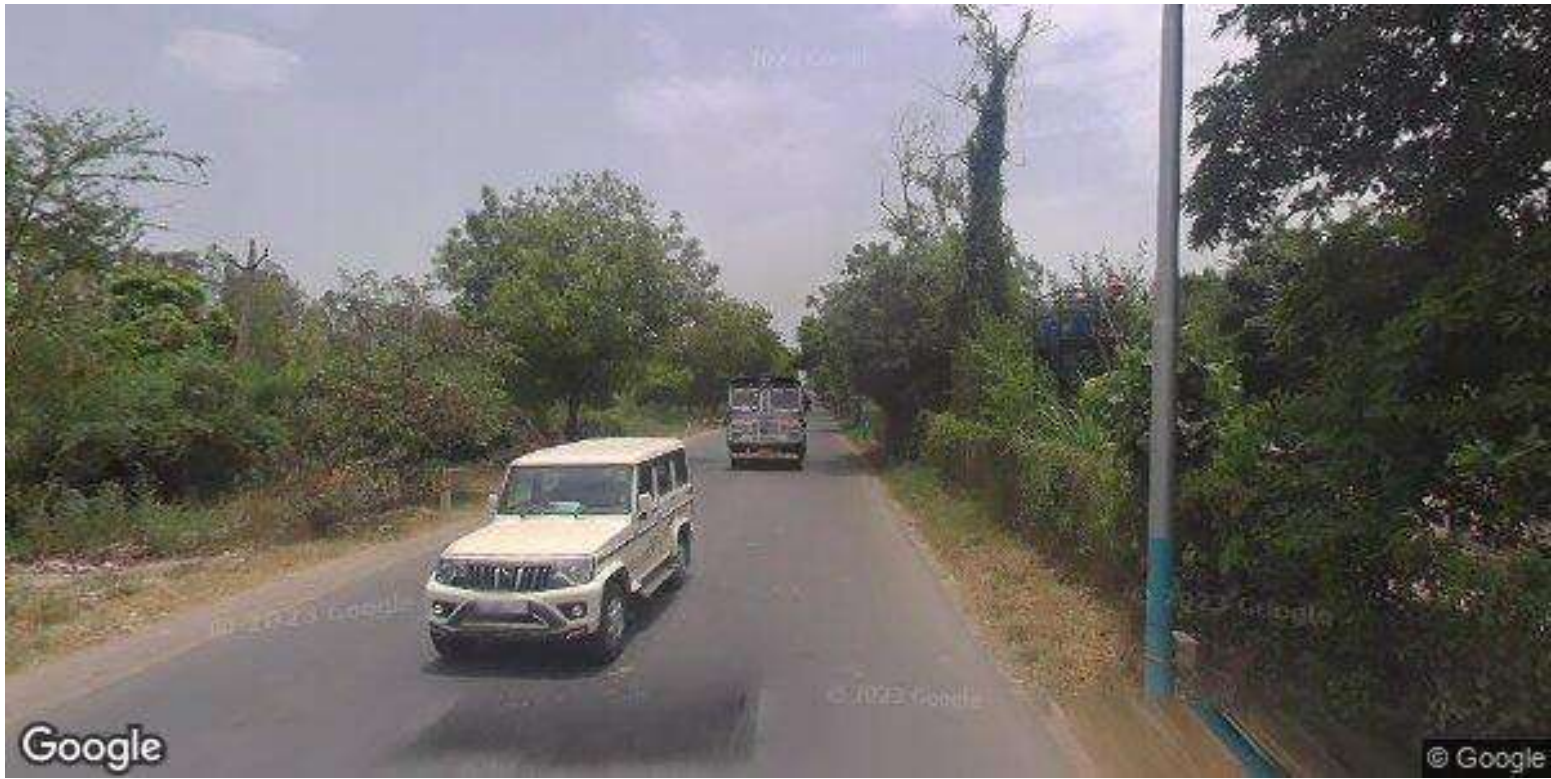
Risk Type: Descent
Speed Limit: 15 KM/Hr
Distance from Start: 1.22 km
Coordinates: 29.48564, 76.89091

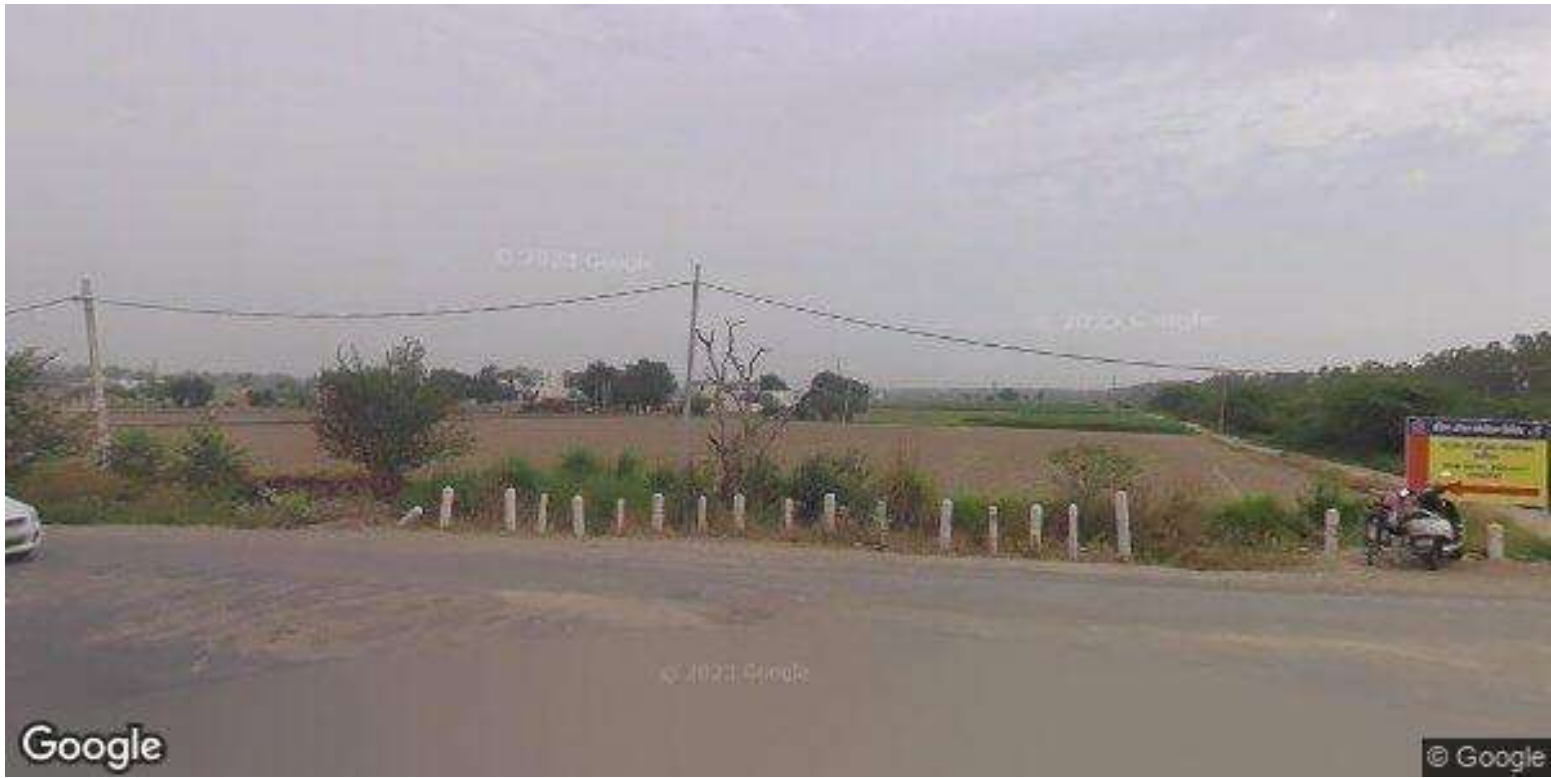
Risk Type: Turn
Speed Limit: 15 KM/Hr
Distance from Start: 2.18 km
Coordinates: 29.49351, 76.88856

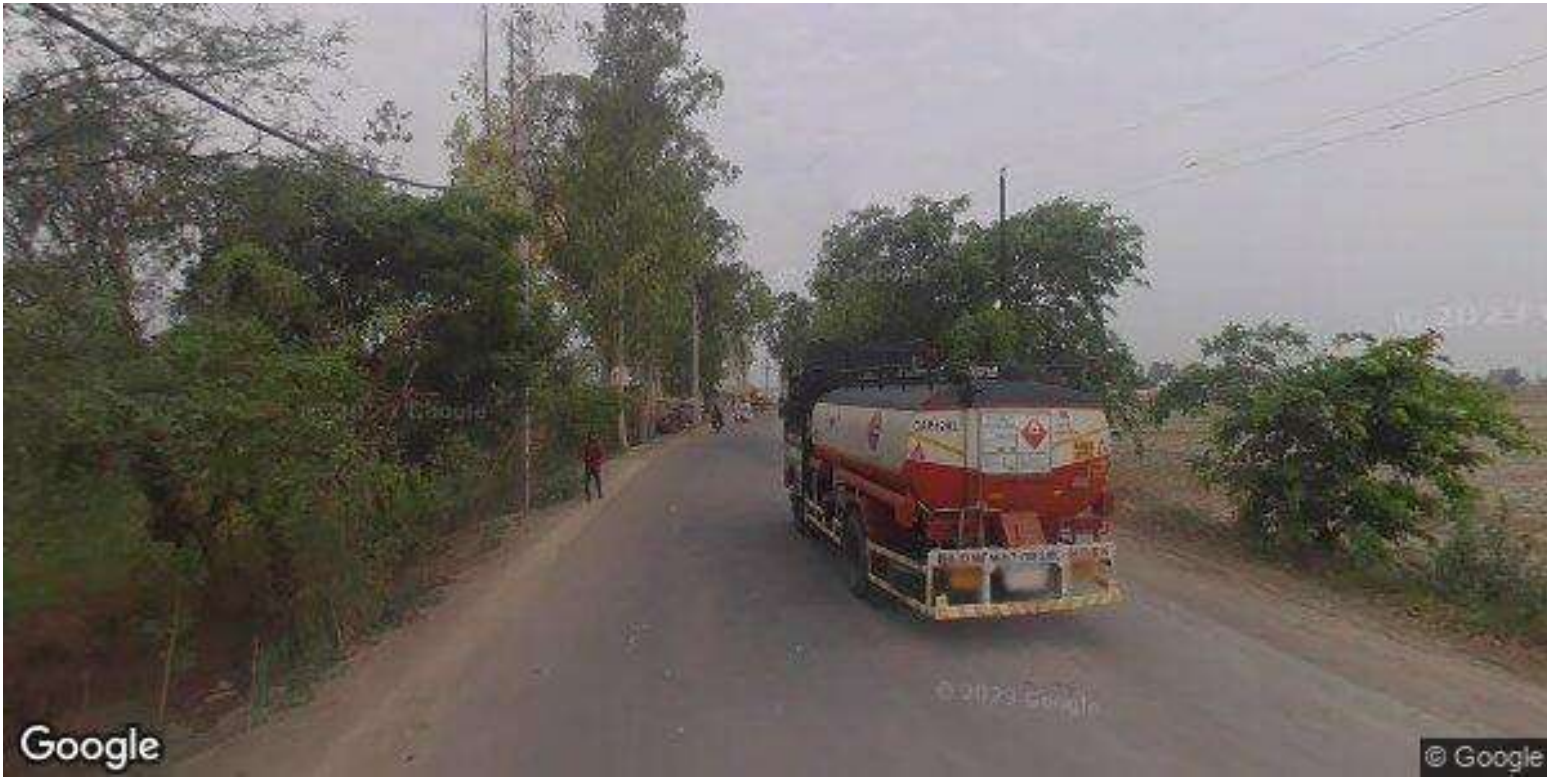
Risk Type: Ascent

Speed Limit: 15 KM/Hr

Distance from Start: 2.50 km

Coordinates: 29.49264, 76.88521
