## JOURNEY RISK MANAGEMENT (JRM) STUDY

### Salem Terminal TO JAYAA JYOTHI ENTERPRISE

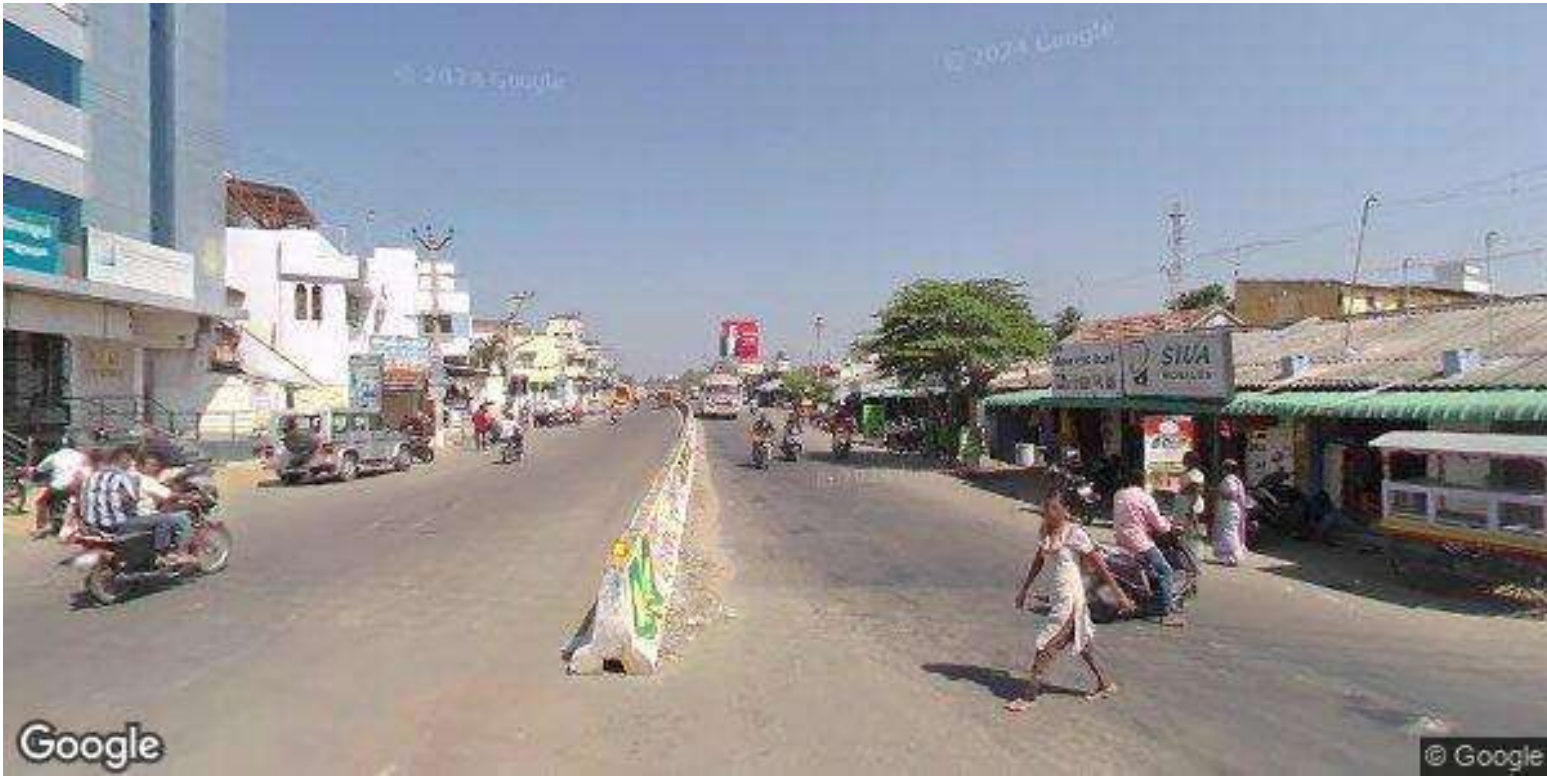
**Speed Limit: 15 KM/Hr**  
**Coordinates: 11.37086, 77.74828**

Risk Type: Roundabout  
Risk Level: High

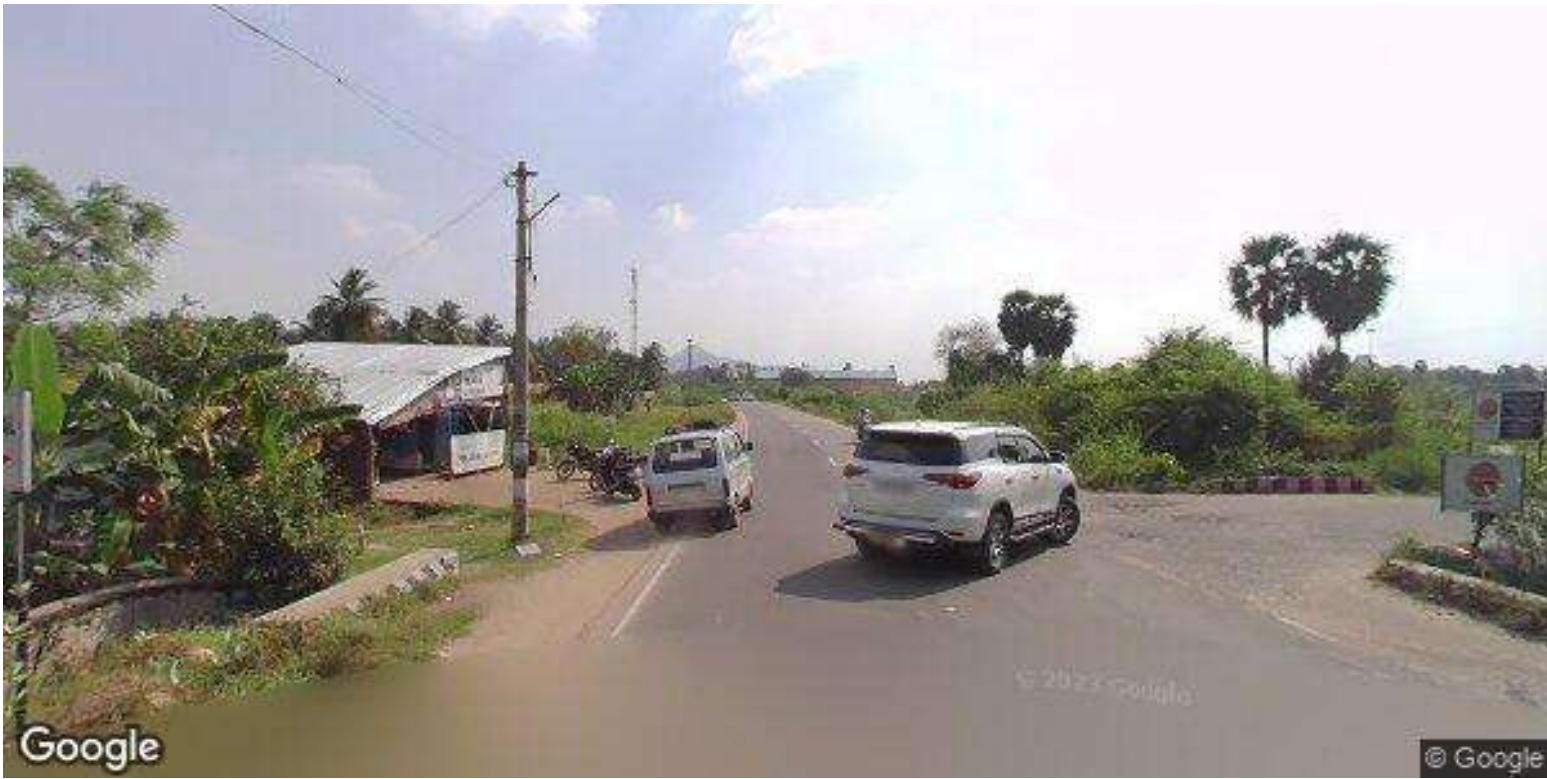
**Risk Type: Turn**  
**Risk Level: High**  
**Speed Limit: 15 KM/Hr**  
**Coordinates: 11.44029, 77.87544**

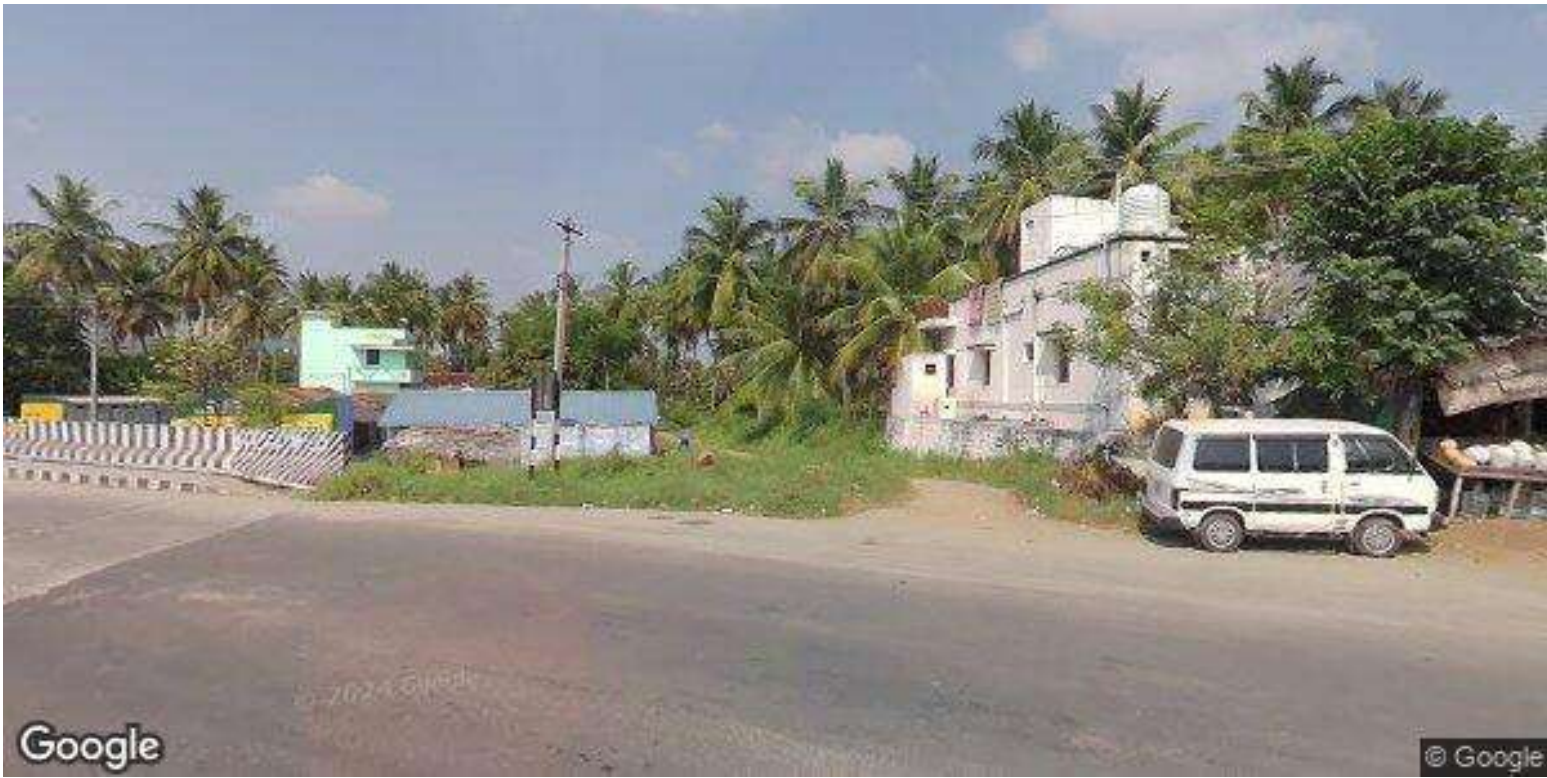
**Risk Type: Turn**  
**Risk Level: Medium**  
**Speed Limit: 30 KM/Hr**  
**Coordinates: 11.44898, 77.87410**

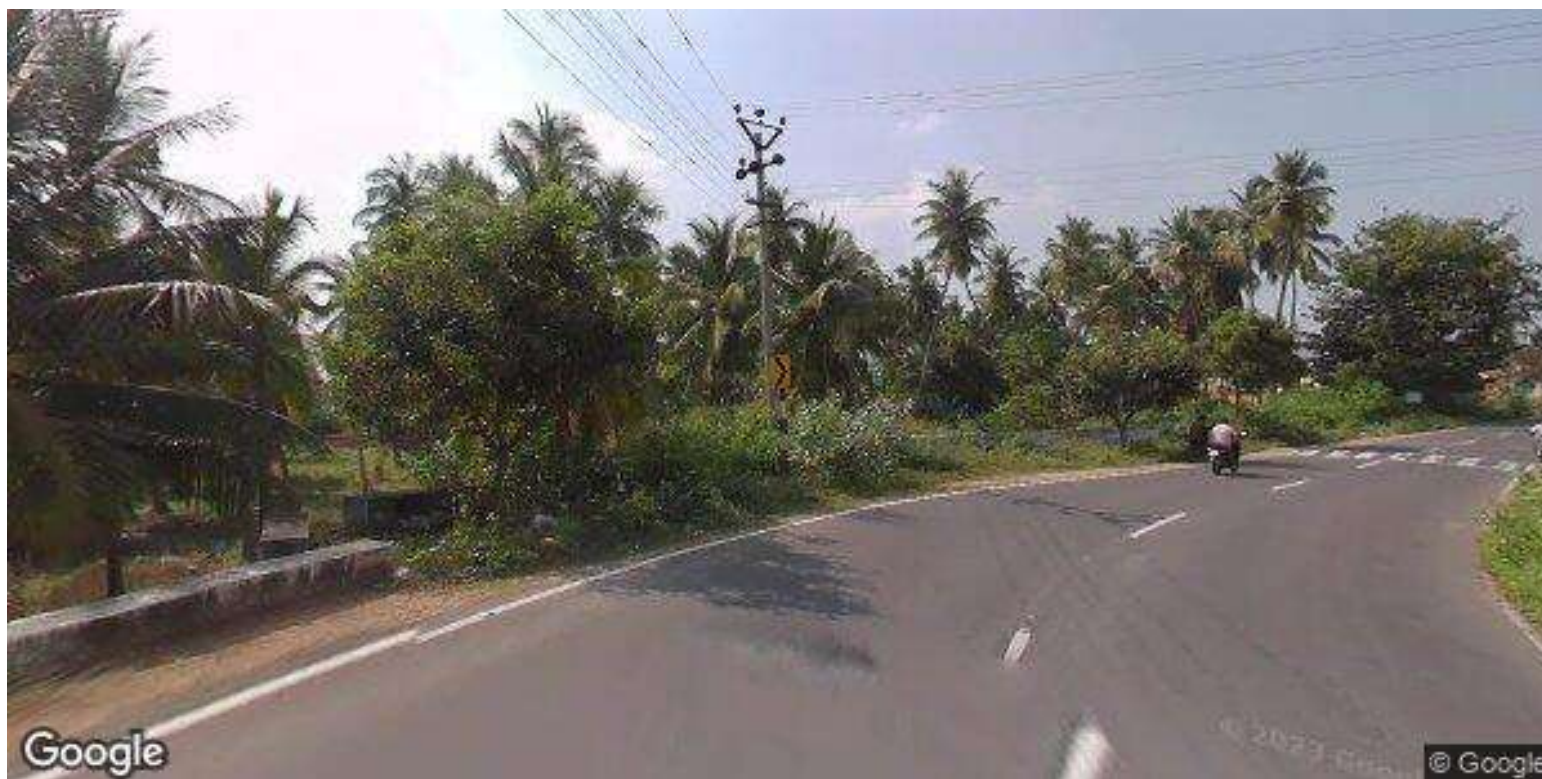
**Coordinates:** 11.45348, 77.85706

**Risk Type:** Turn

**Risk Level:** Medium

**Speed Limit:** 30 KM/Hr

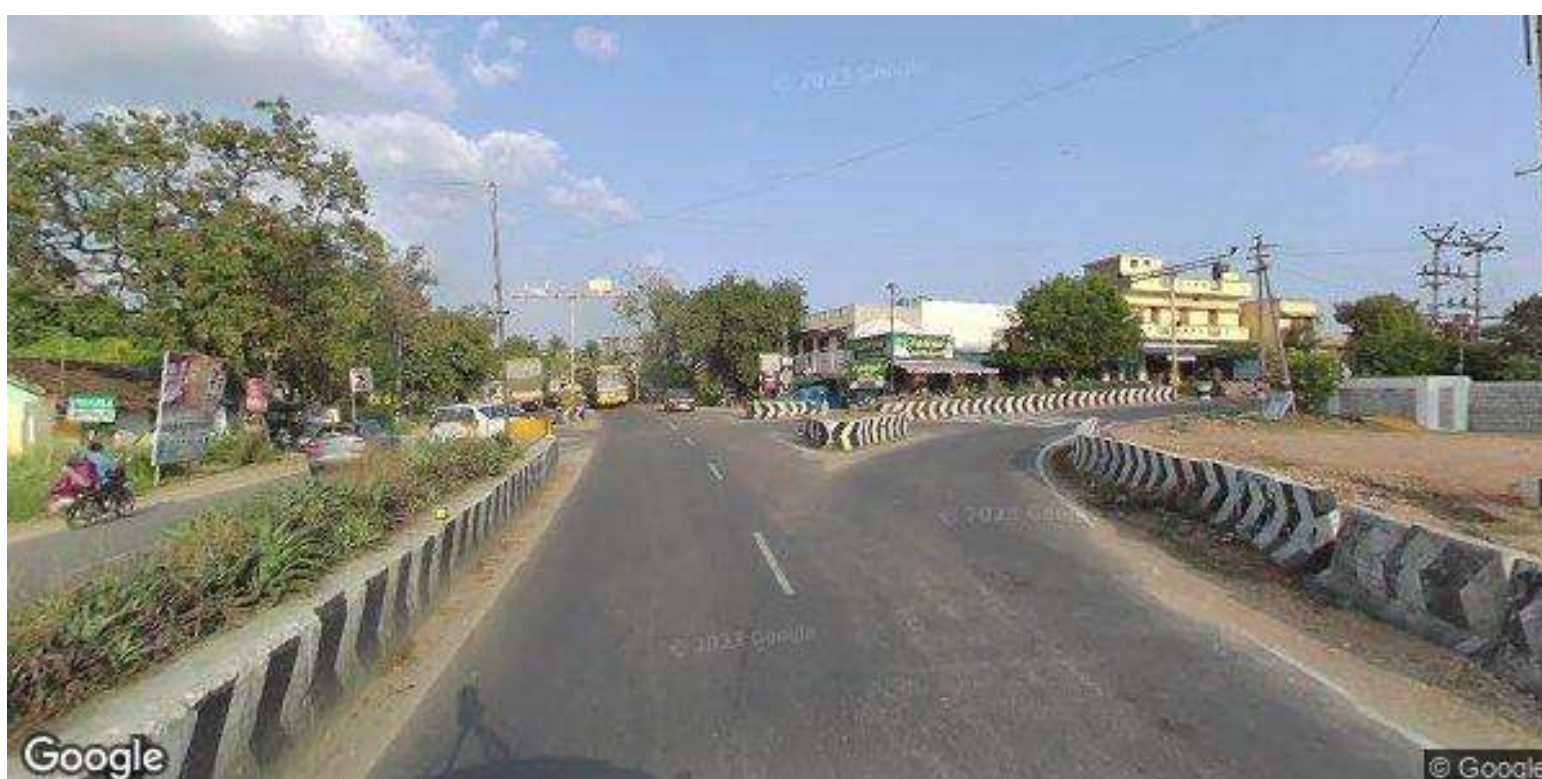
**Coordinates:** 11.46318, 77.84913

**Risk Type:** Turn

**Risk Level:** Medium

**Speed Limit:** 30 KM/Hr

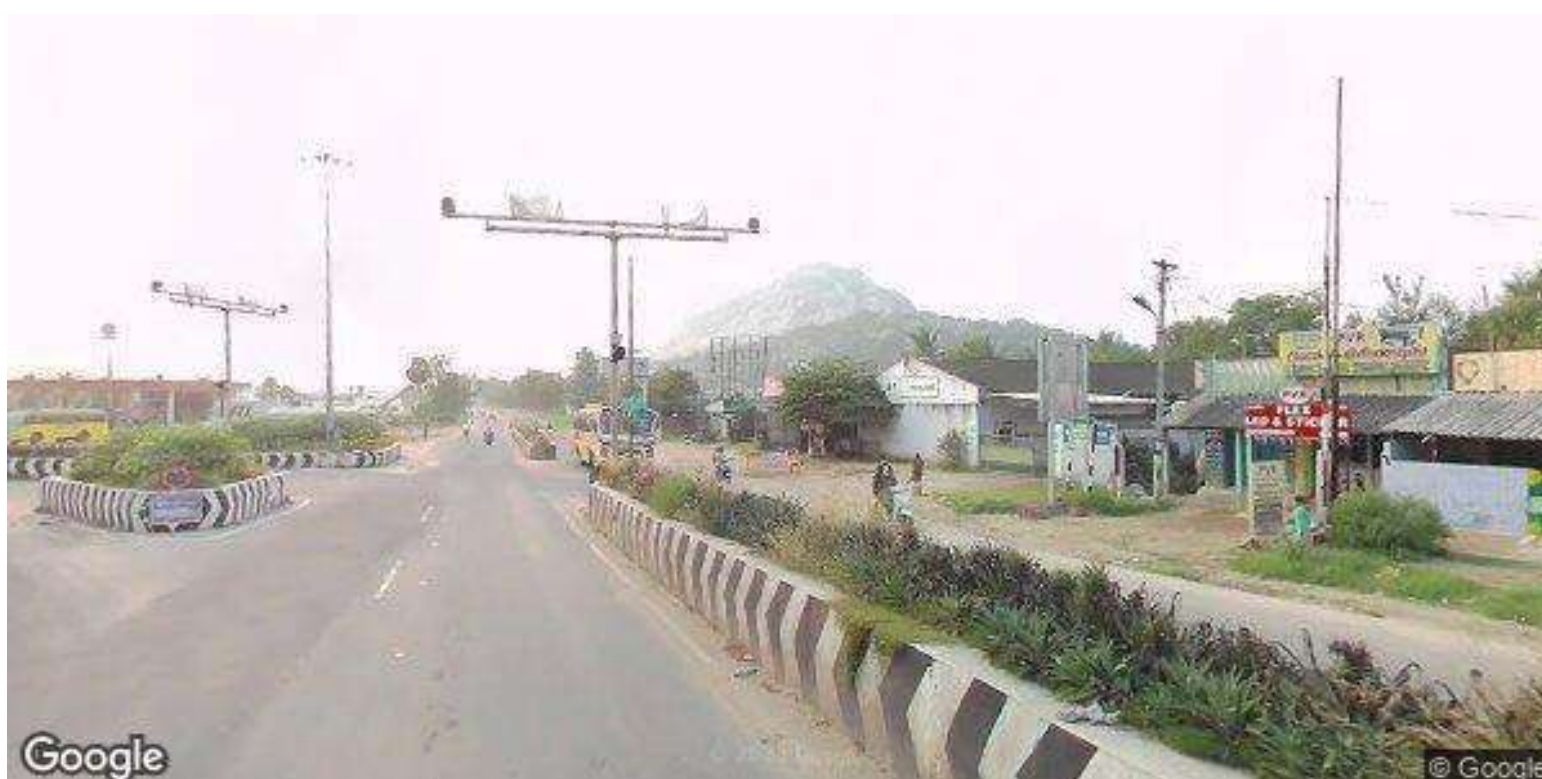
Coordinates: 11.46312, 77.84886

Risk Type: Turn

Risk Level: Medium

Speed Limit: 30 KM/Hr

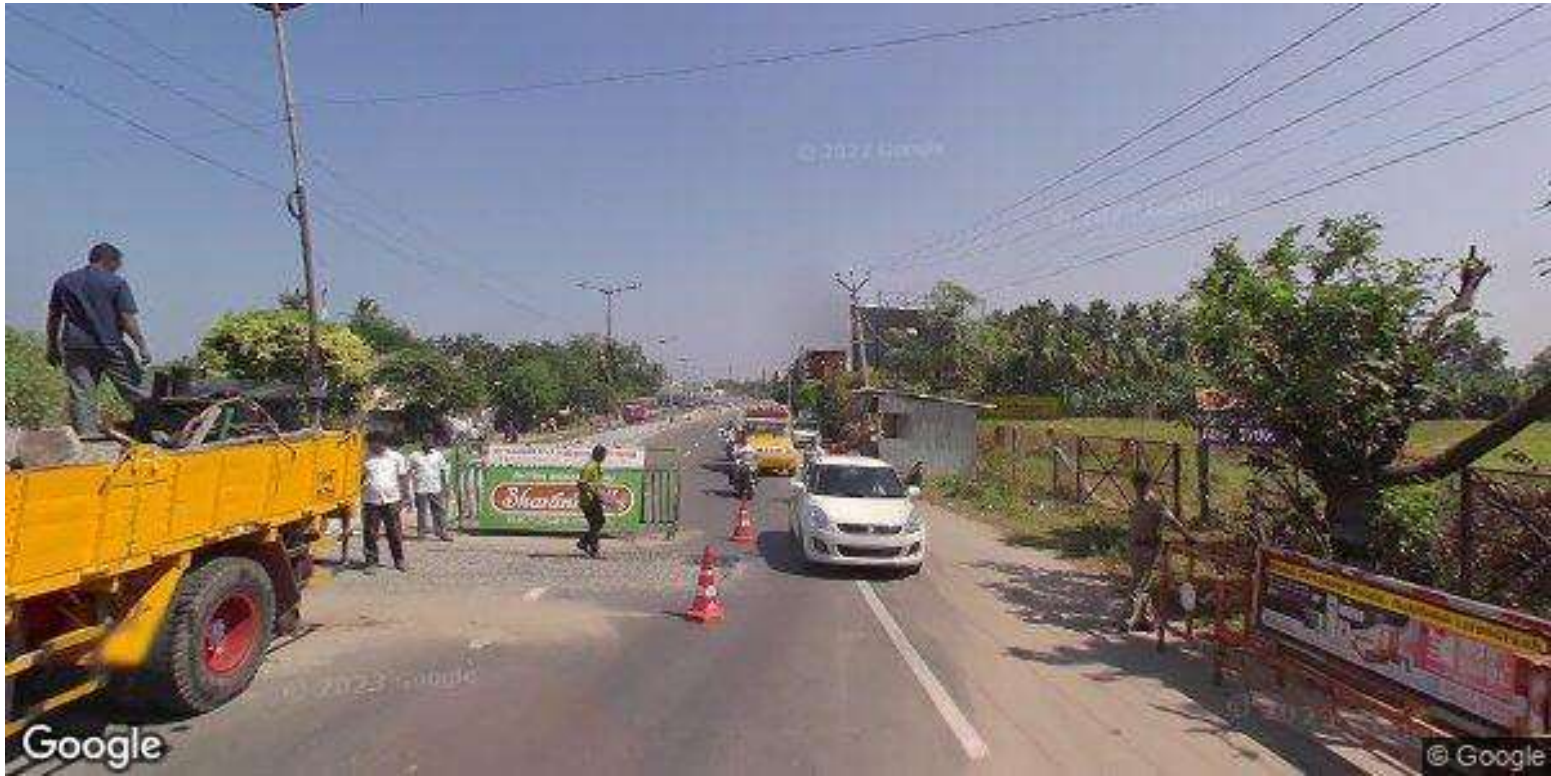
Coordinates: 11.35929, 77.73996

Risk Type: Turn

Risk Level: High

Speed Limit: 15 KM/Hr
