JOURNEY RISK MANAGEMENT (JRM) STUDY

IOCL Coimbatore Terminal to Santhoshkumar Agencies

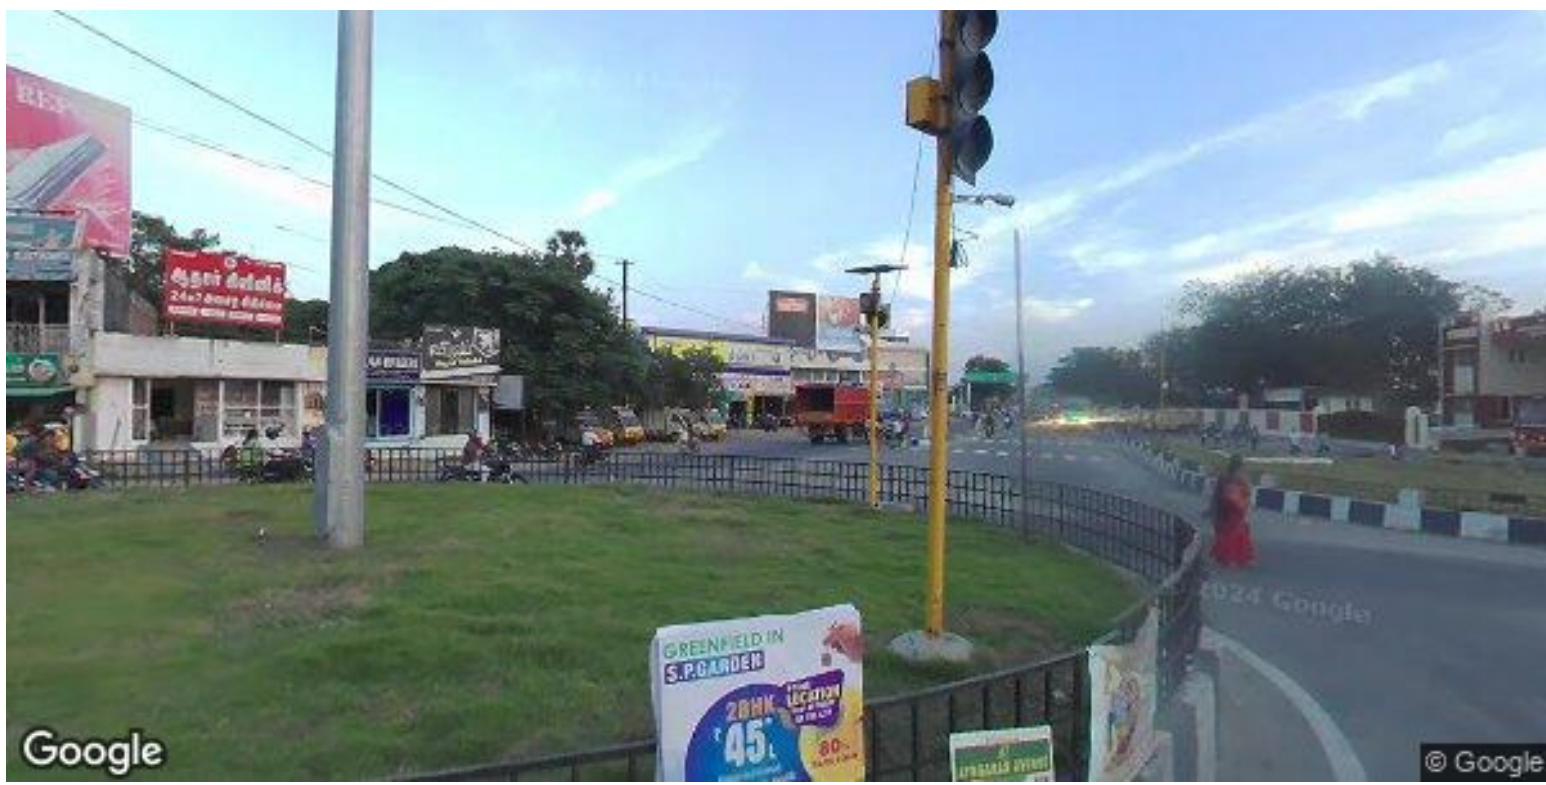
Risk Type: Roundabout

Risk Level: High

Coordinates: 11.18824, 77.27908

Speed Limit: 15 KM/Hr

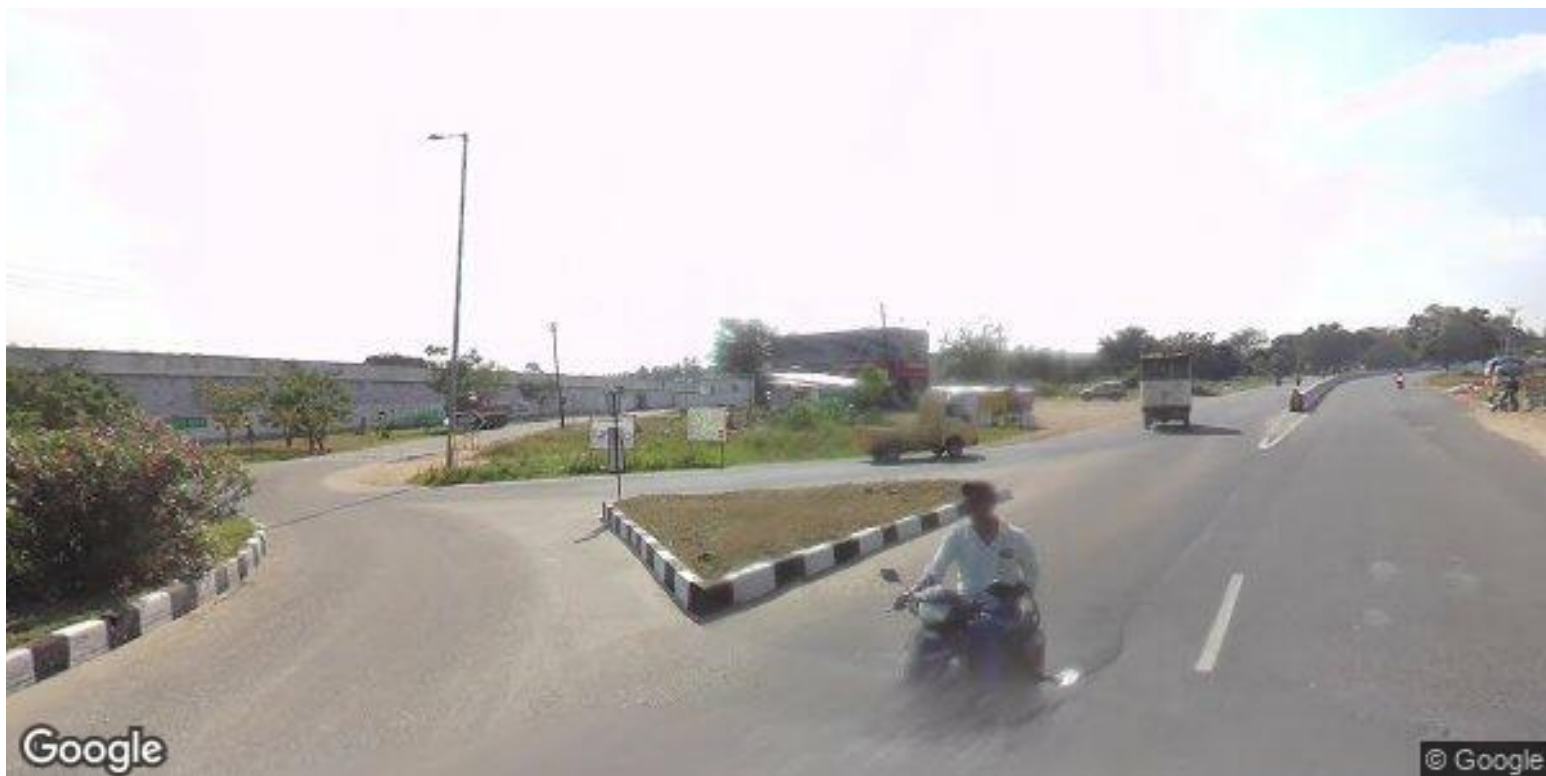
Risk Type: Roundabout

Risk Level: High

Coordinates: 11.19689, 77.29637

Speed Limit: 15 KM/Hr

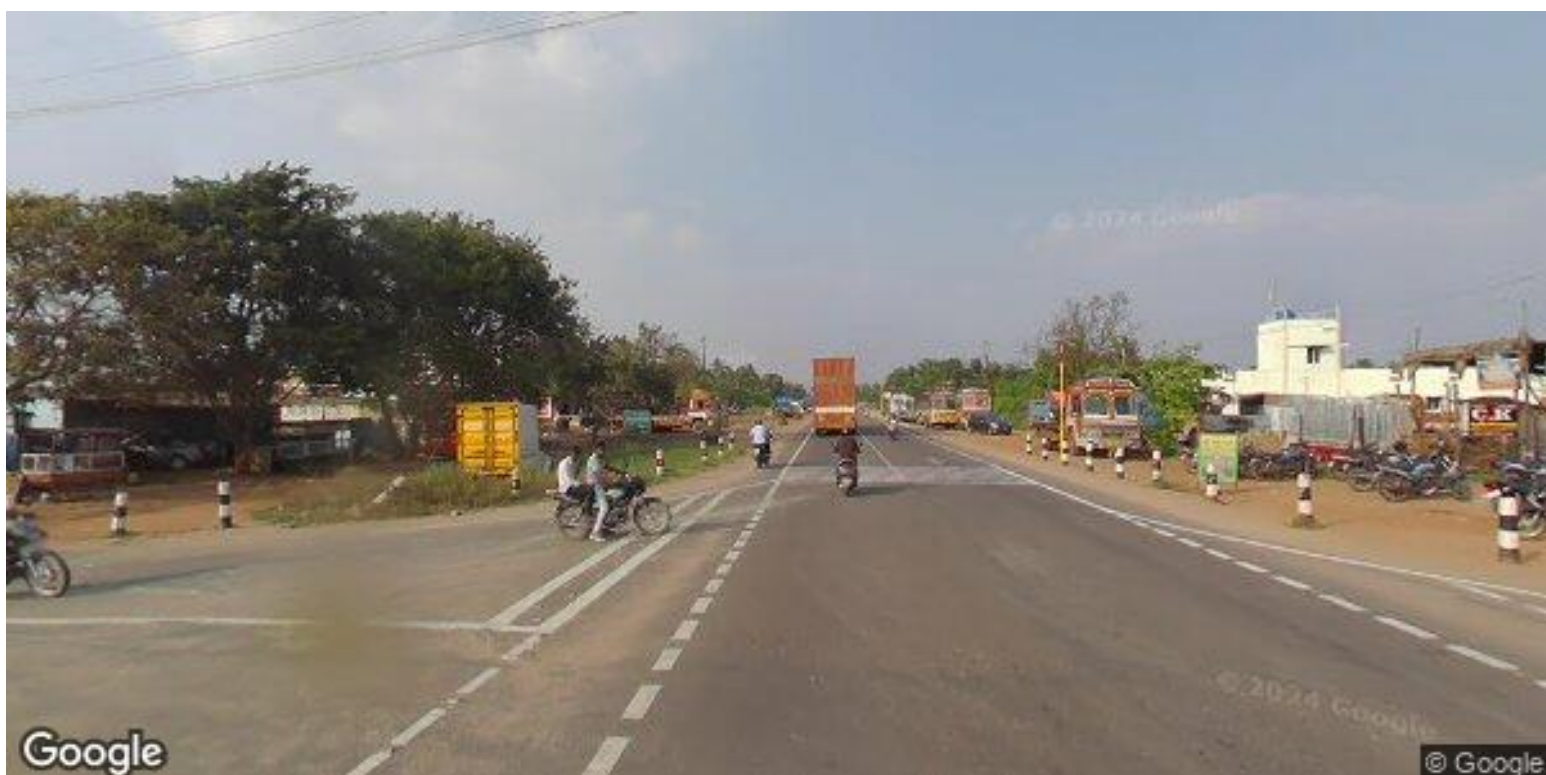
Risk Type: Turn
Risk Level: High
Speed Limit: 15 KM/Hr
Coordinates: 11.03211, 77.07640

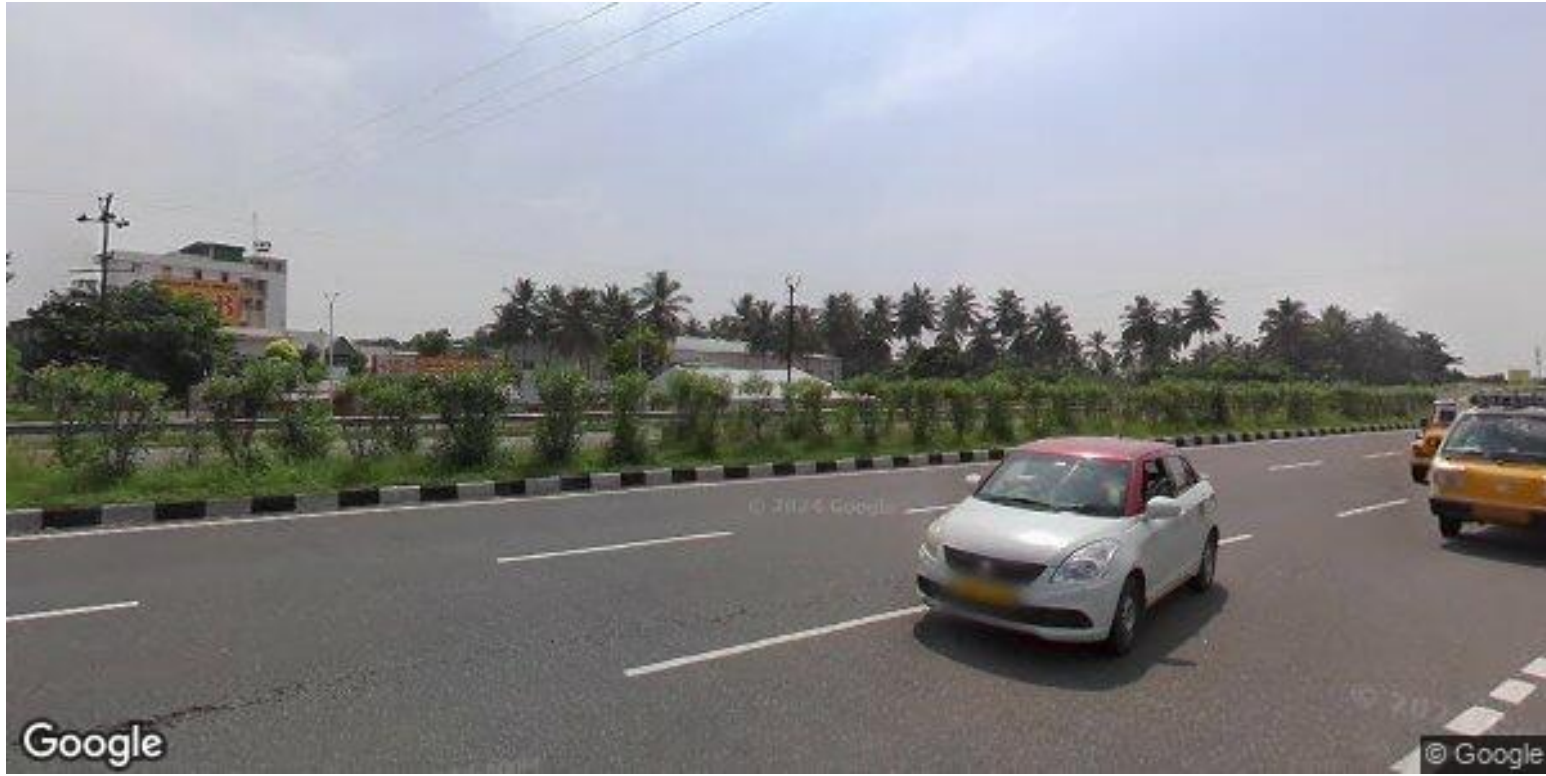
Risk Type: Turn
Risk Level: High
Speed Limit: 15 KM/Hr
Coordinates: 11.17275, 77.23622

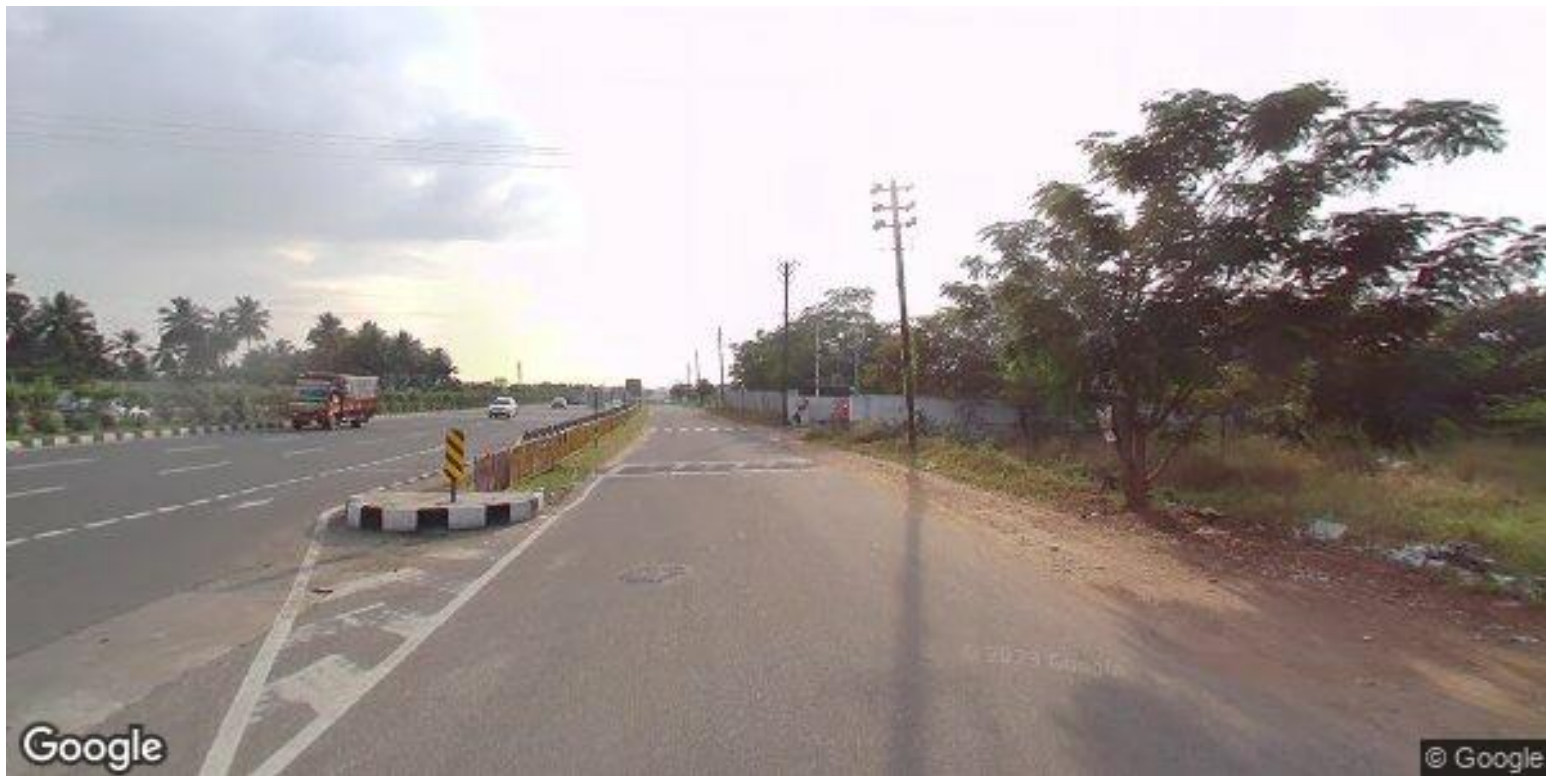
Risk Type: Turn
Risk Level: High
Speed Limit: 15 KM/Hr
Coordinates: 11.17294, 77.23619

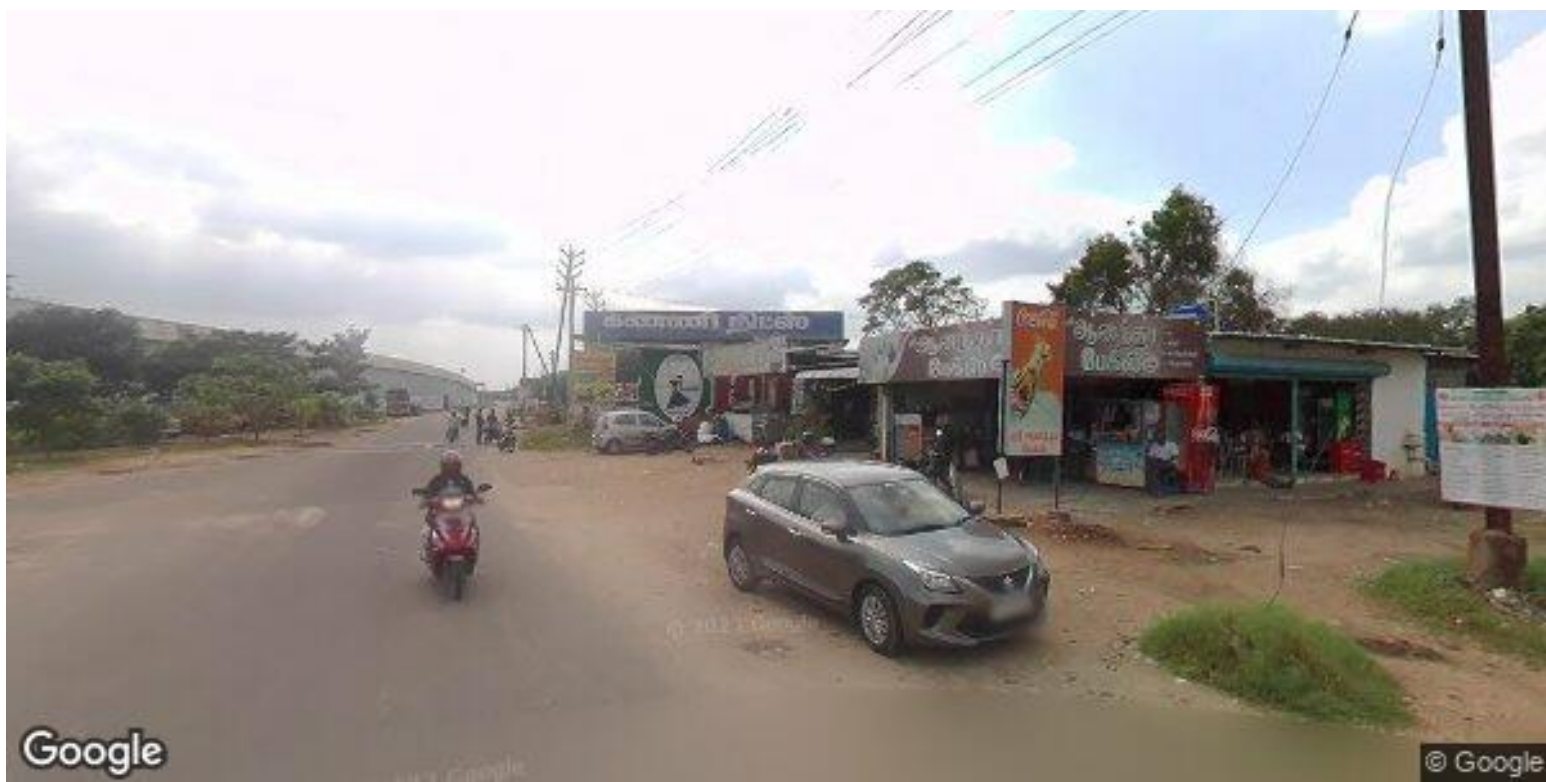
Risk Type: Turn

Risk Level: Medium

Coordinates: 11.17688, 77.24112

Speed Limit: 30 KM/Hr

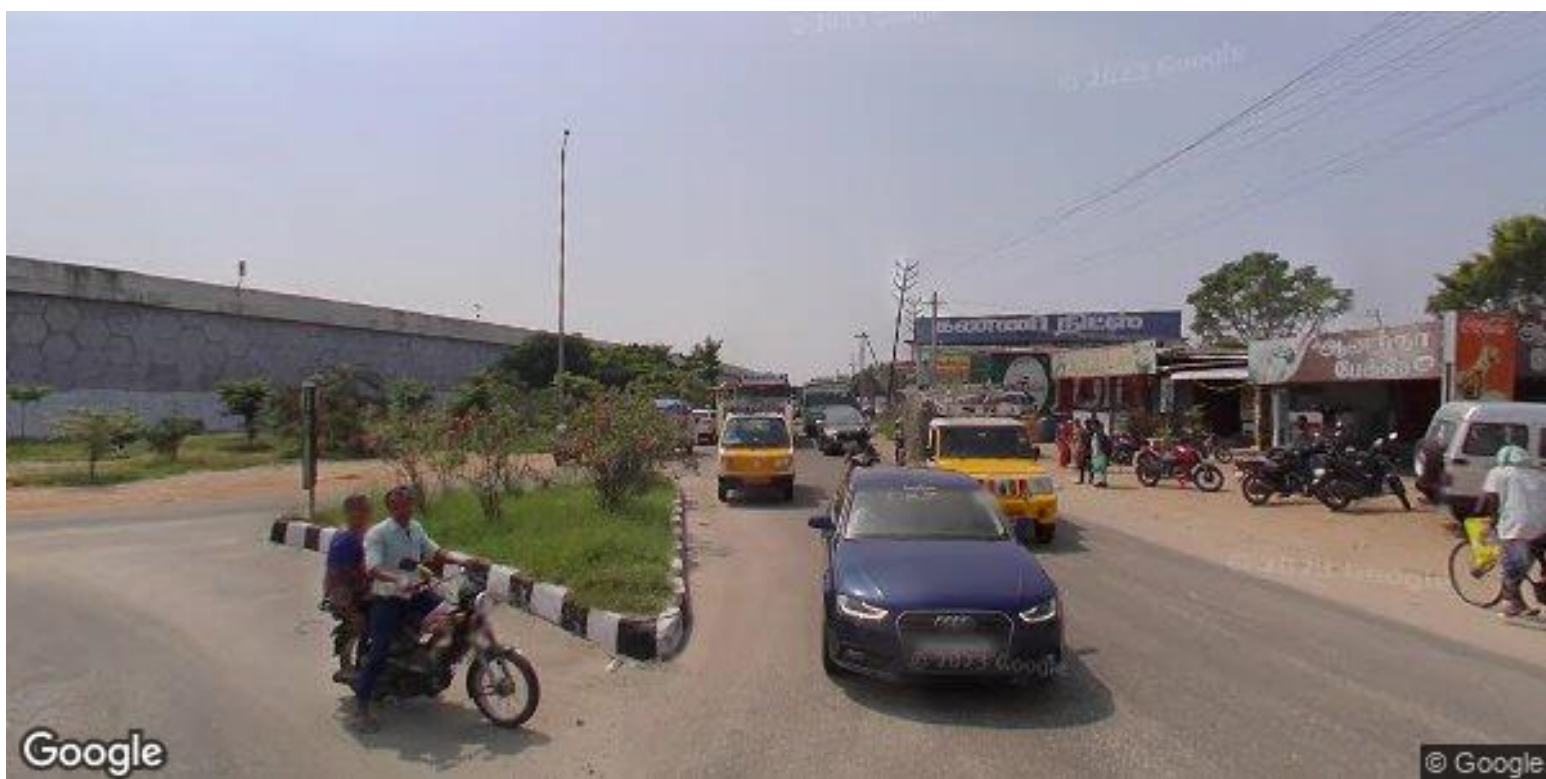
Risk Type: Turn

Risk Level: High

Coordinates: 11.17689, 77.24118

Speed Limit: 15 KM/Hr

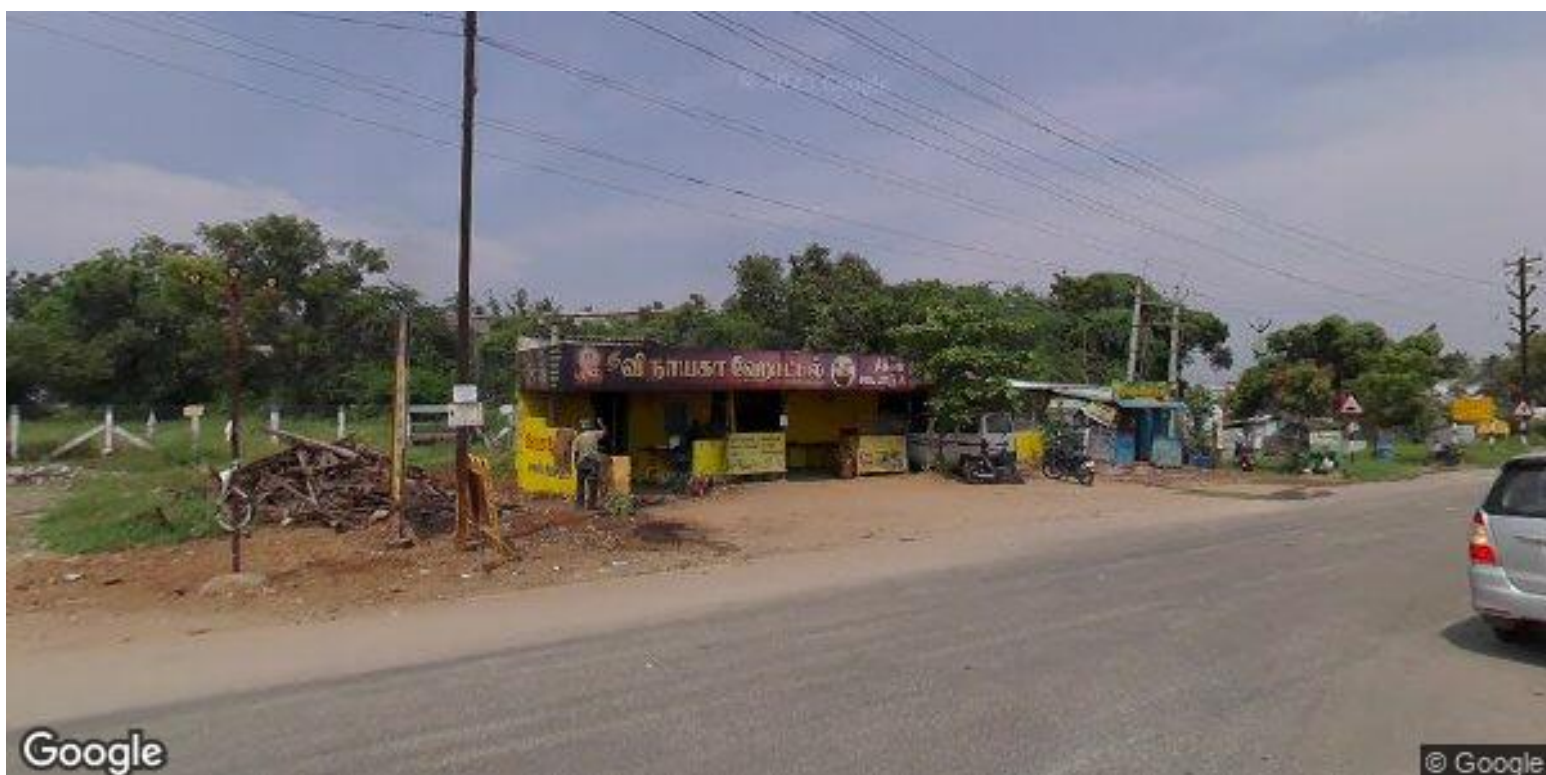
Risk Type: Turn
Risk Level: Medium
Speed Limit: 30 KM/Hr
Coordinates: 11.17694, 77.24119

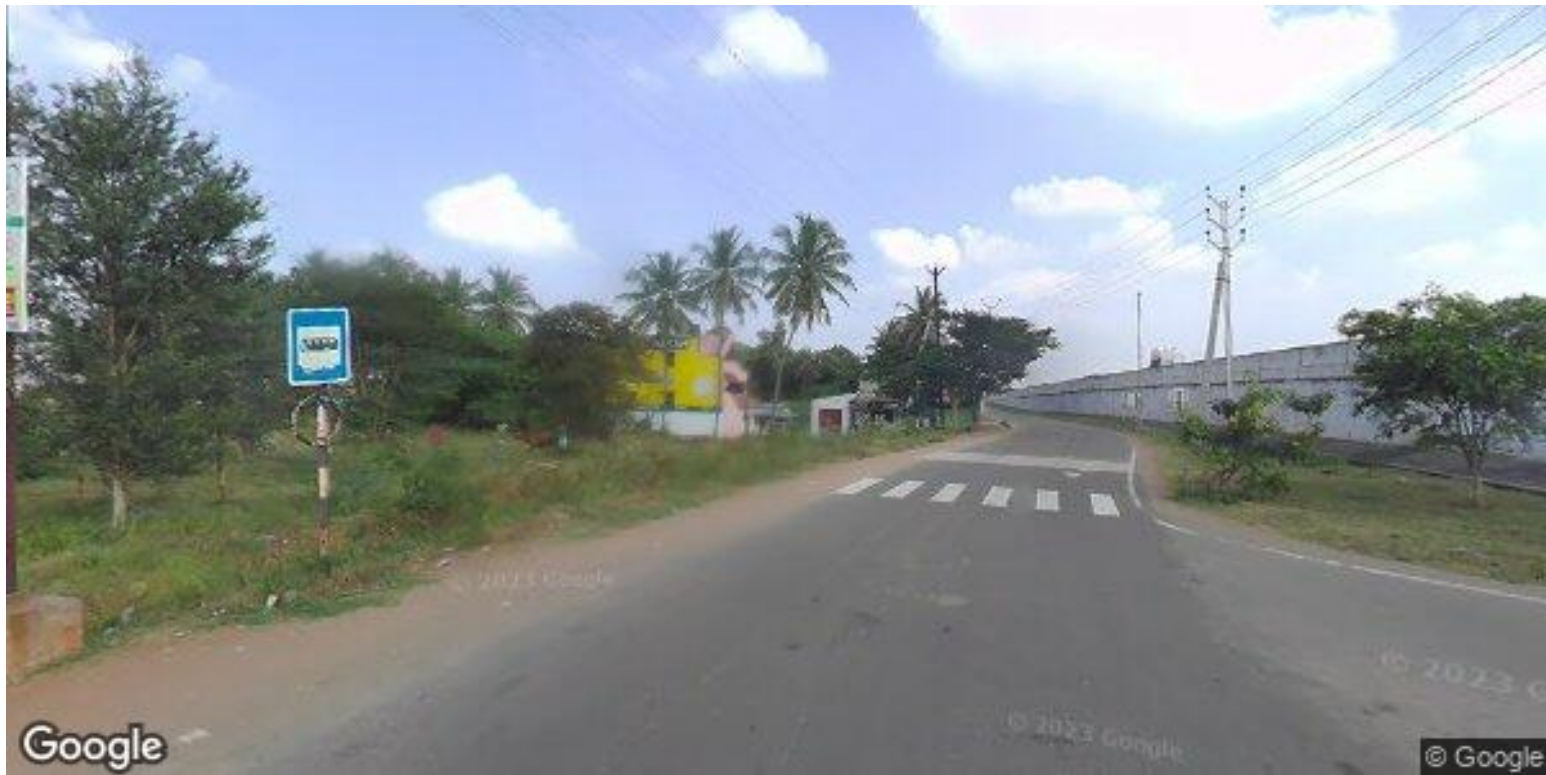
Risk Type: Blind Spot
Risk Level: Blind Spot
Speed Limit: 10 KM/Hr
Coordinates: 11.19877, 77.31257

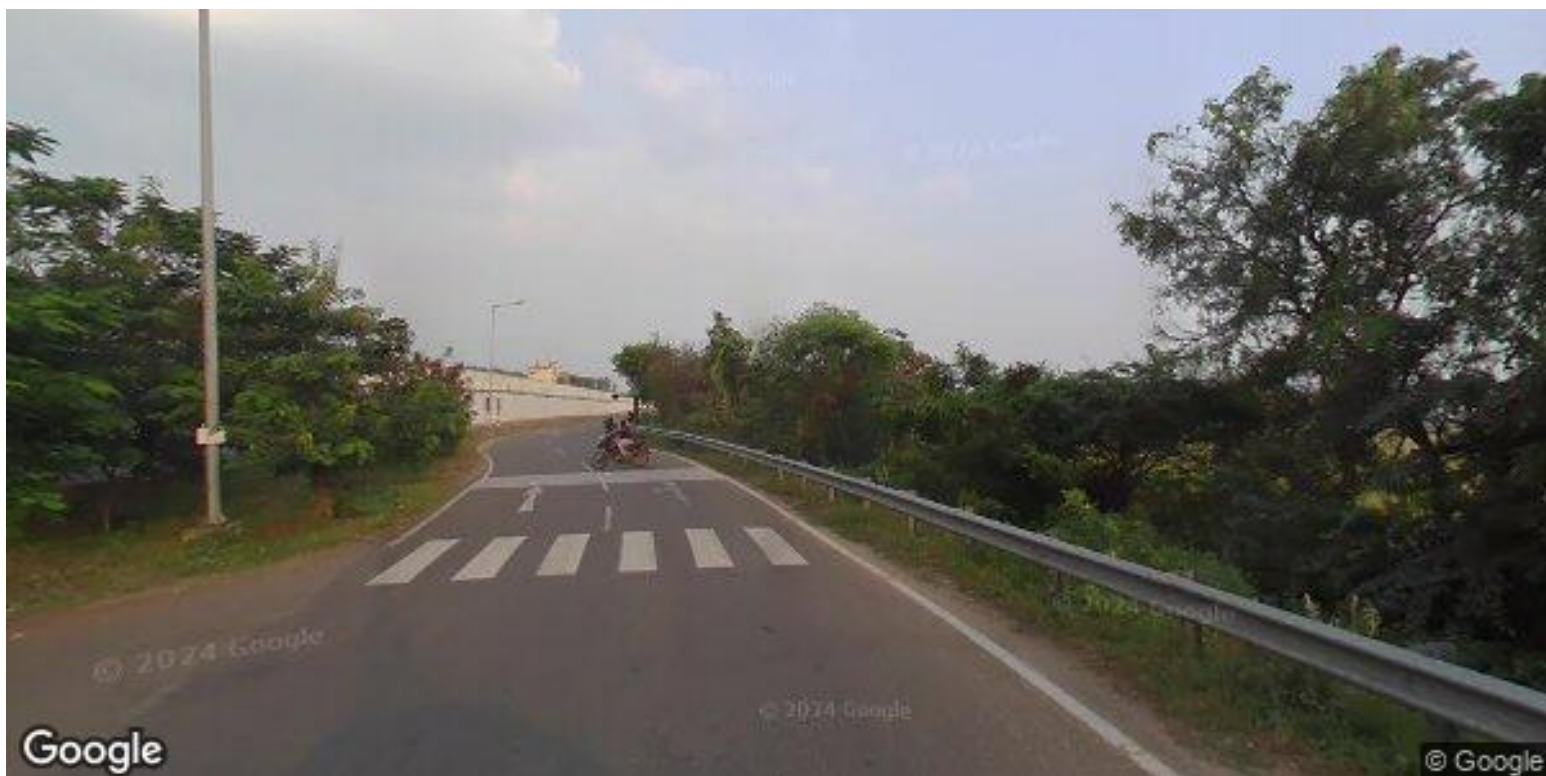
Risk Type: Blind Spot
Risk Level: Blind Spot
Speed Limit: 10 KM/Hr
Coordinates: 11.19817, 77.31266

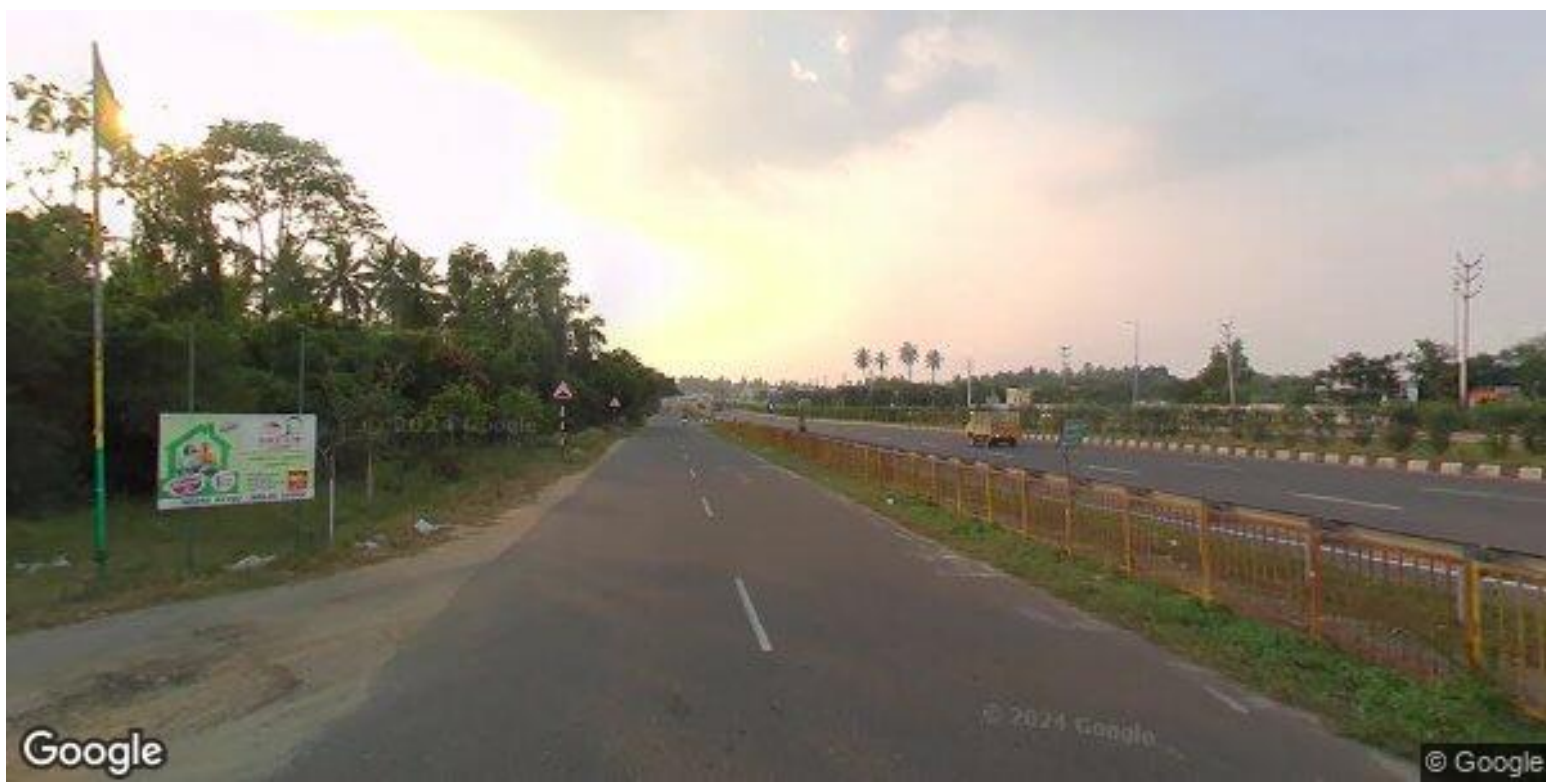
Risk Type: Turn

Risk Level: High

Coordinates: 11.19835, 77.30832

Speed Limit: 15 KM/Hr

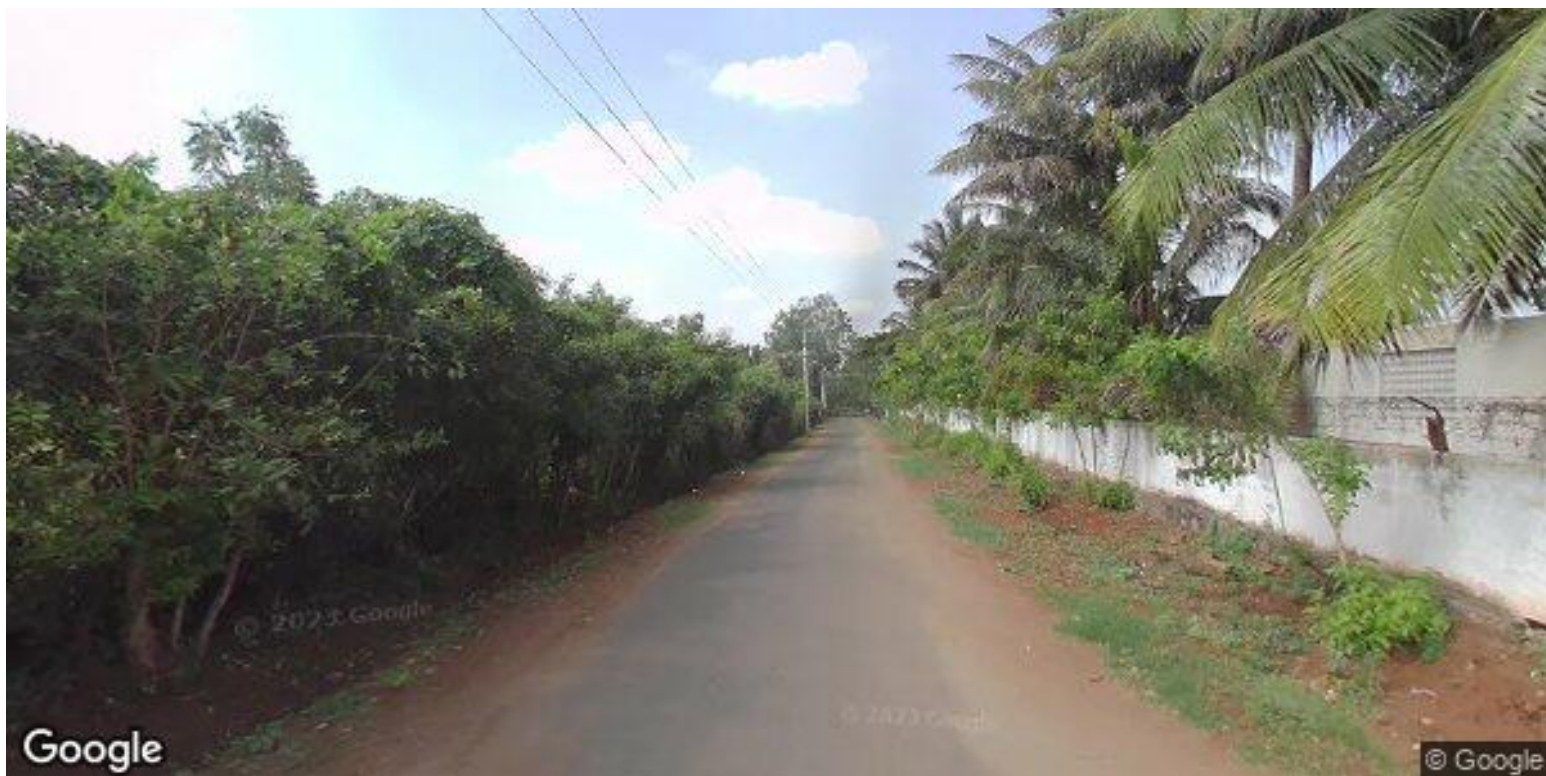
Risk Type: Blind Spot

Risk Level: Blind Spot

Coordinates: 11.19241, 77.30829

Speed Limit: 10 KM/Hr

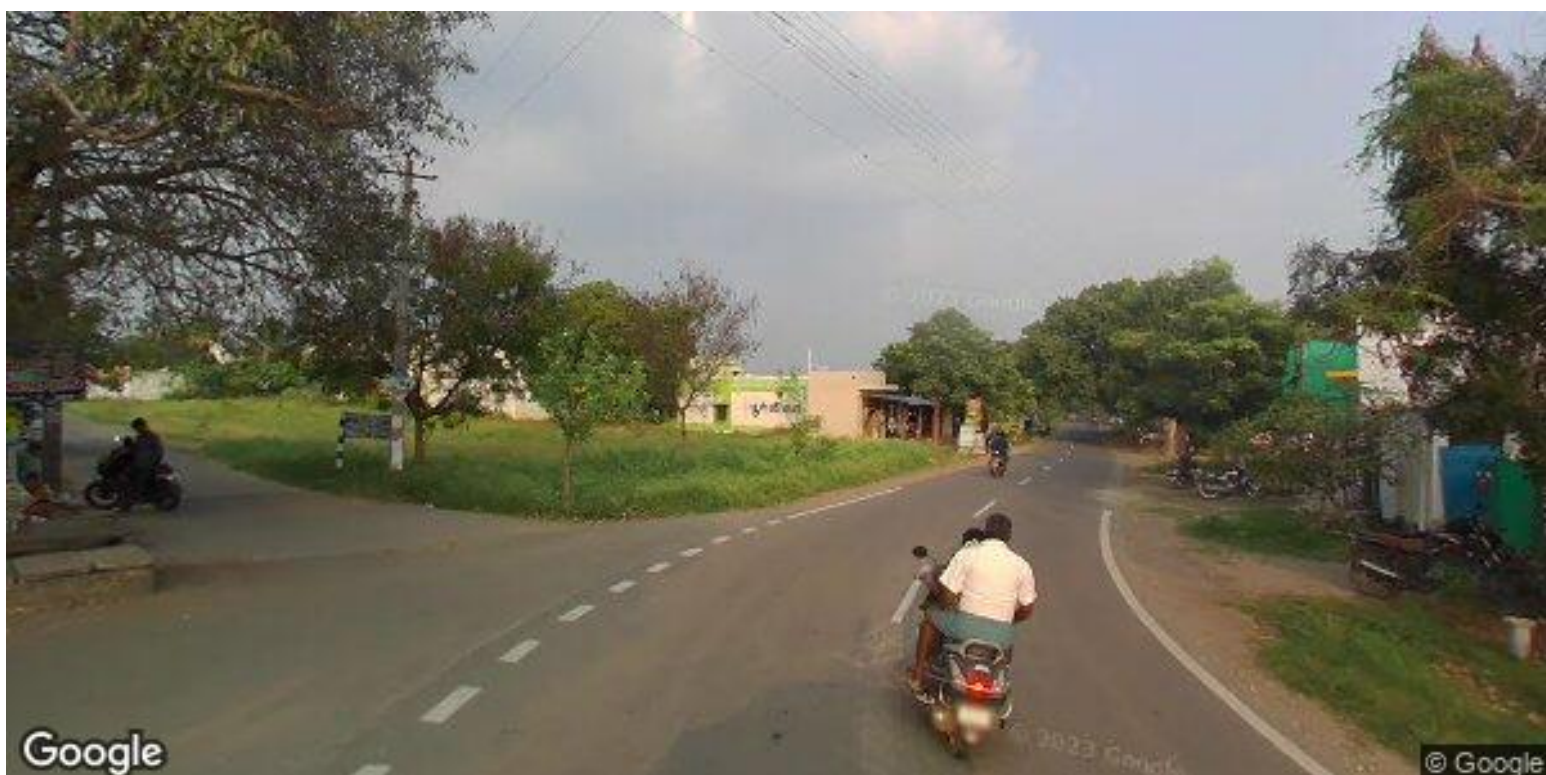
Risk Type: Blind Spot
Risk Level: Blind Spot
Speed Limit: 10 KM/Hr
Coordinates: 11.19175, 77.31406

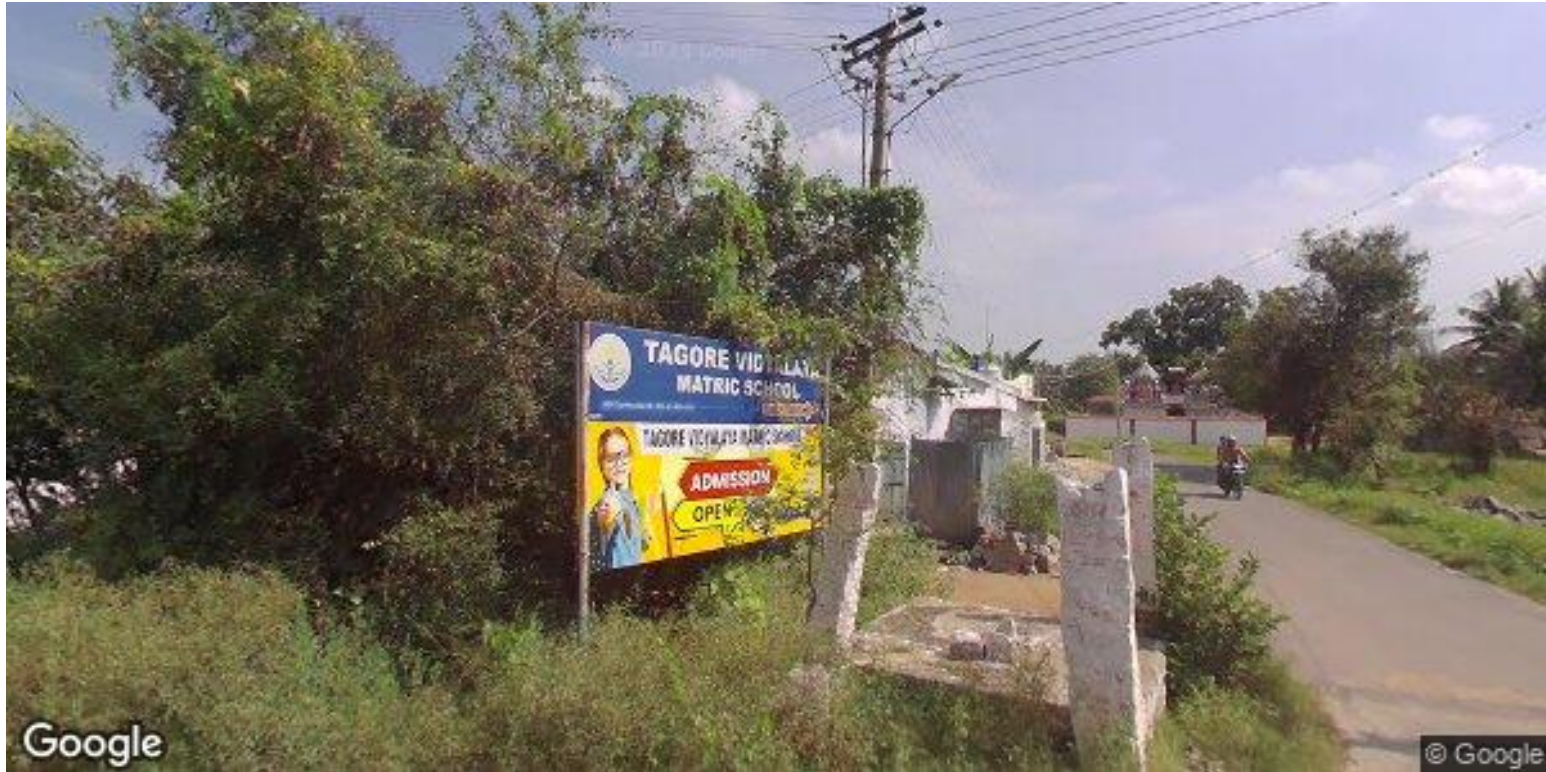
Risk Type: Turn
Risk Level: Medium
Speed Limit: 30 KM/Hr
Coordinates: 11.19019, 77.31449

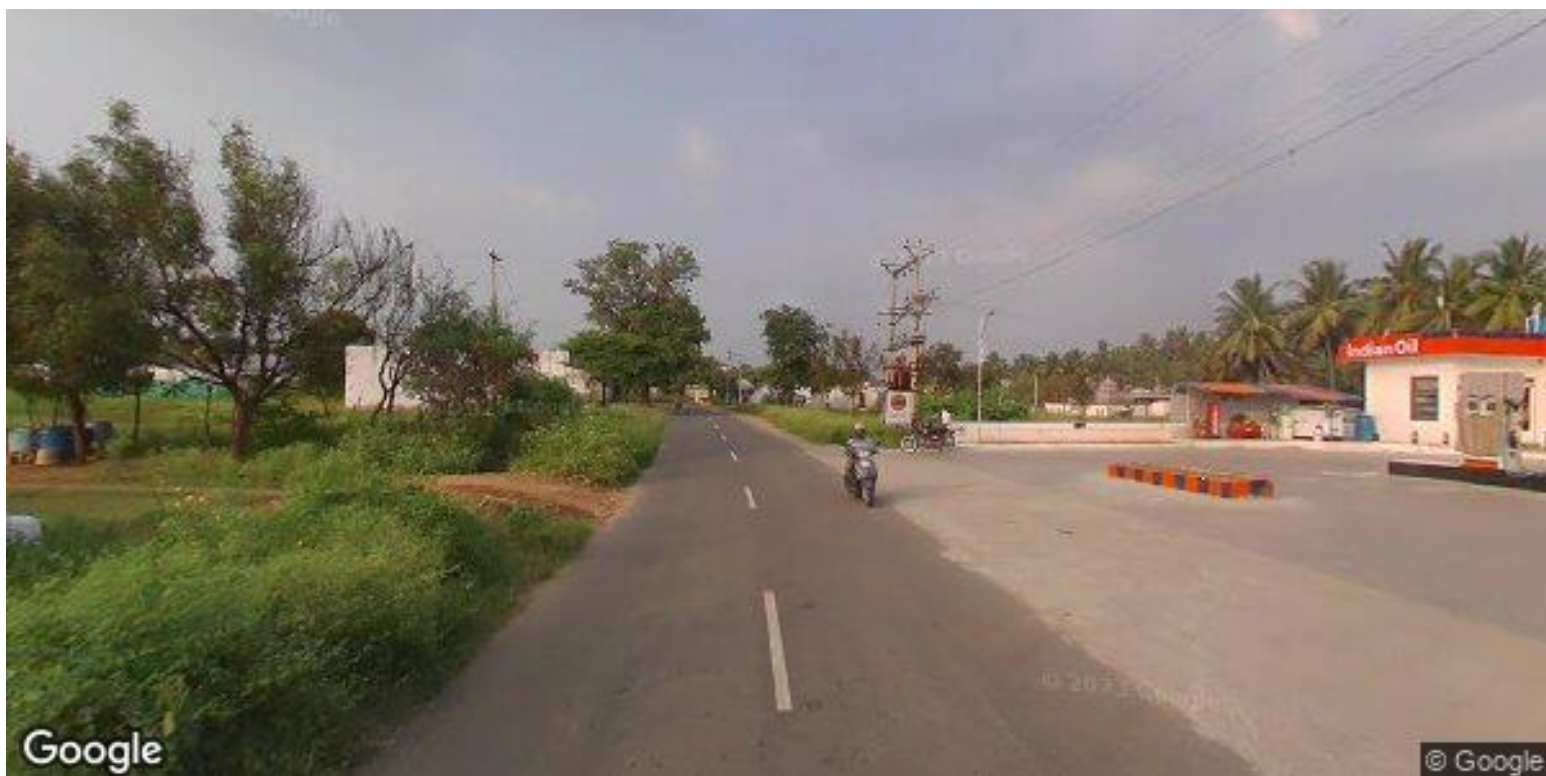
Risk Type: Blind Spot
Risk Level: Blind Spot
Speed Limit: 10 KM/Hr
Coordinates: 11.18943, 77.31441
