JOURNEY RISK MANAGEMENT (JRM) STUDY

IOCL Coimbatore Terminal to Almighty Agencies

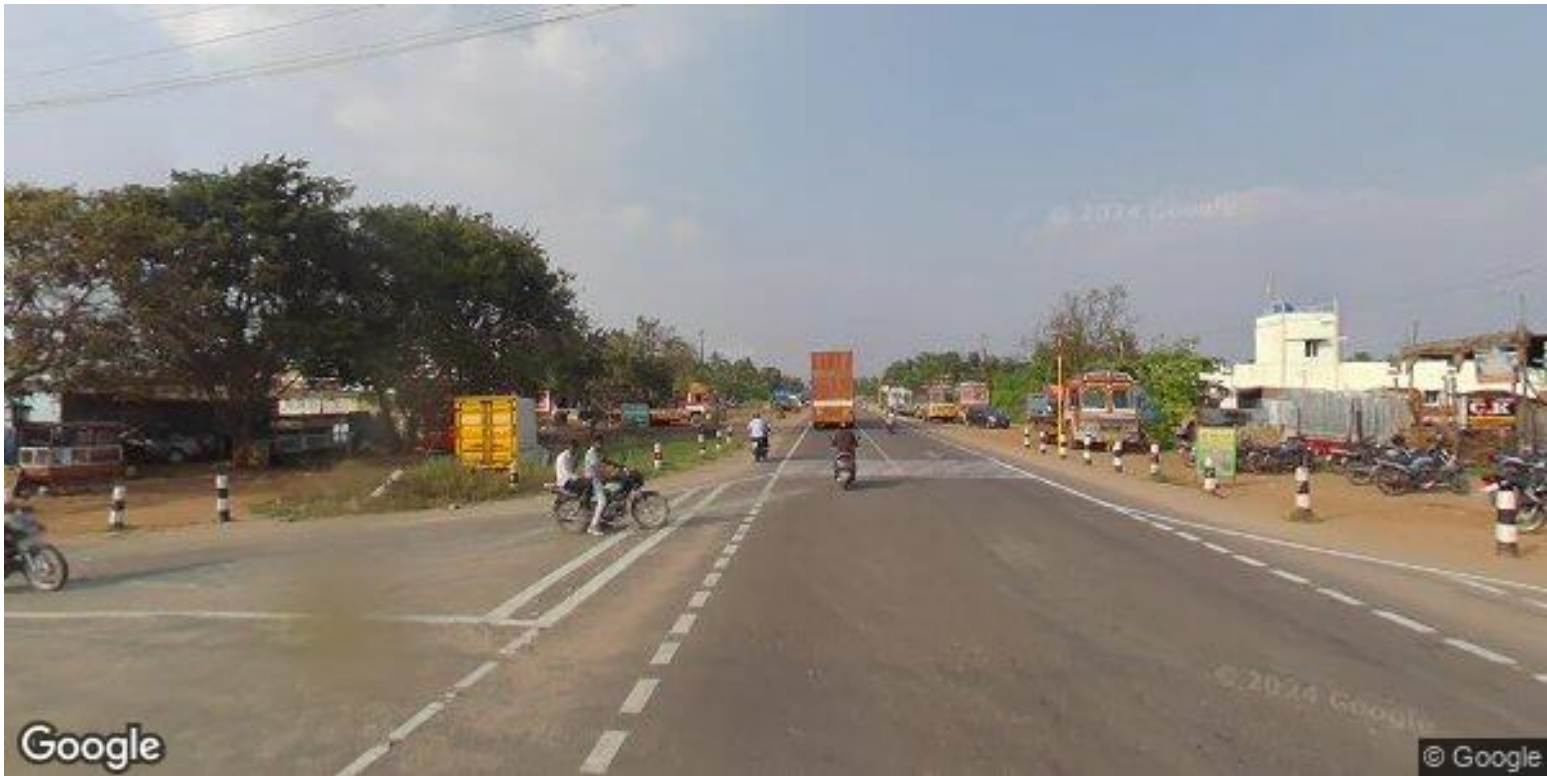
Coordinates: 11.03211, 77.07640

Risk Type: Turn

Risk Level: High

Speed Limit: 15 KM/Hr

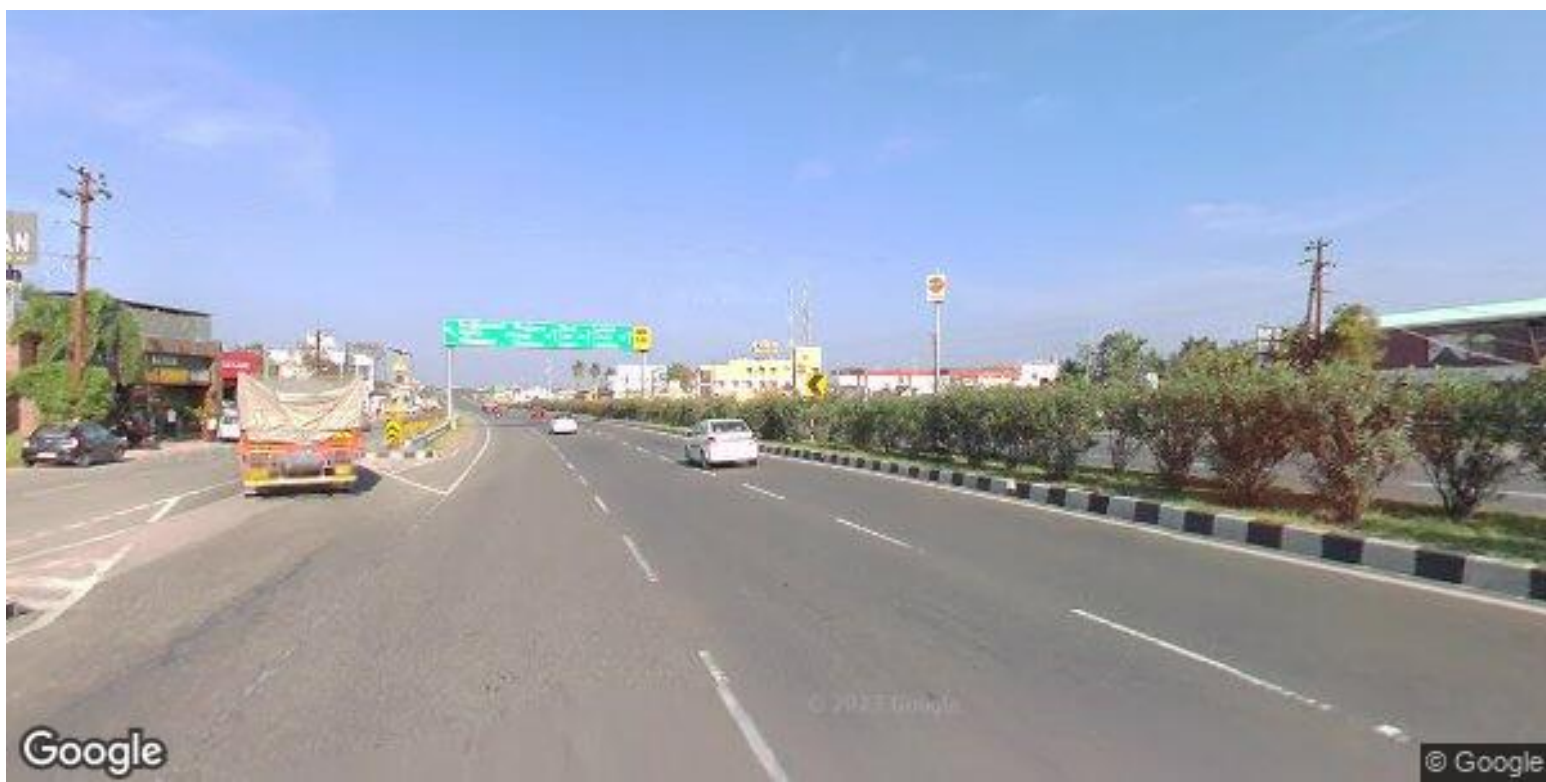
Coordinates: 11.10499, 77.17299

Risk Type: Turn

Risk Level: Medium

Speed Limit: 30 KM/Hr

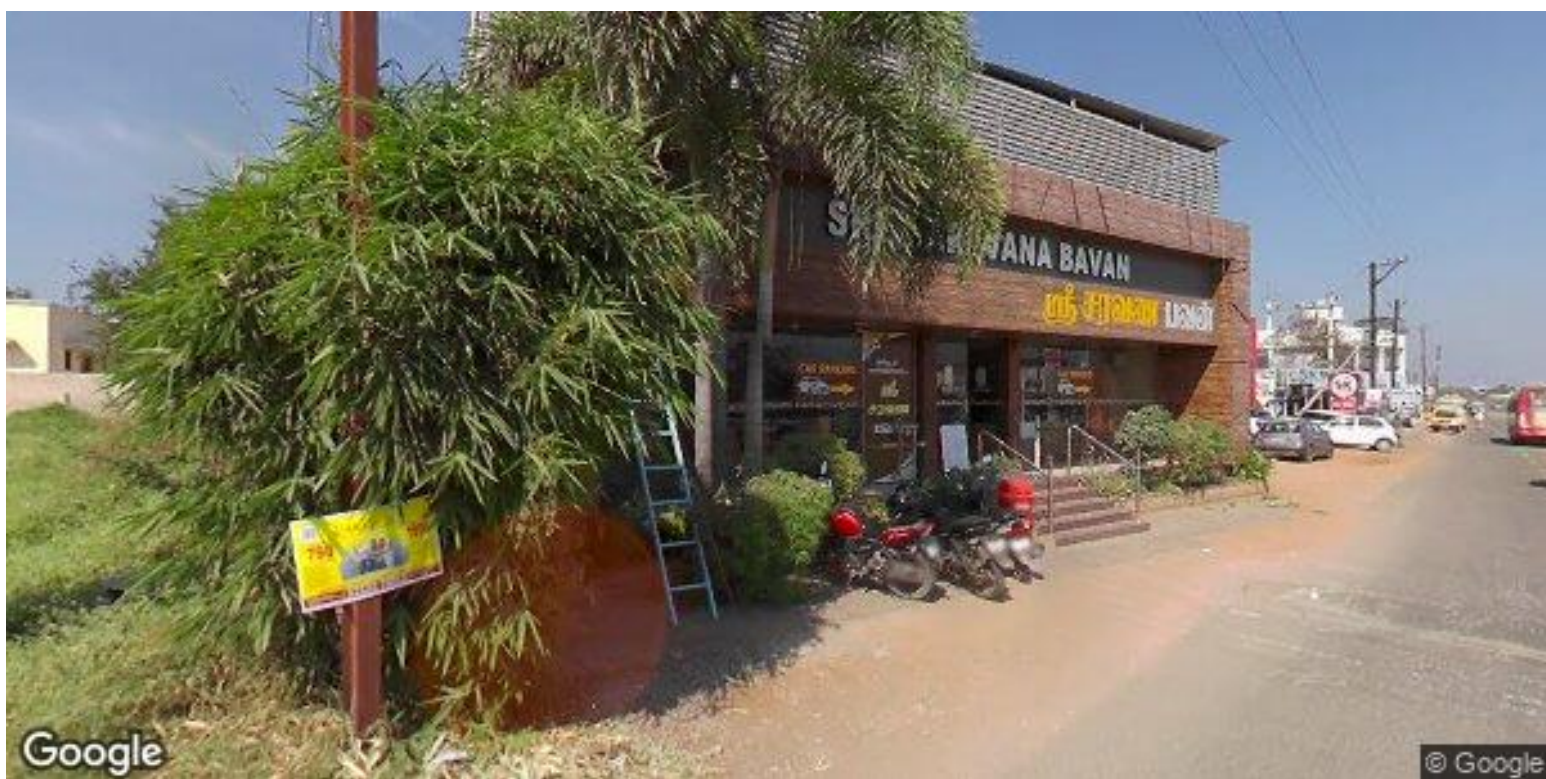
Coordinates: 11.10527, 77.17318

Risk Type: Turn

Risk Level: Medium

Speed Limit: 30 KM/Hr

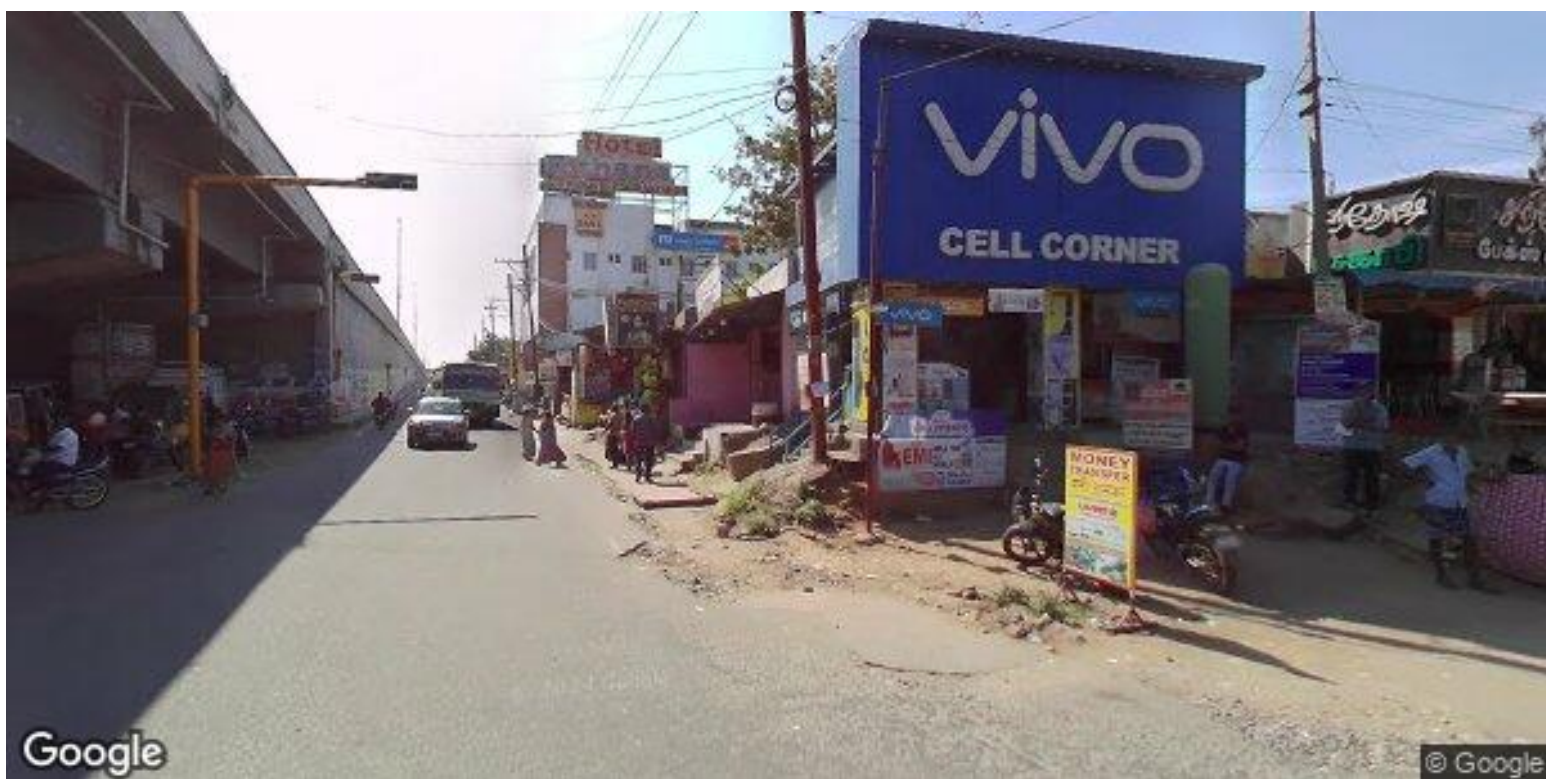
Risk Type: Turn
Risk Level: High
Speed Limit: 15 KM/Hr
Coordinates: 11.10777, 77.17700

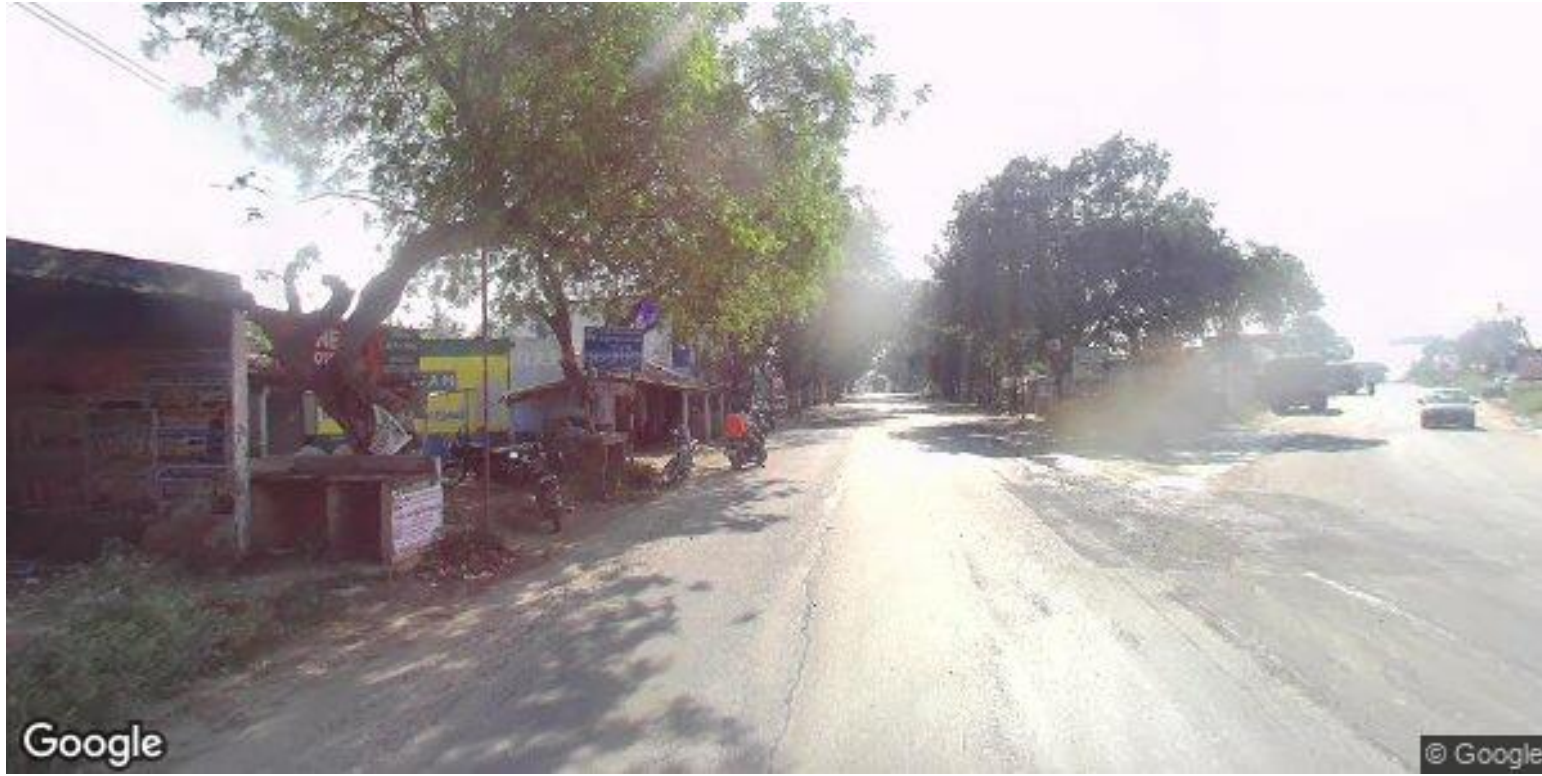
Risk Type: Turn
Risk Level: Medium
Speed Limit: 30 KM/Hr
Coordinates: 11.22872, 77.12009
