JOURNEY RISK MANAGEMENT (JRM) STUDY

IOCL Coimbatore Terminal to Shree Raam Petro Fills

Route Safety Analysis Report

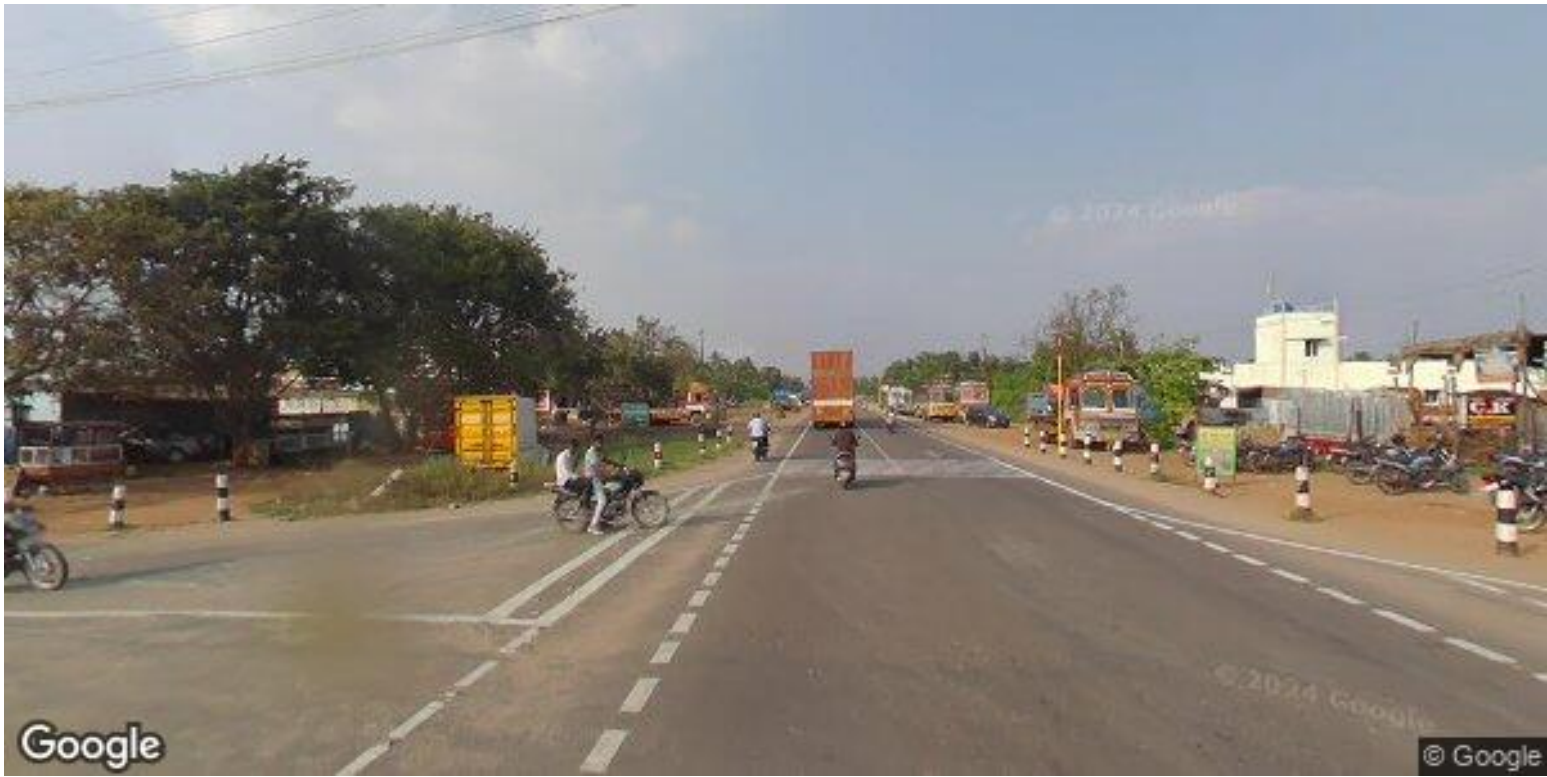
Coordinates: 11.03211, 77.07640

Risk Type: Turn

Risk Level: High

Speed Limit: 15 KM/Hr

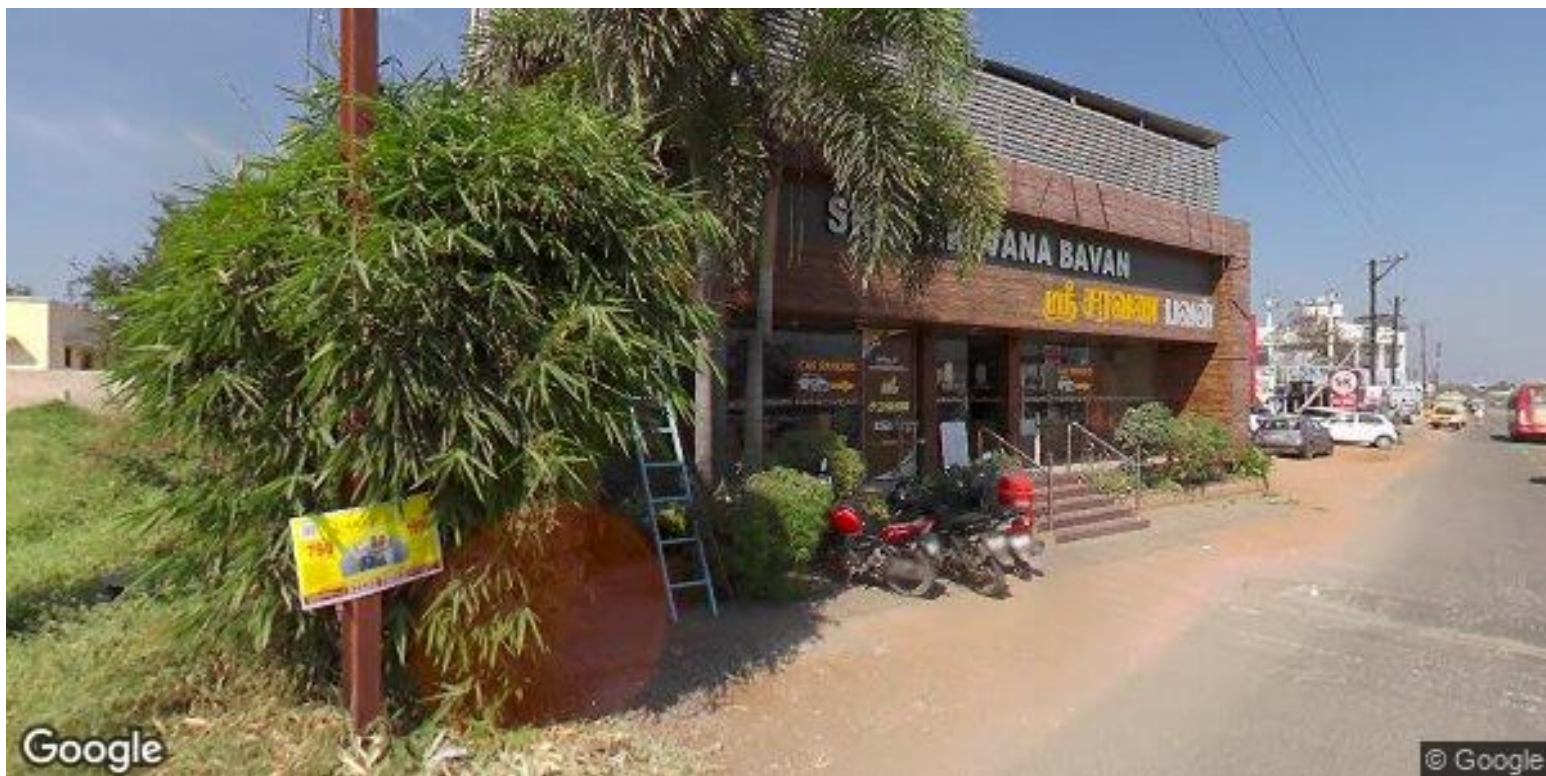
Coordinates: 11.10527, 77.17318

Risk Type: Turn

Risk Level: Medium

Speed Limit: 30 KM/Hr

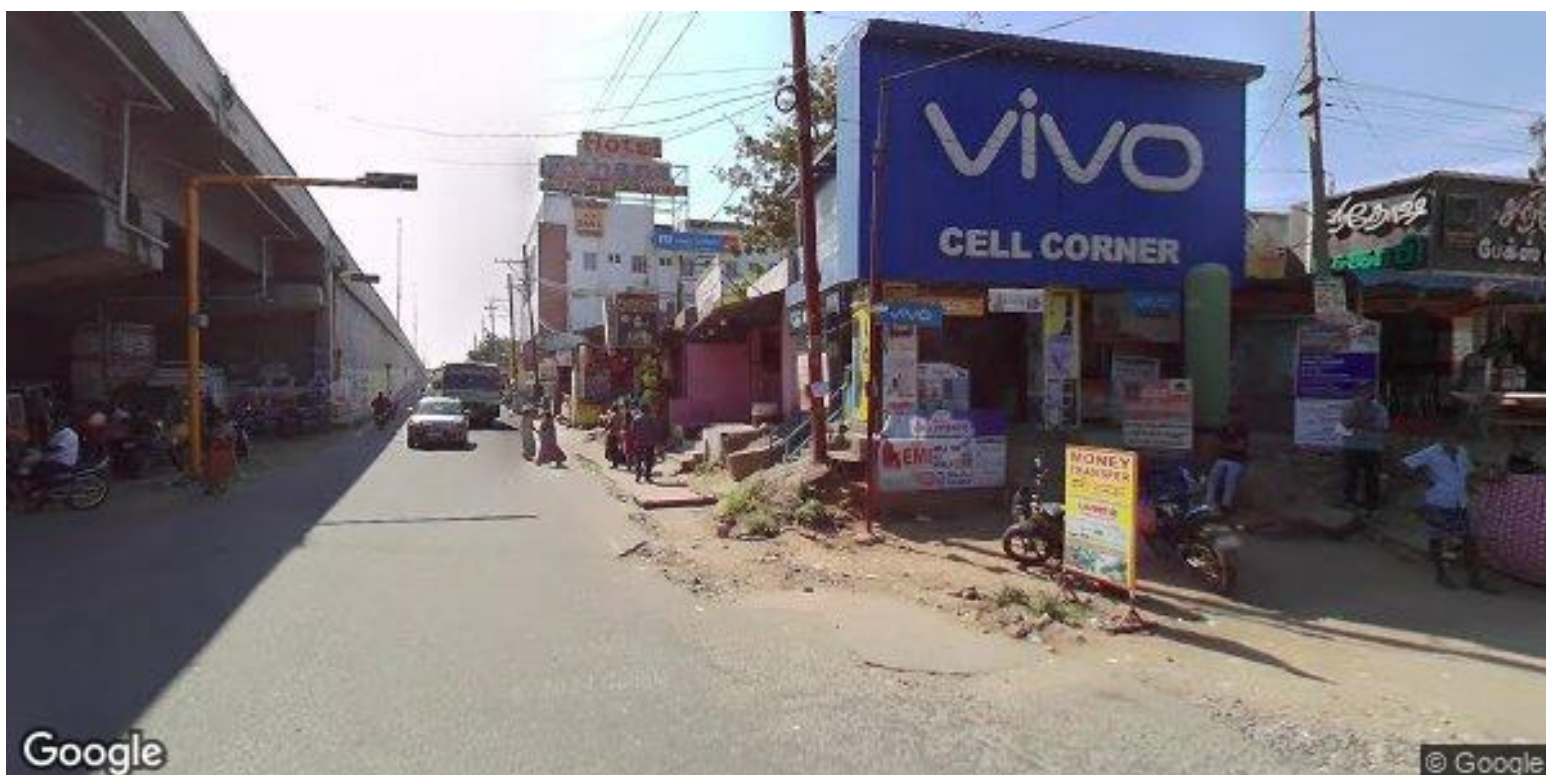
Risk Type: Turn
Risk Level: High
Speed Limit: 15 KM/Hr
Coordinates: 11.10777, 77.17700

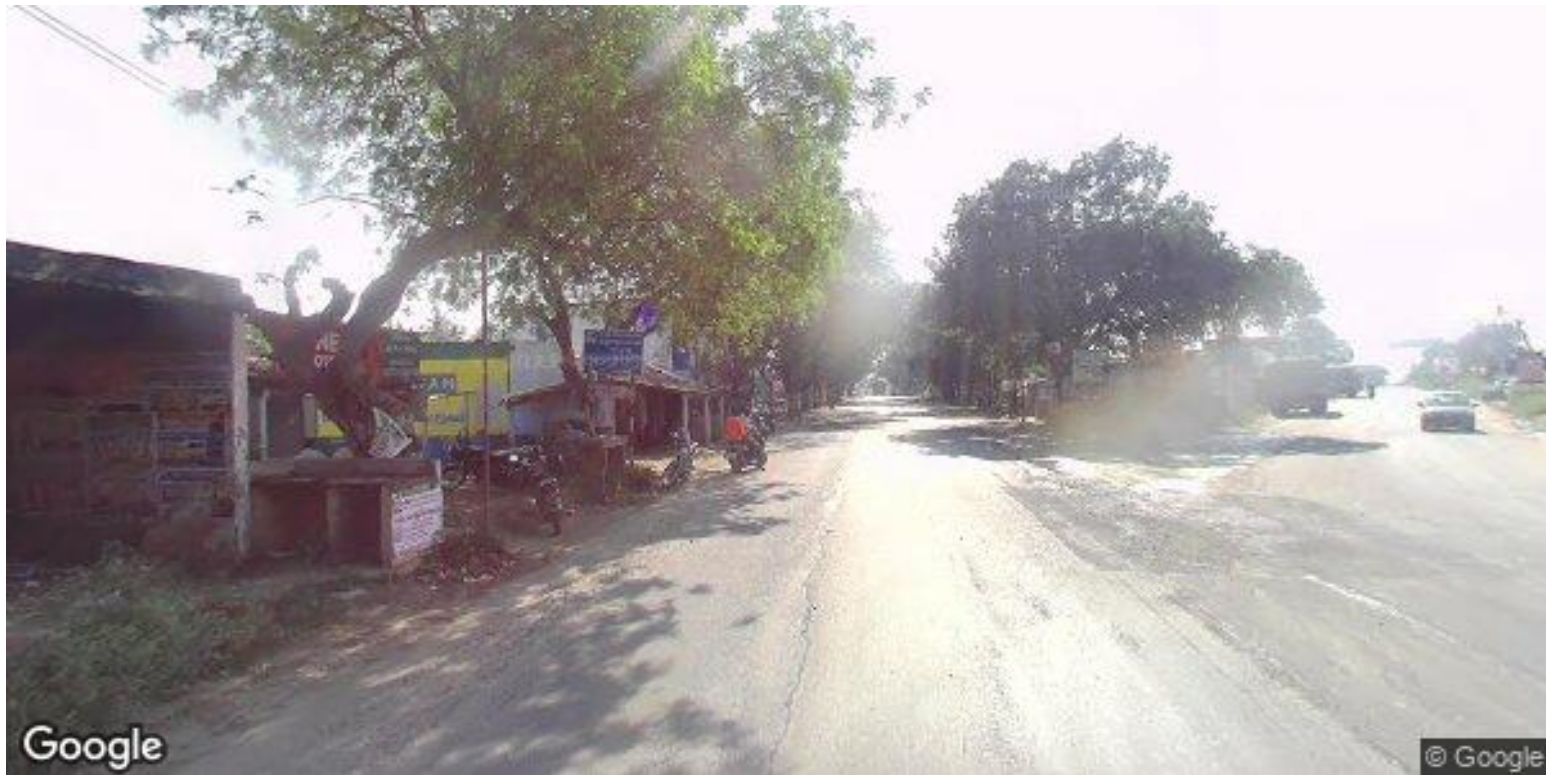
Risk Type: Turn
Risk Level: Medium
Speed Limit: 30 KM/Hr
Coordinates: 11.22872, 77.12009

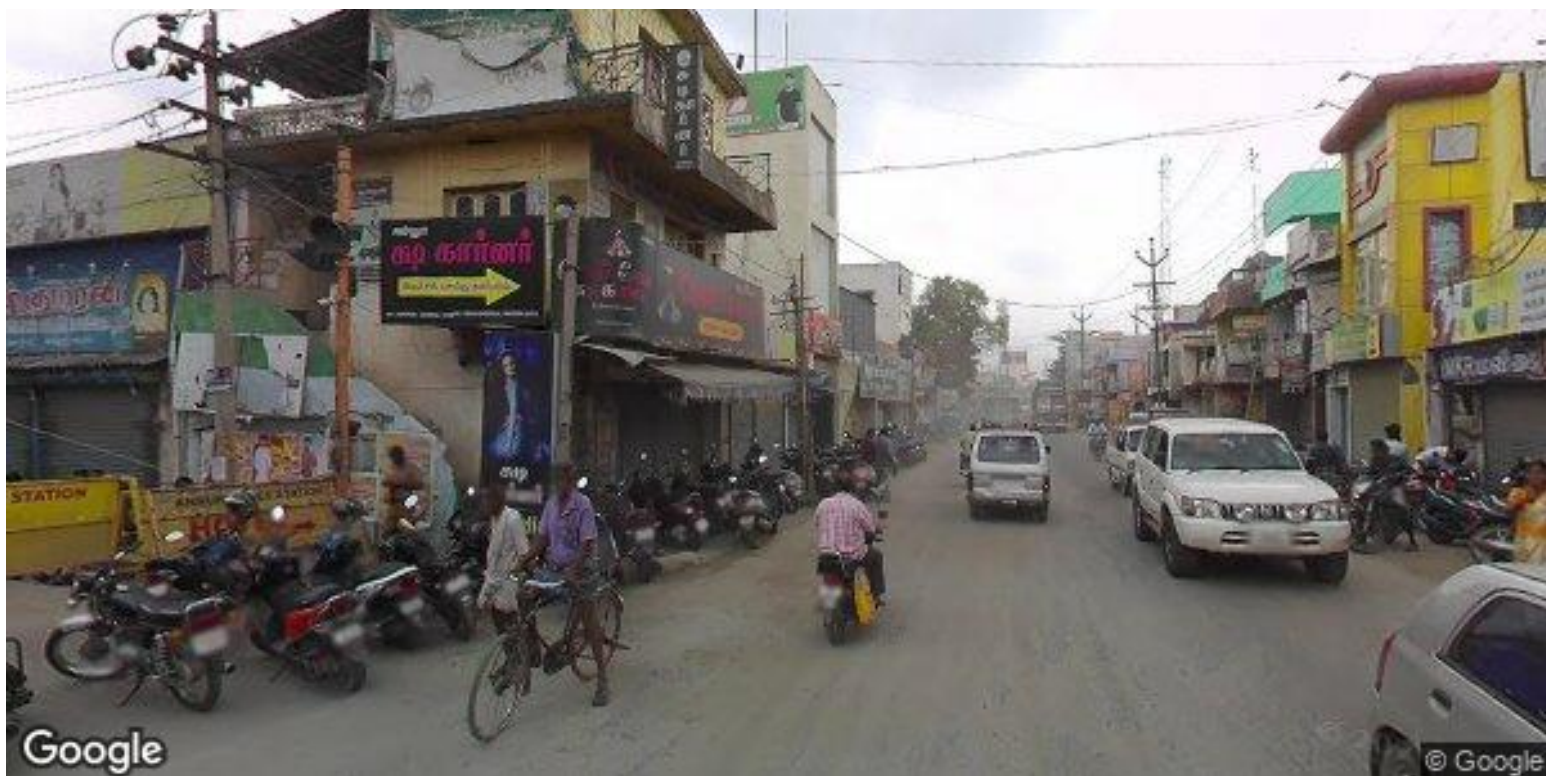
Risk Type: Turn
Risk Level: High
Speed Limit: 15 KM/Hr
Coordinates: 11.23330, 77.10347

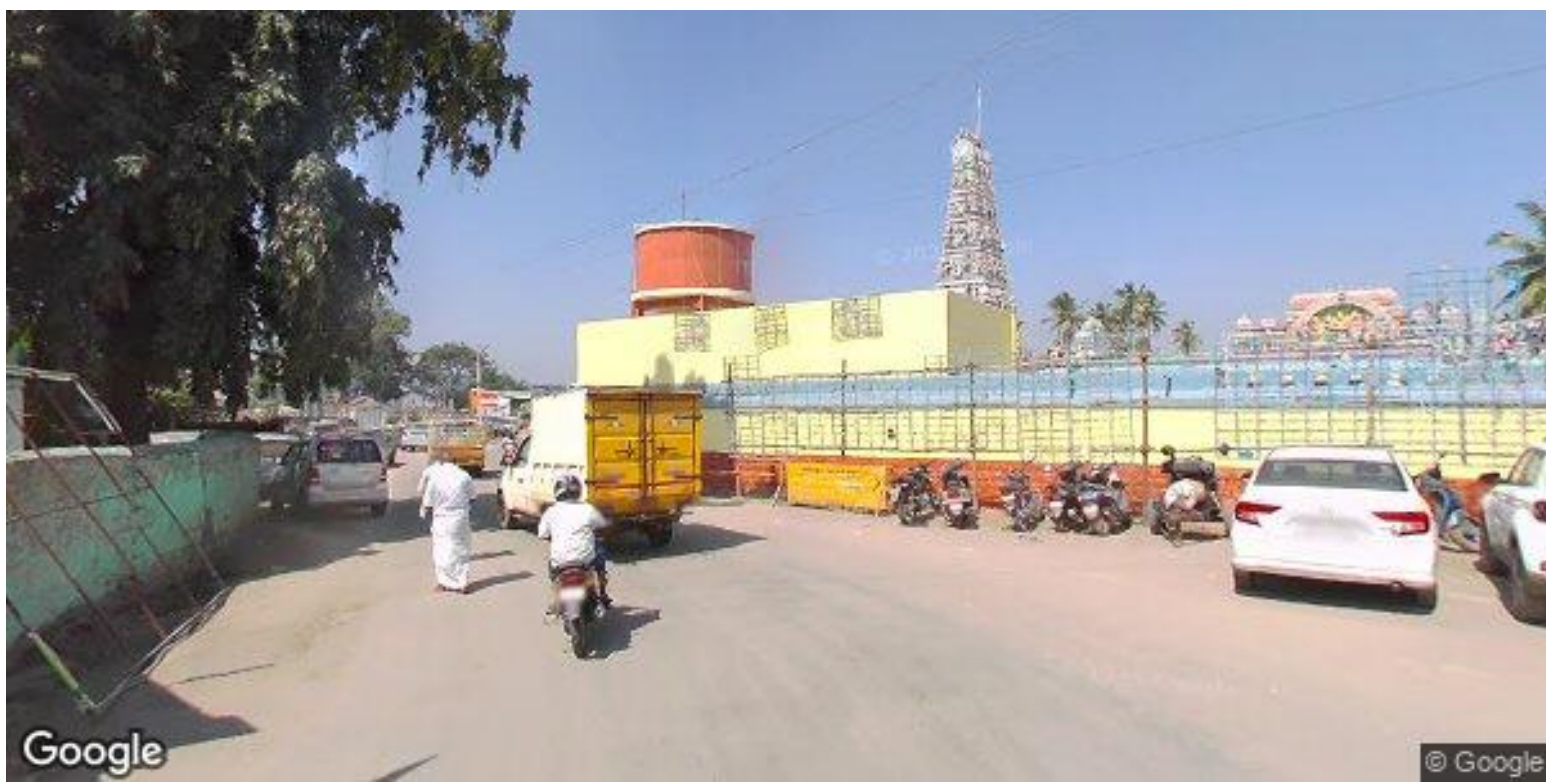
Coordinates: 11.23499, 77.10349

Risk Type: Turn

Risk Level: High

Speed Limit: 15 KM/Hr

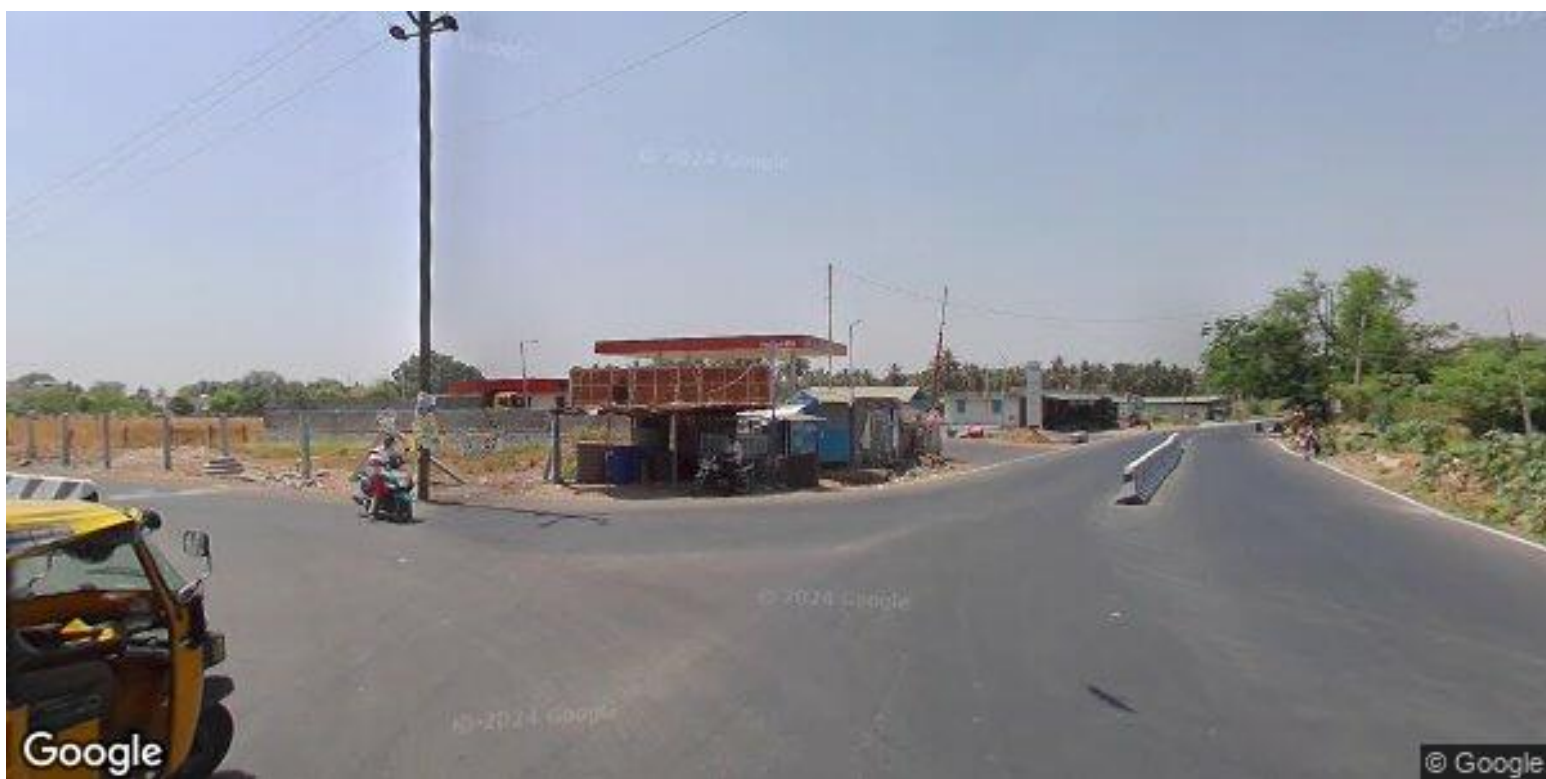
Coordinates: 11.24077, 77.10268

Risk Type: Turn

Risk Level: Medium

Speed Limit: 30 KM/Hr

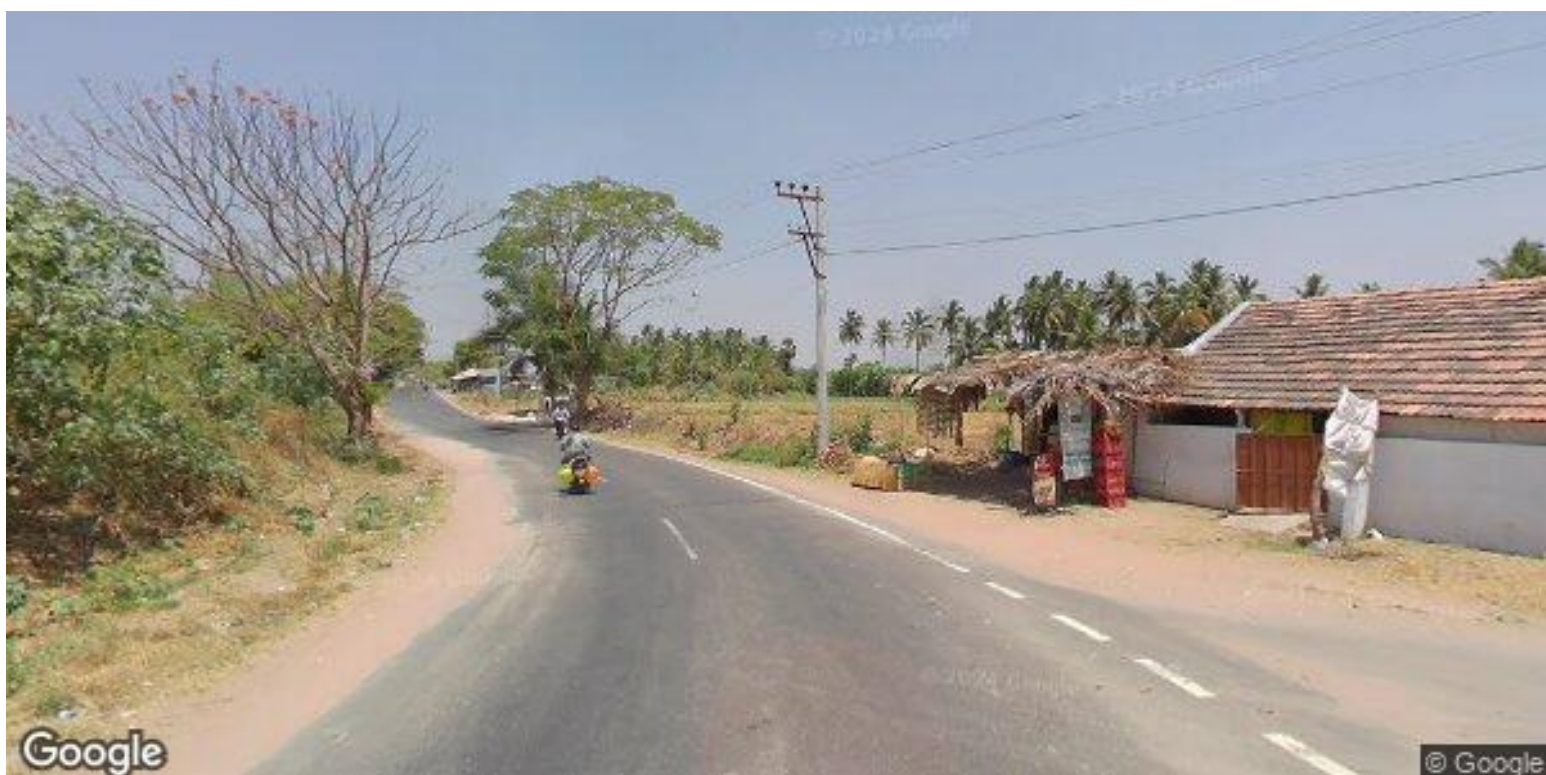
Coordinates: 11.29254, 77.02192

Risk Type: Turn

Risk Level: Medium

Speed Limit: 30 KM/Hr
