JOURNEY RISK MANAGEMENT (JRM) STUDY

Salem Terminal to VEERAKUMAR AGENCIES

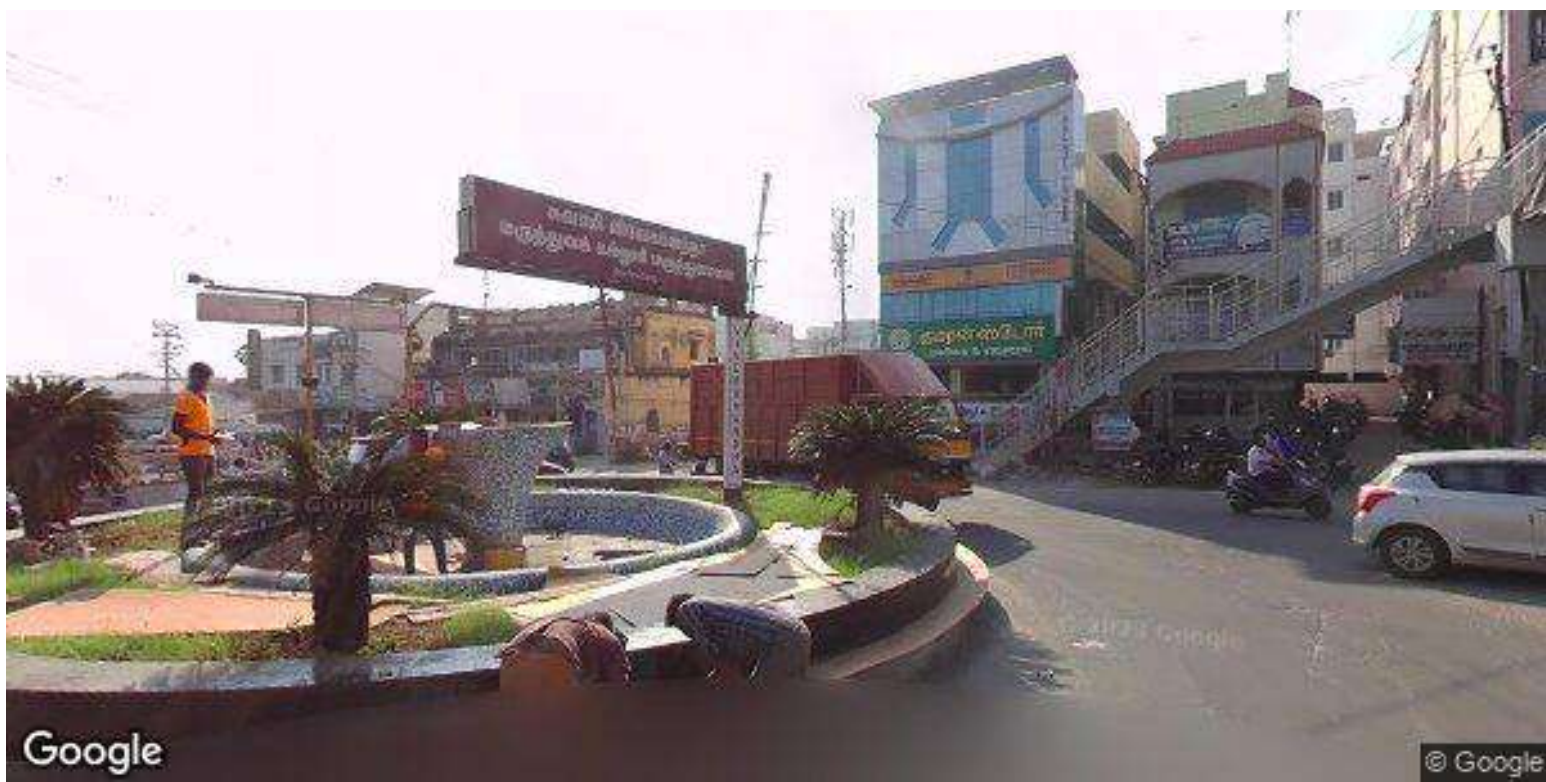
Coordinates: 11.38395, 77.89480

Risk Type: Roundabout

Risk Level: High

Speed Limit: 15 KM/Hr

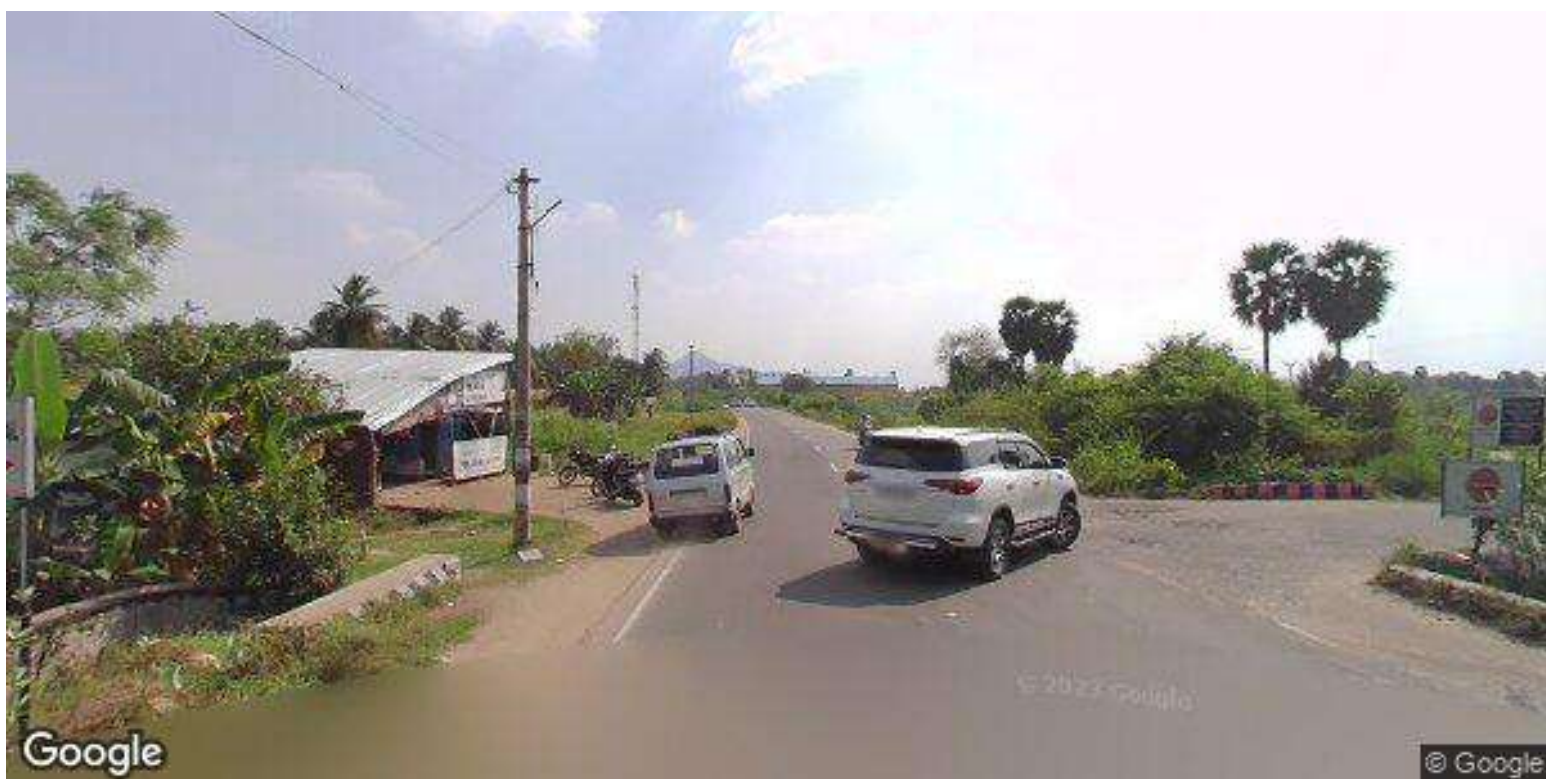
Coordinates: 11.44029, 77.87544

Risk Type: Blind Spot

Risk Level: Blind Spot

Speed Limit: 10 KM/Hr

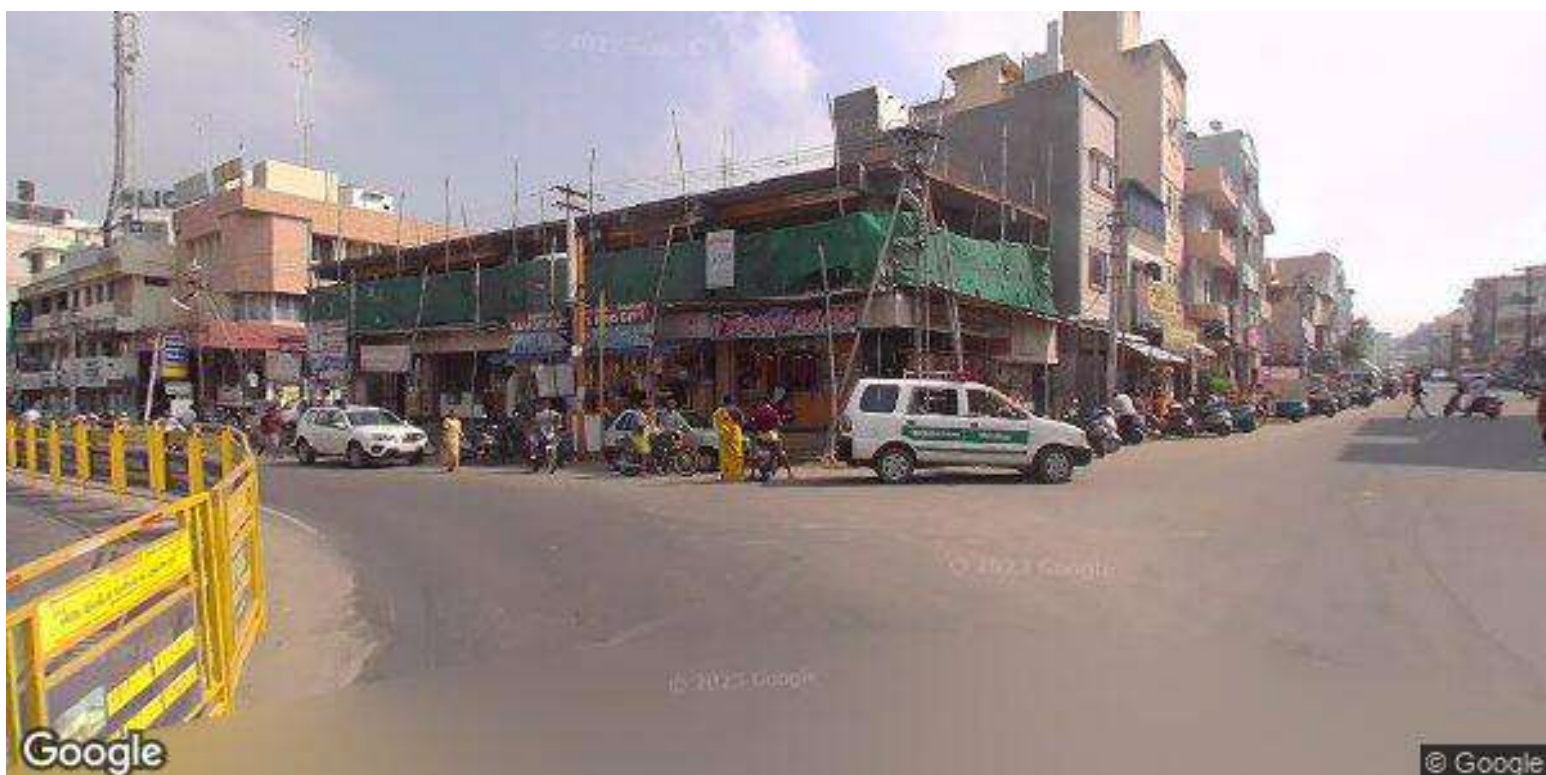
Coordinates: 11.37868, 77.89498

Risk Type: Turn

Risk Level: High

Speed Limit: 15 KM/Hr

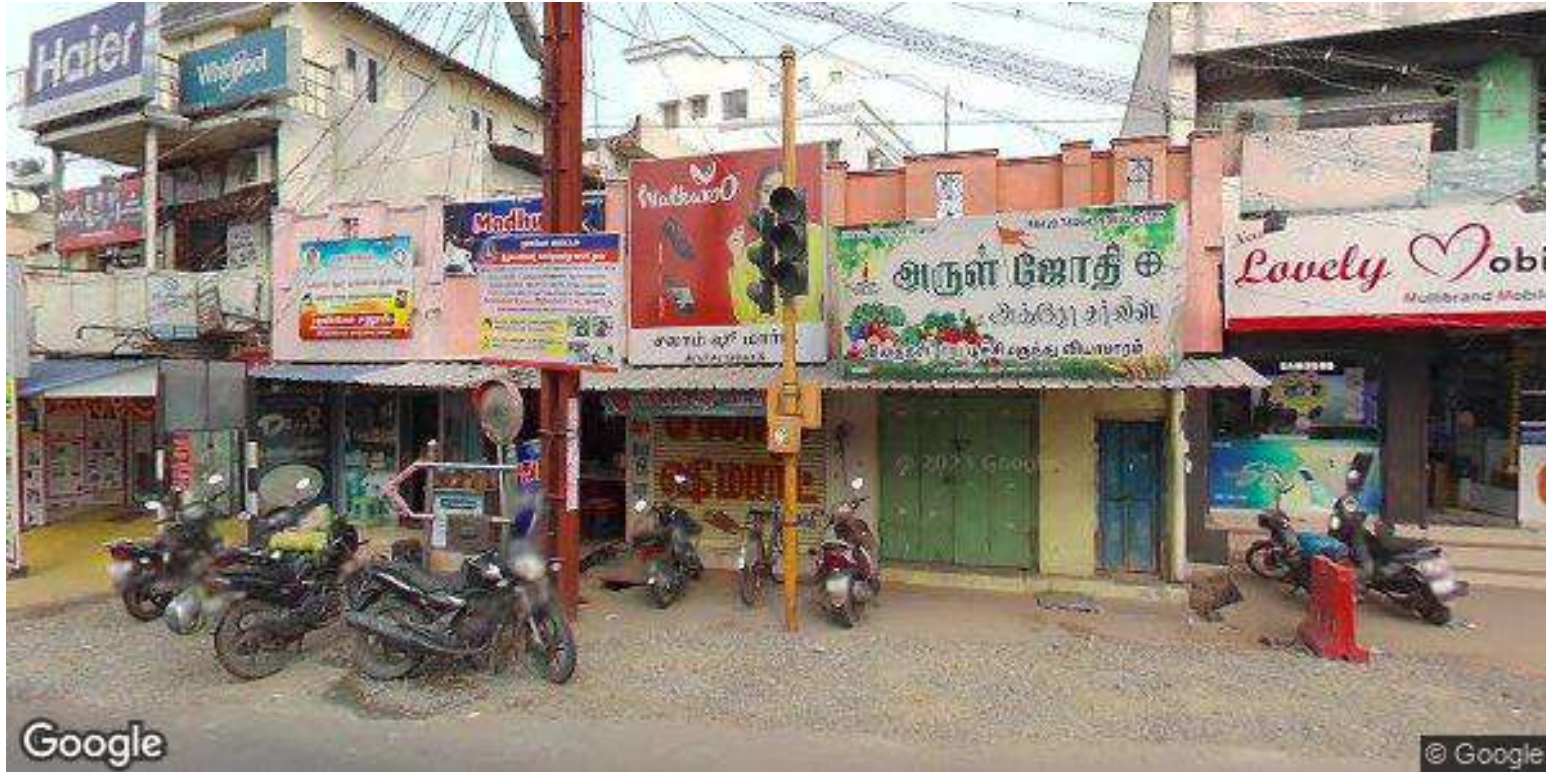
Coordinates: 11.37850, 77.89453

Risk Type: Turn

Risk Level: High

Speed Limit: 15 KM/Hr

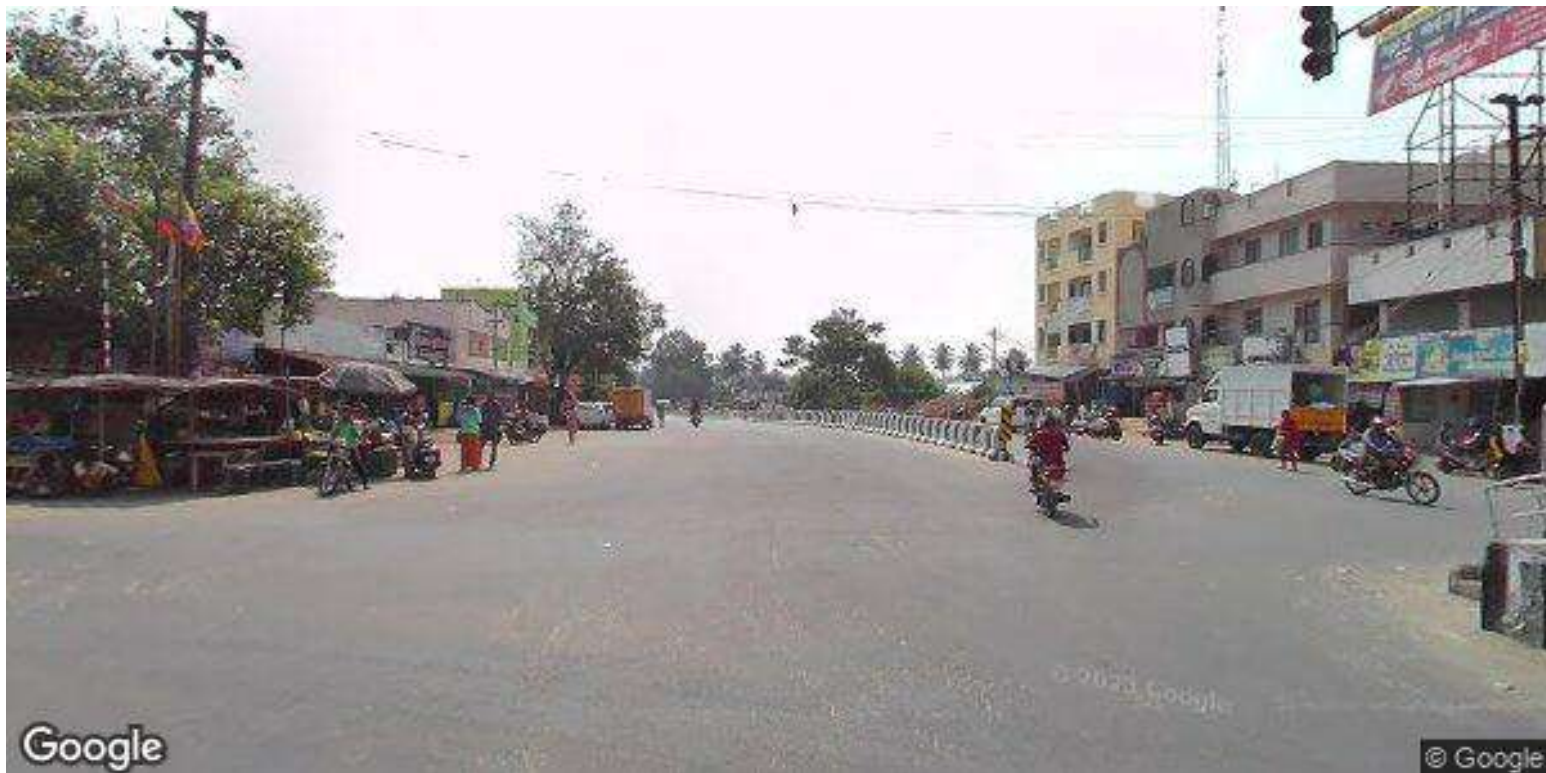
Coordinates: 11.36604, 77.88887

Risk Type: Turn

Risk Level: High

Speed Limit: 15 KM/Hr

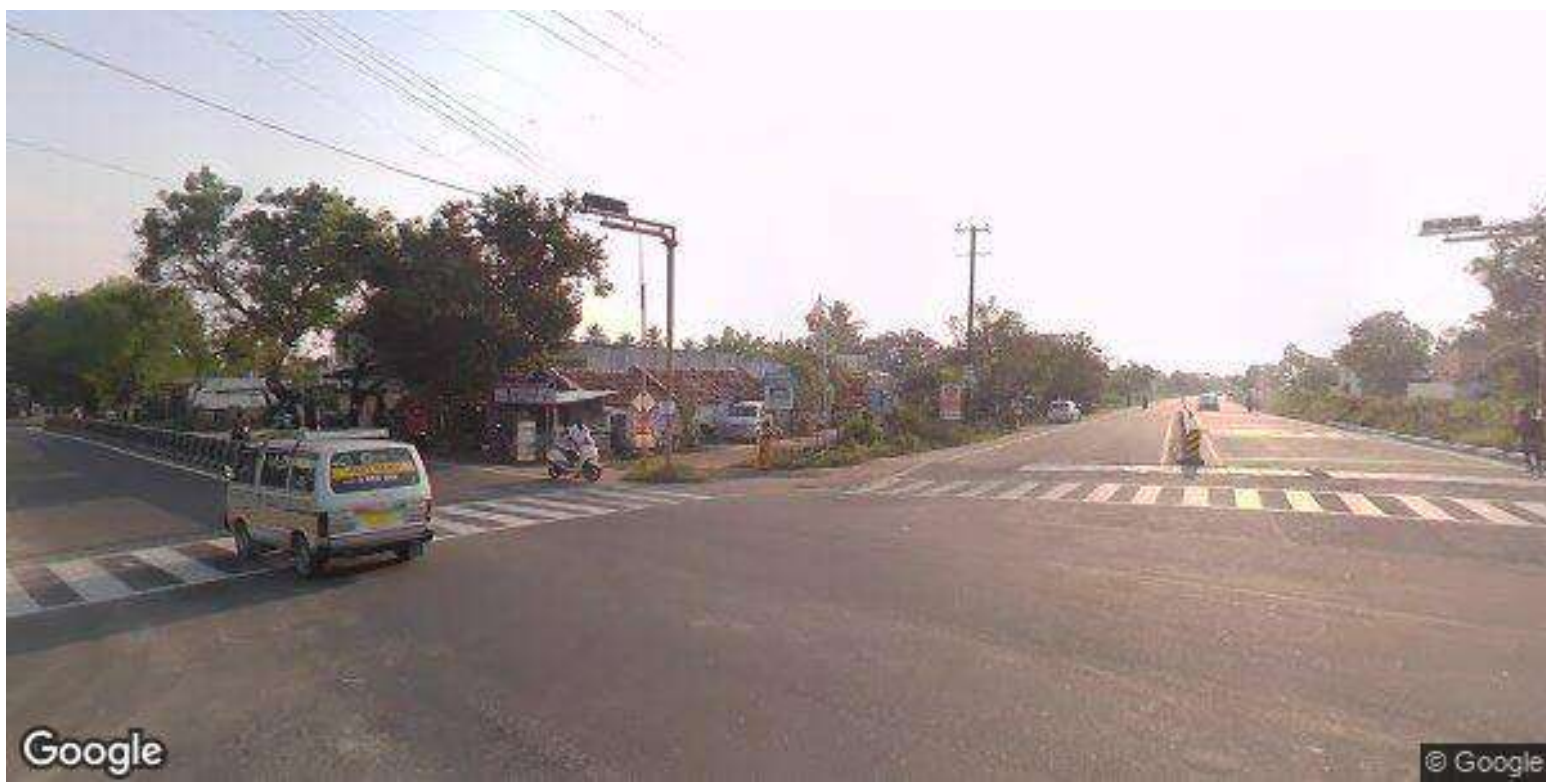
Coordinates: 11.29899, 77.75806

Risk Type: Turn

Risk Level: High

Speed Limit: 15 KM/Hr

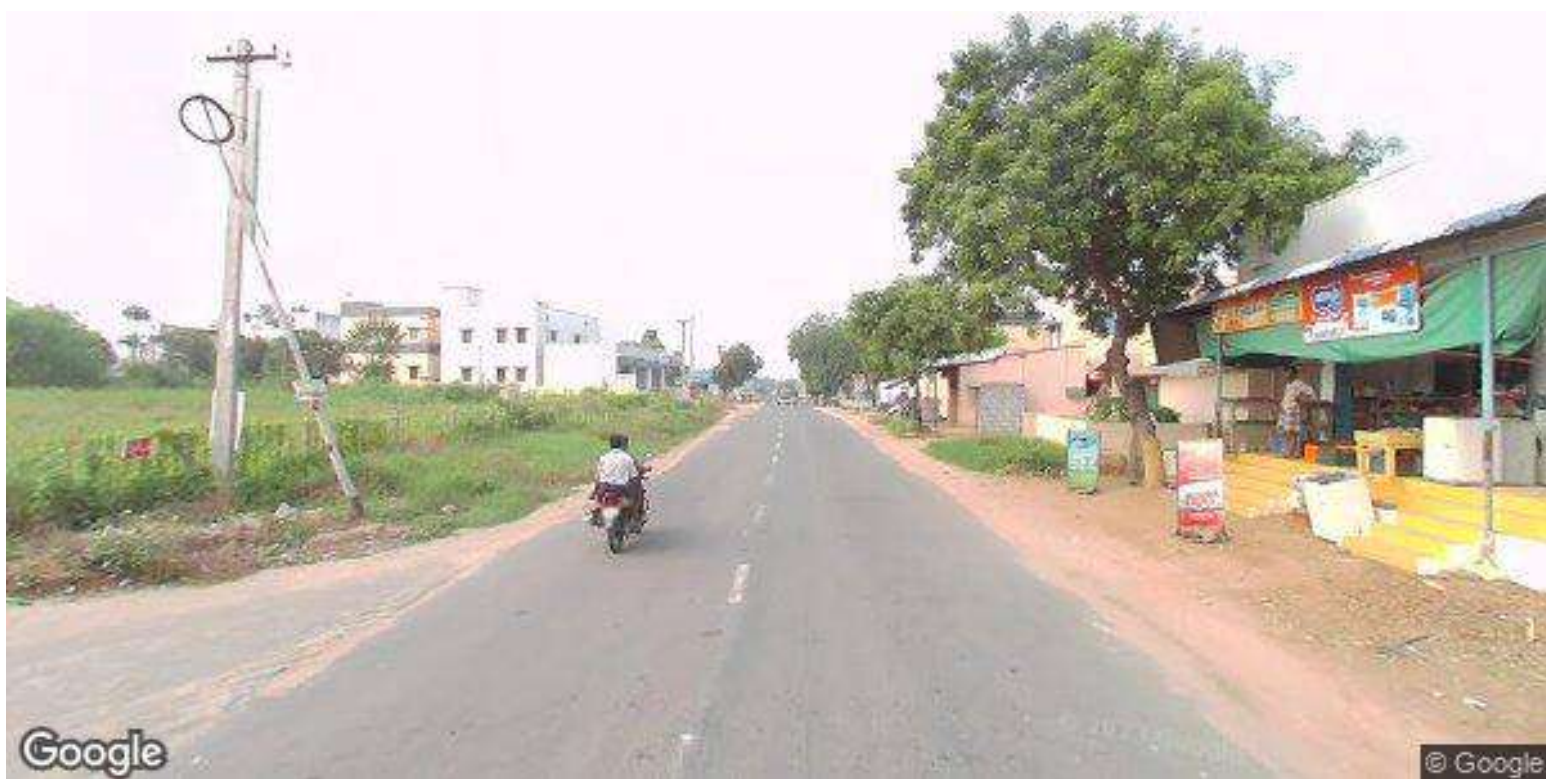
Coordinates: 11.26338, 77.77118

Risk Type: Turn

Risk Level: High

Speed Limit: 15 KM/Hr

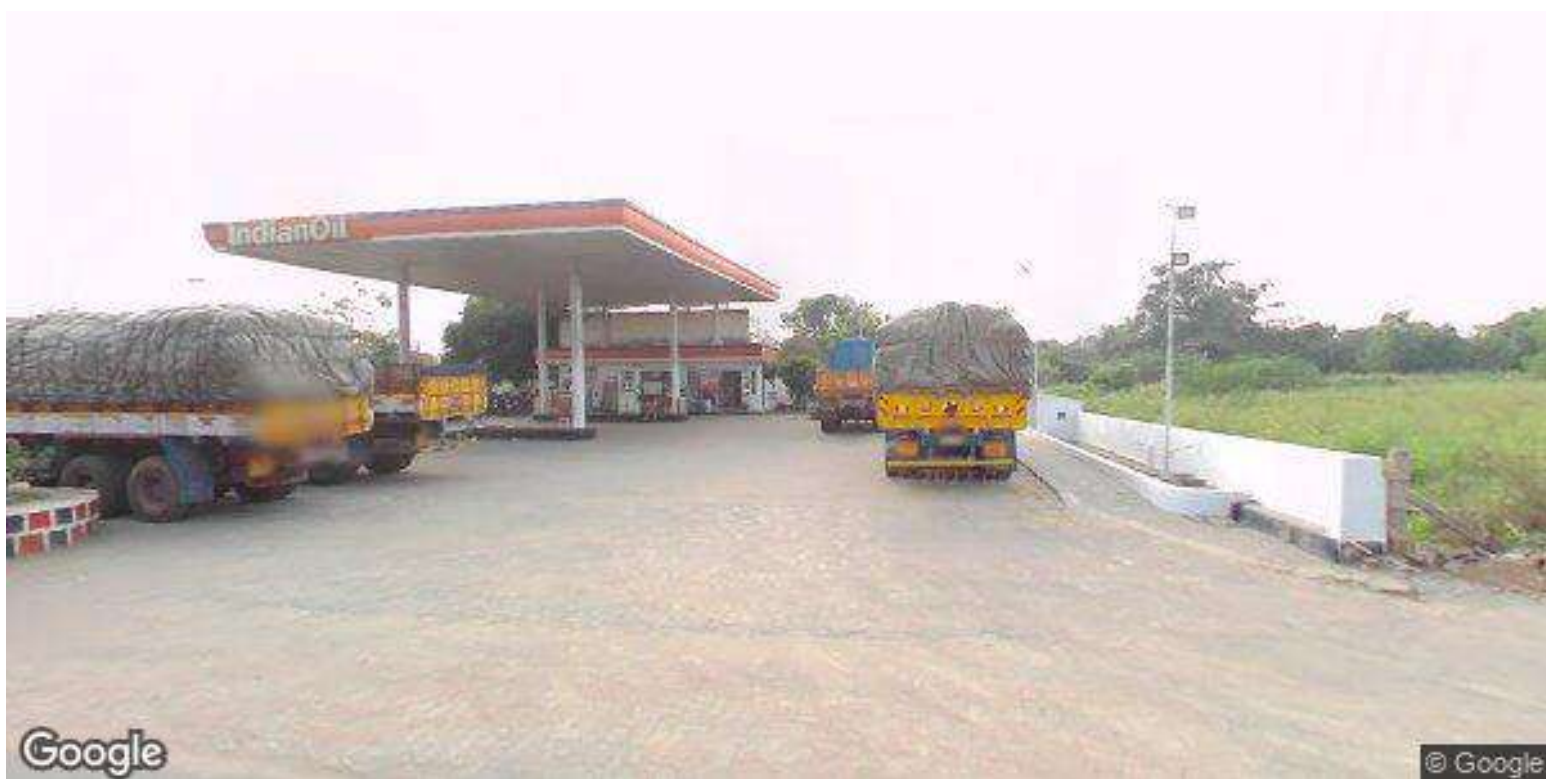
Coordinates: 11.26326, 77.77100

Risk Type: Turn

Risk Level: High

Speed Limit: 15 KM/Hr
