JOURNEY RISK MANAGEMENT (JRM) STUDY

Salem Terminal TO KMS ENTERPRISES

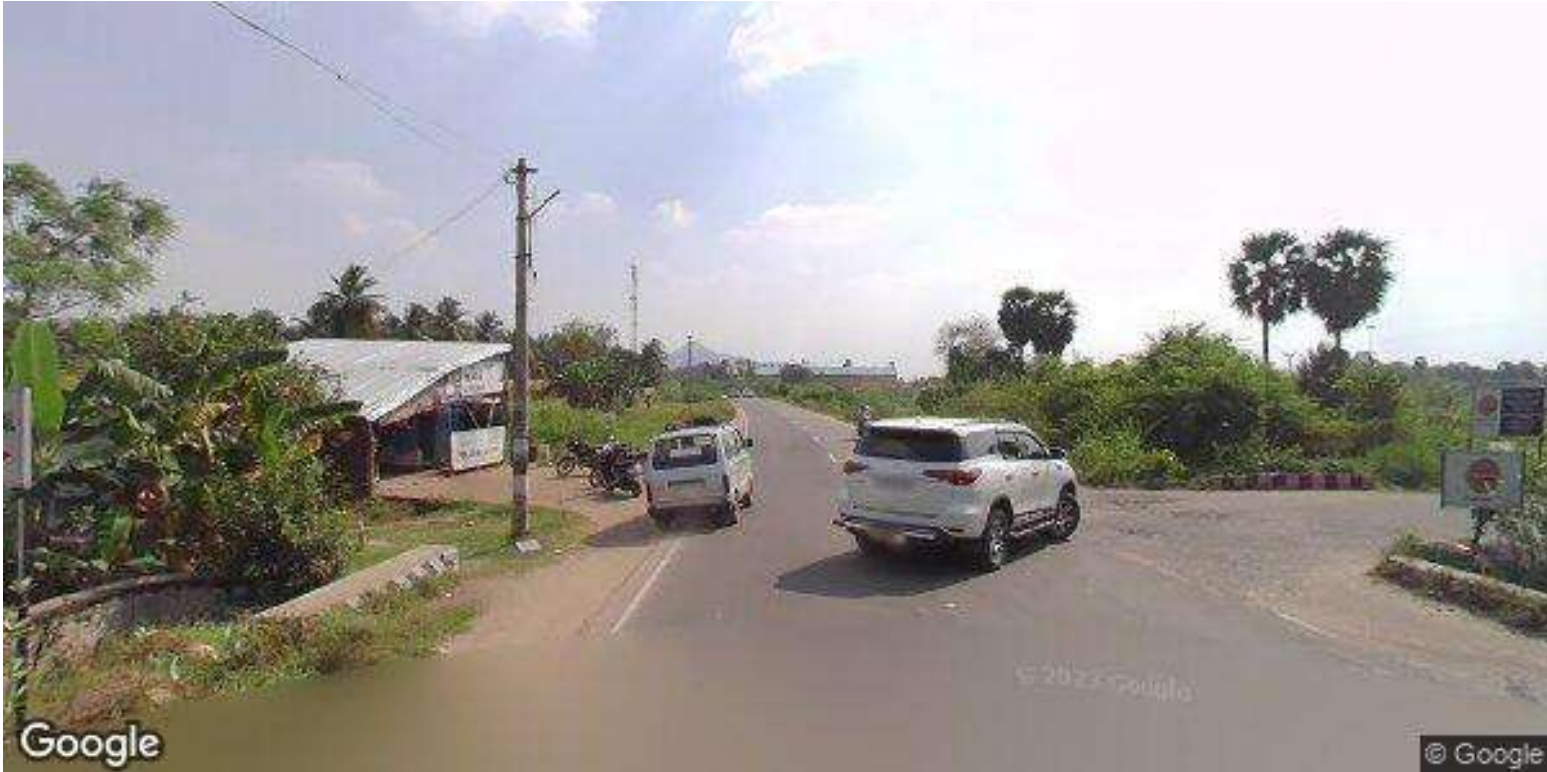
Risk Type: Turn
Risk Level: High
Speed Limit: 15 KM/Hr
Coordinates: 11.44029, 77.87544

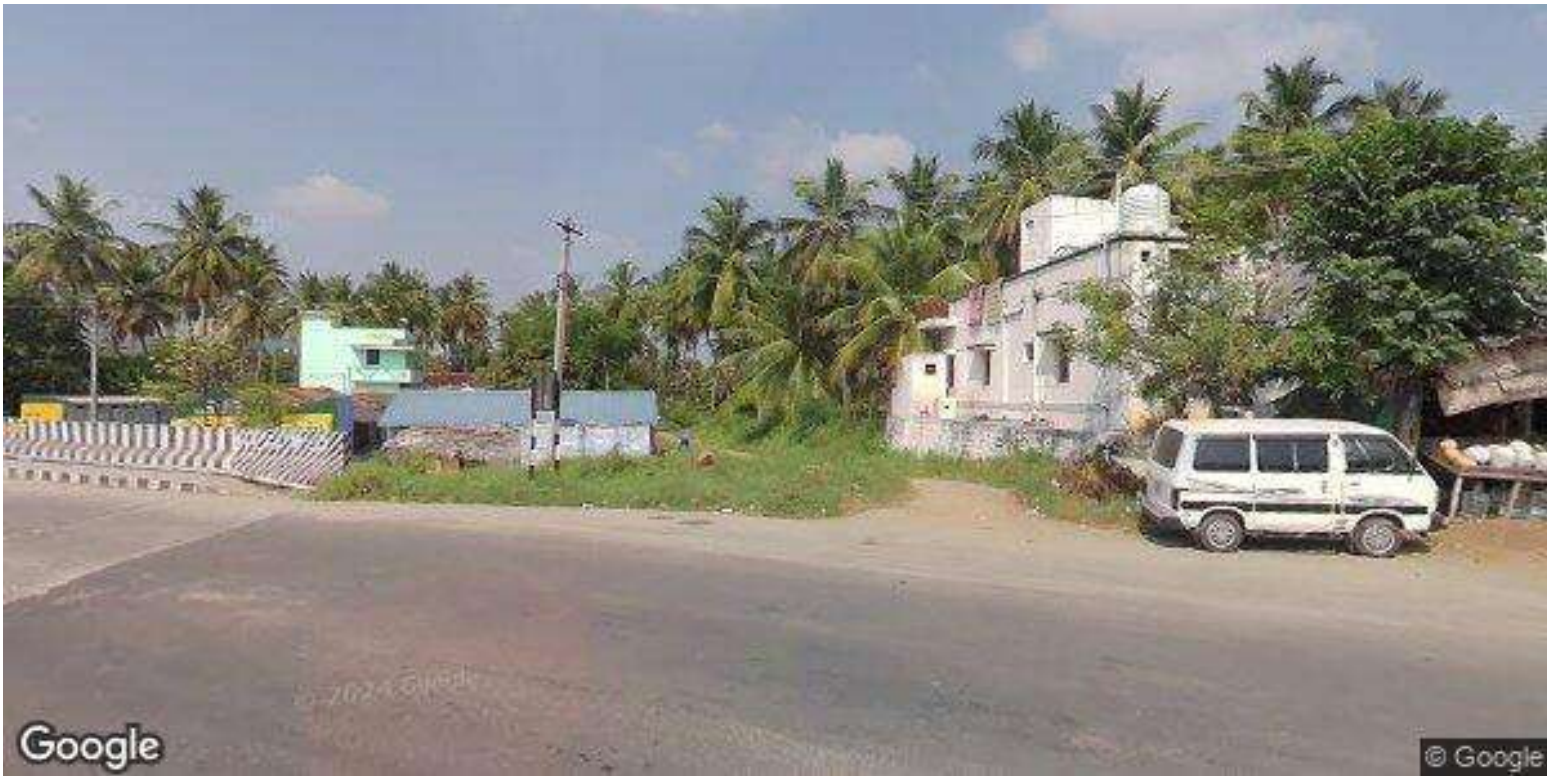
Risk Type: Turn
Risk Level: Medium
Speed Limit: 30 KM/Hr
Coordinates: 11.44898, 77.87410

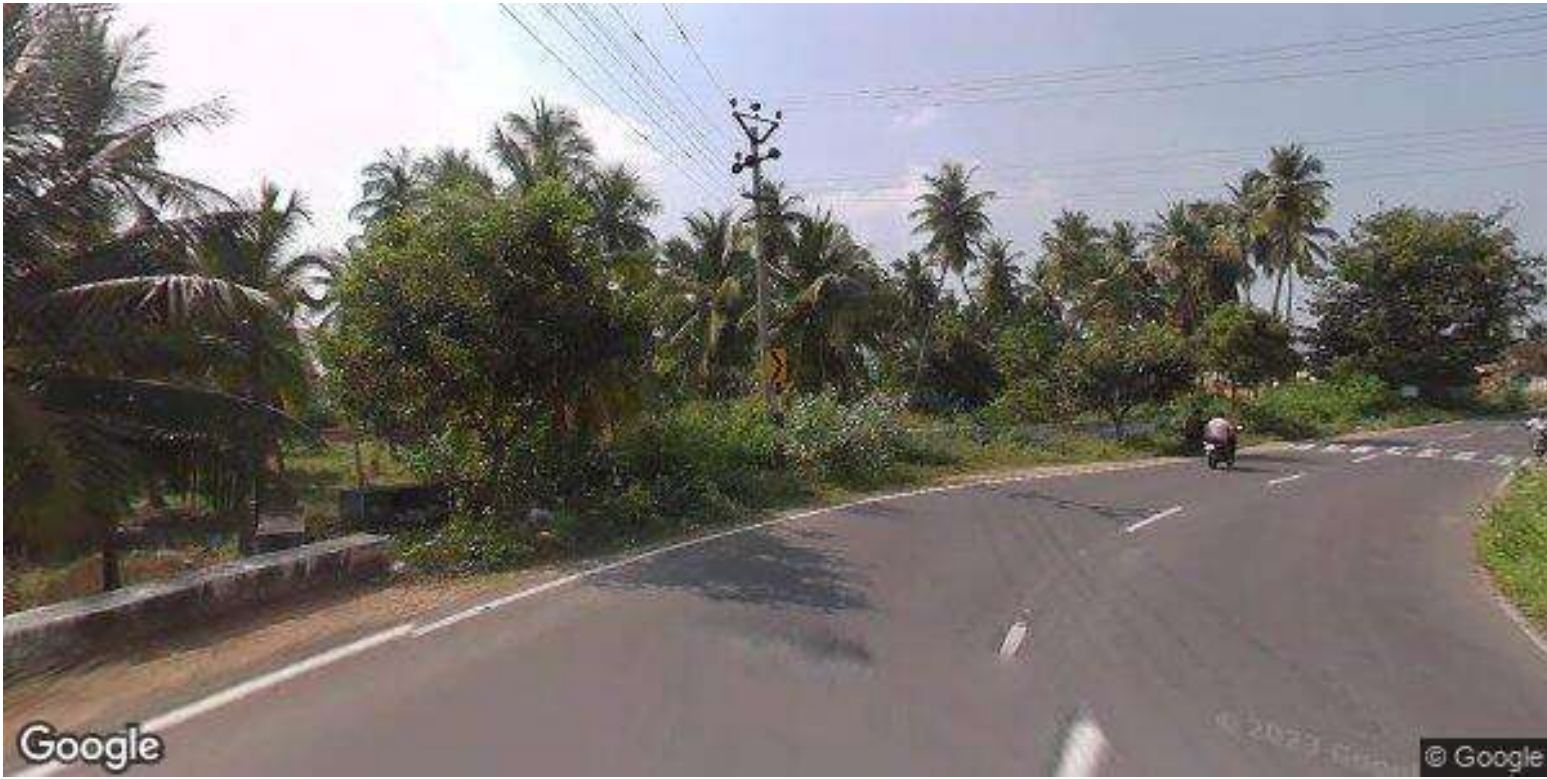
Risk Type: Turn
Risk Level: Medium
Speed Limit: 30 KM/Hr
Coordinates: 11.45348, 77.85706

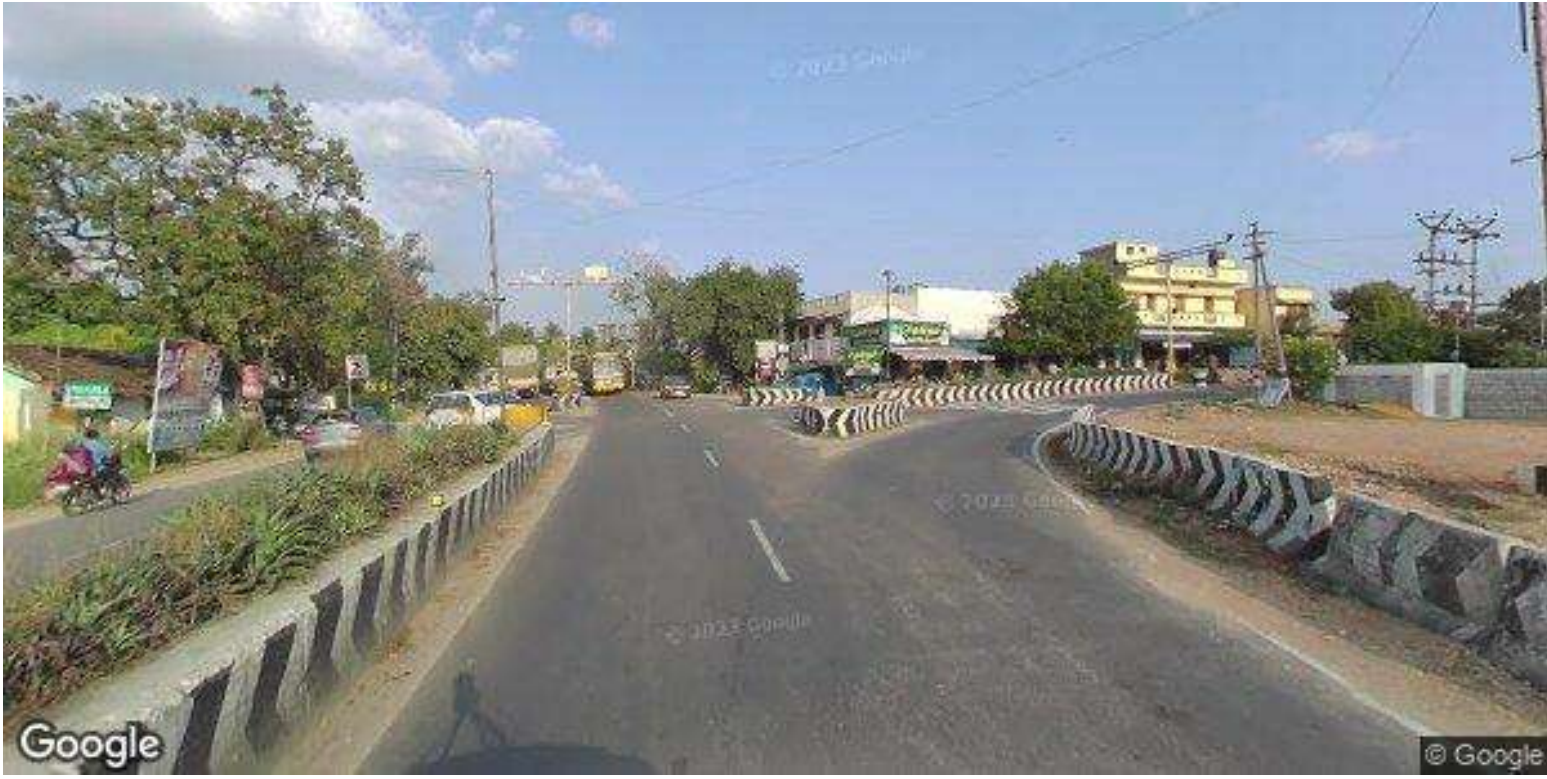
Risk Type: Turn
Risk Level: Medium
Speed Limit: 30 KM/Hr
Coordinates: 11.46318, 77.84913

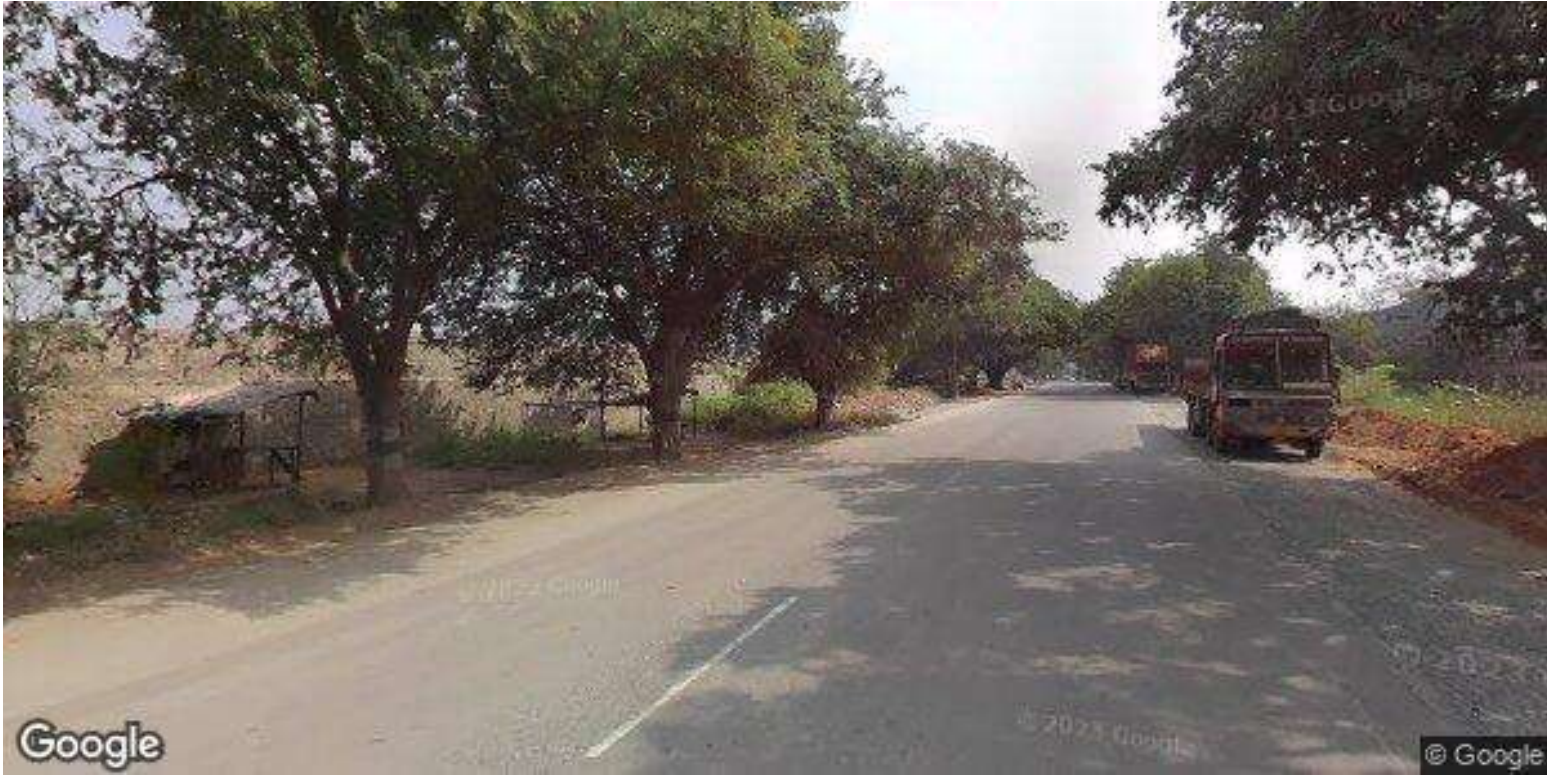
Risk Type: Turn
Risk Level: Medium
Speed Limit: 30 KM/Hr
Coordinates: 11.45697, 77.82719

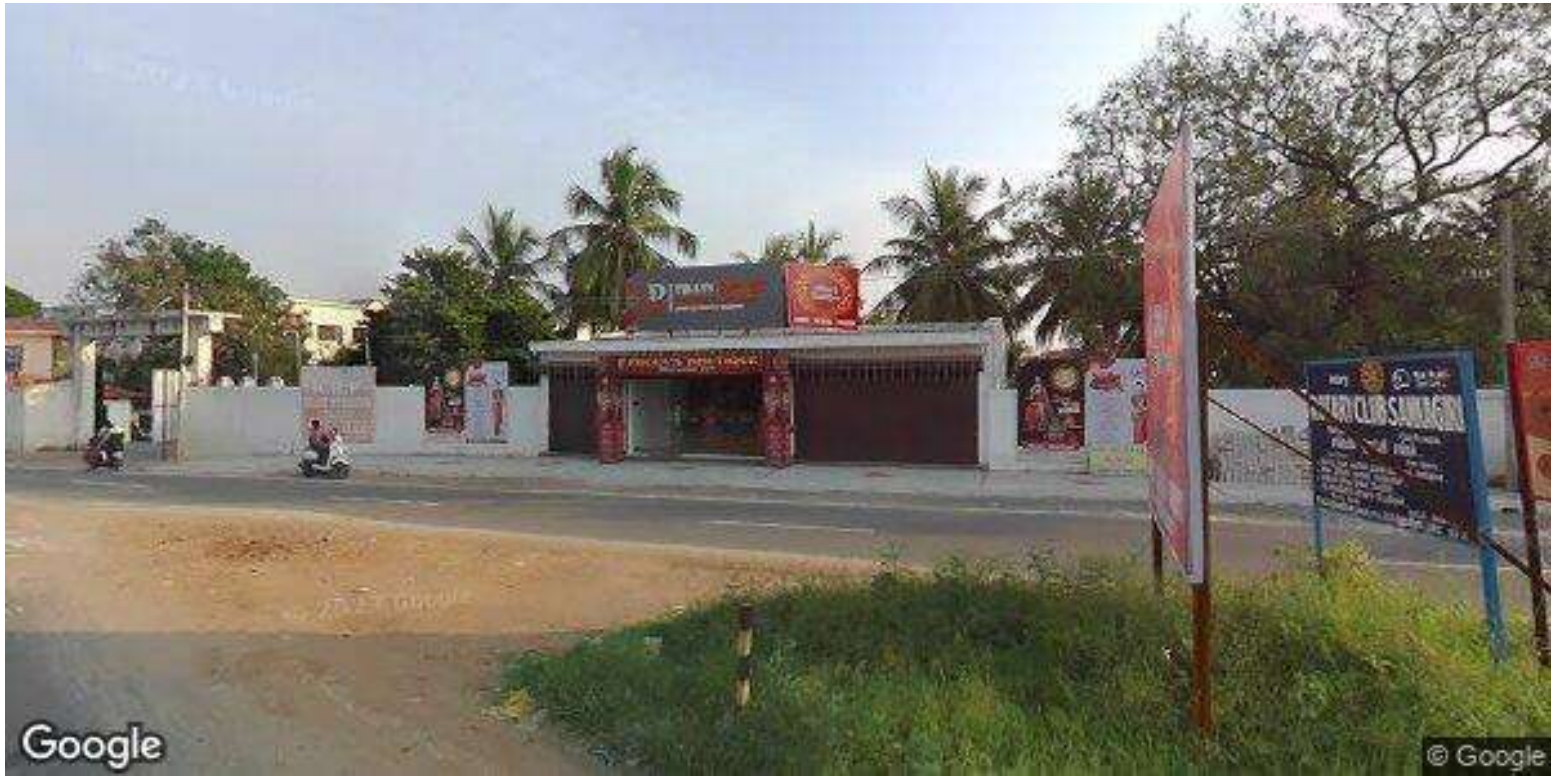
Risk Type: Turn
Risk Level: High
Speed Limit: 15 KM/Hr
Coordinates: 11.45516, 77.81346

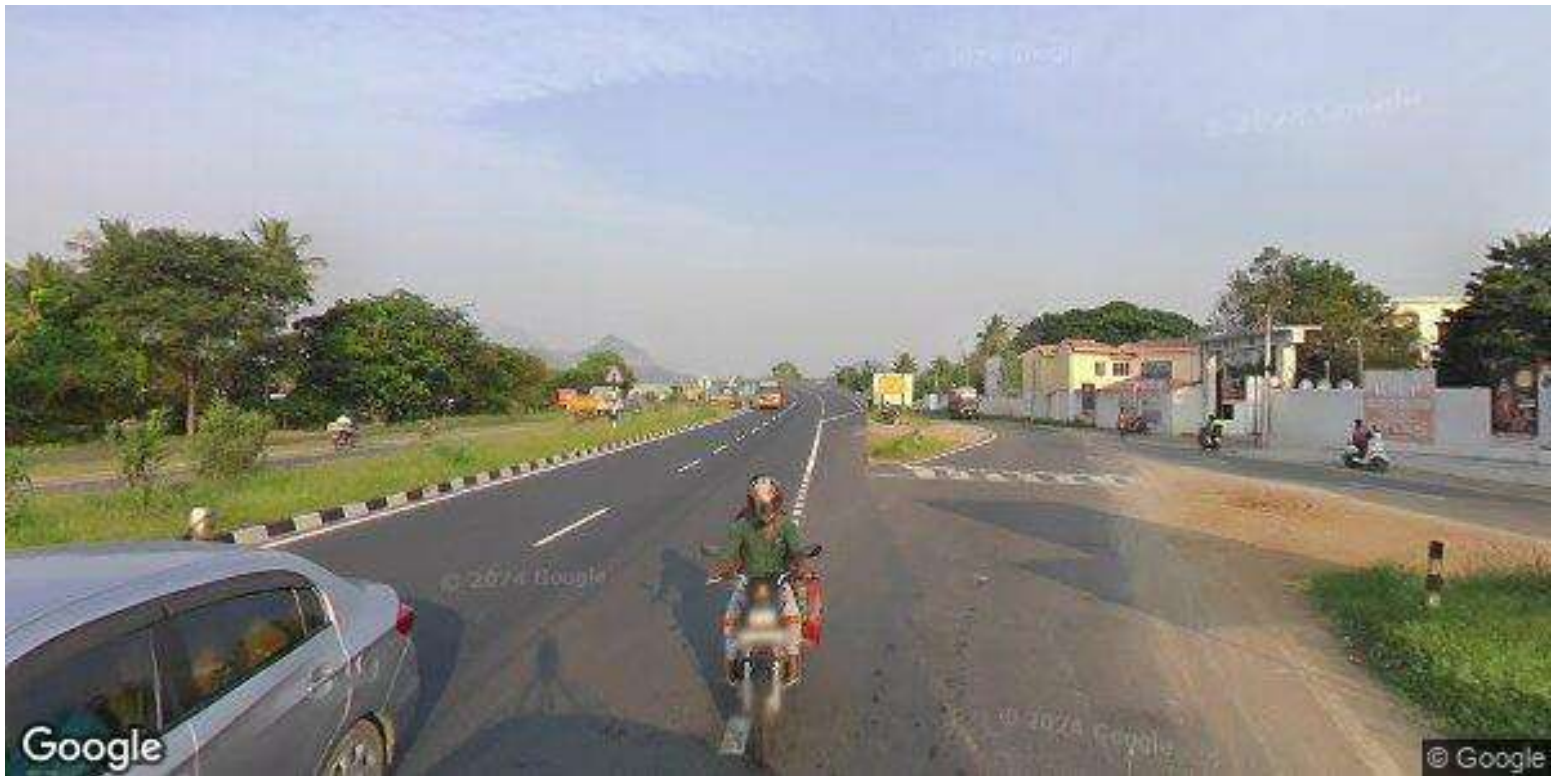
Risk Type: Turn
Risk Level: High
Speed Limit: 15 KM/Hr
Coordinates: 11.45521, 77.81343

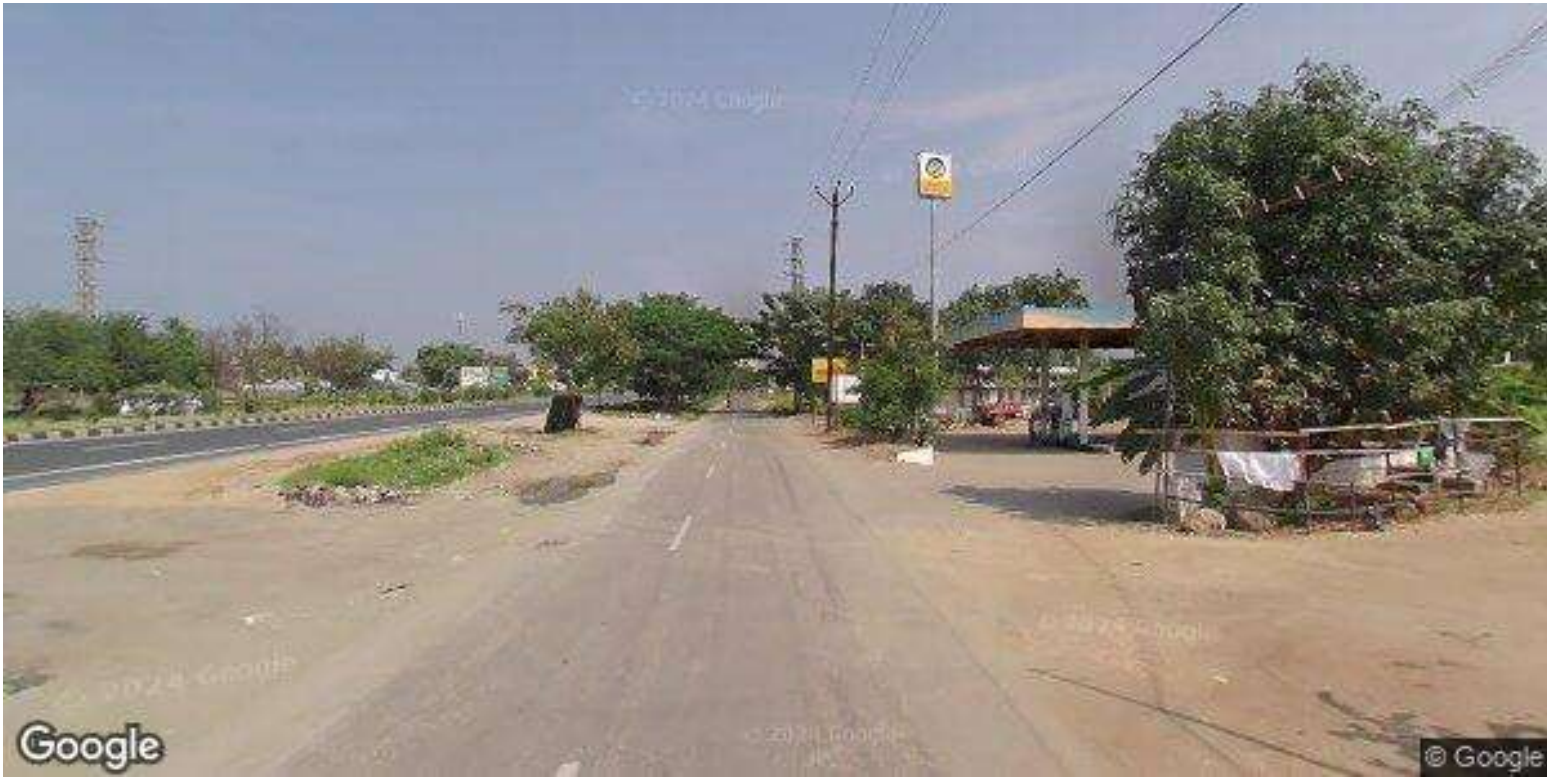
Risk Type: Turn
Risk Level: Medium
Speed Limit: 30 KM/Hr
Coordinates: 11.43994, 77.71111

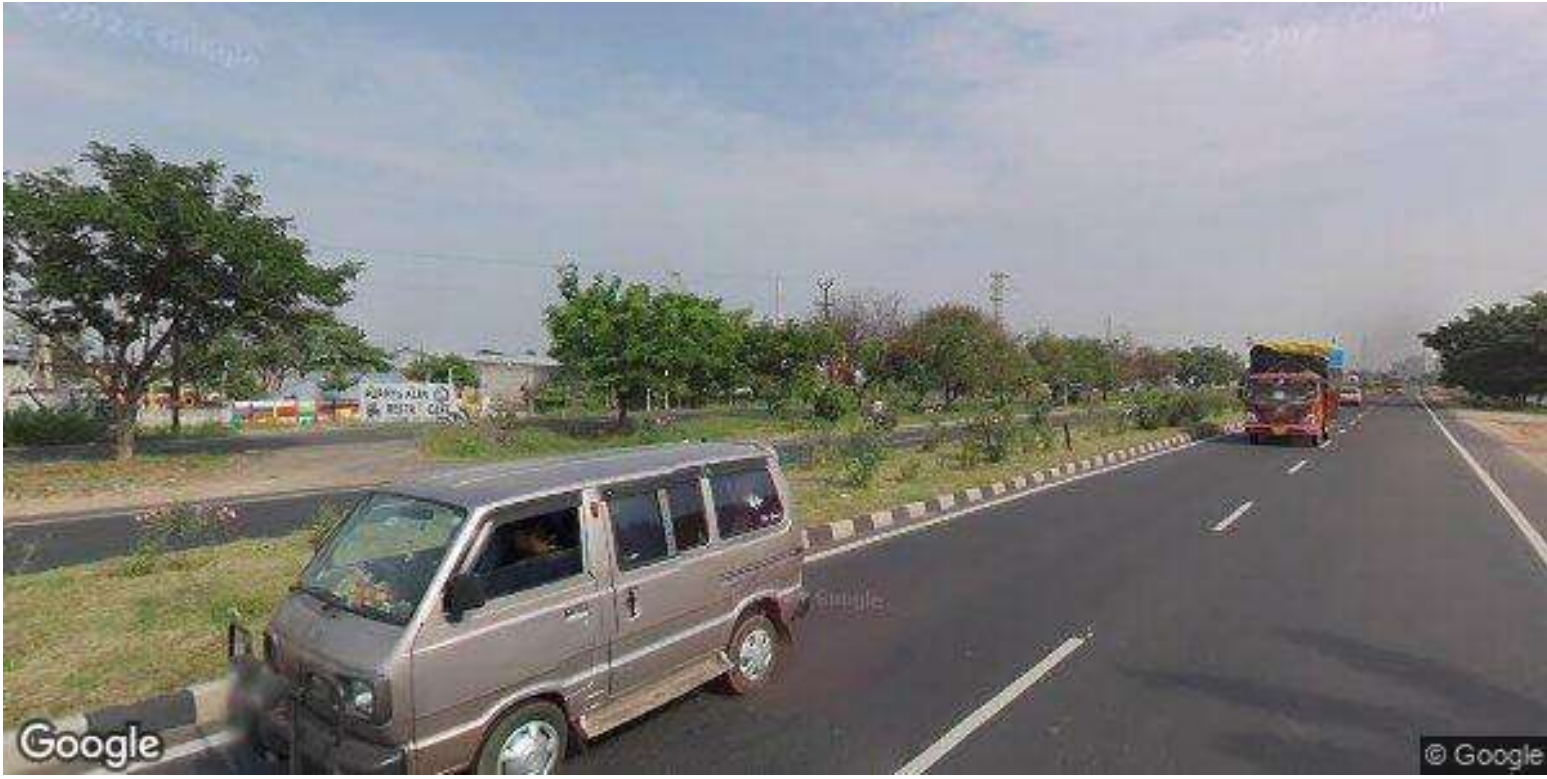
Risk Type: Turn
Risk Level: Medium
Speed Limit: 30 KM/Hr
Coordinates: 11.43982, 77.71084

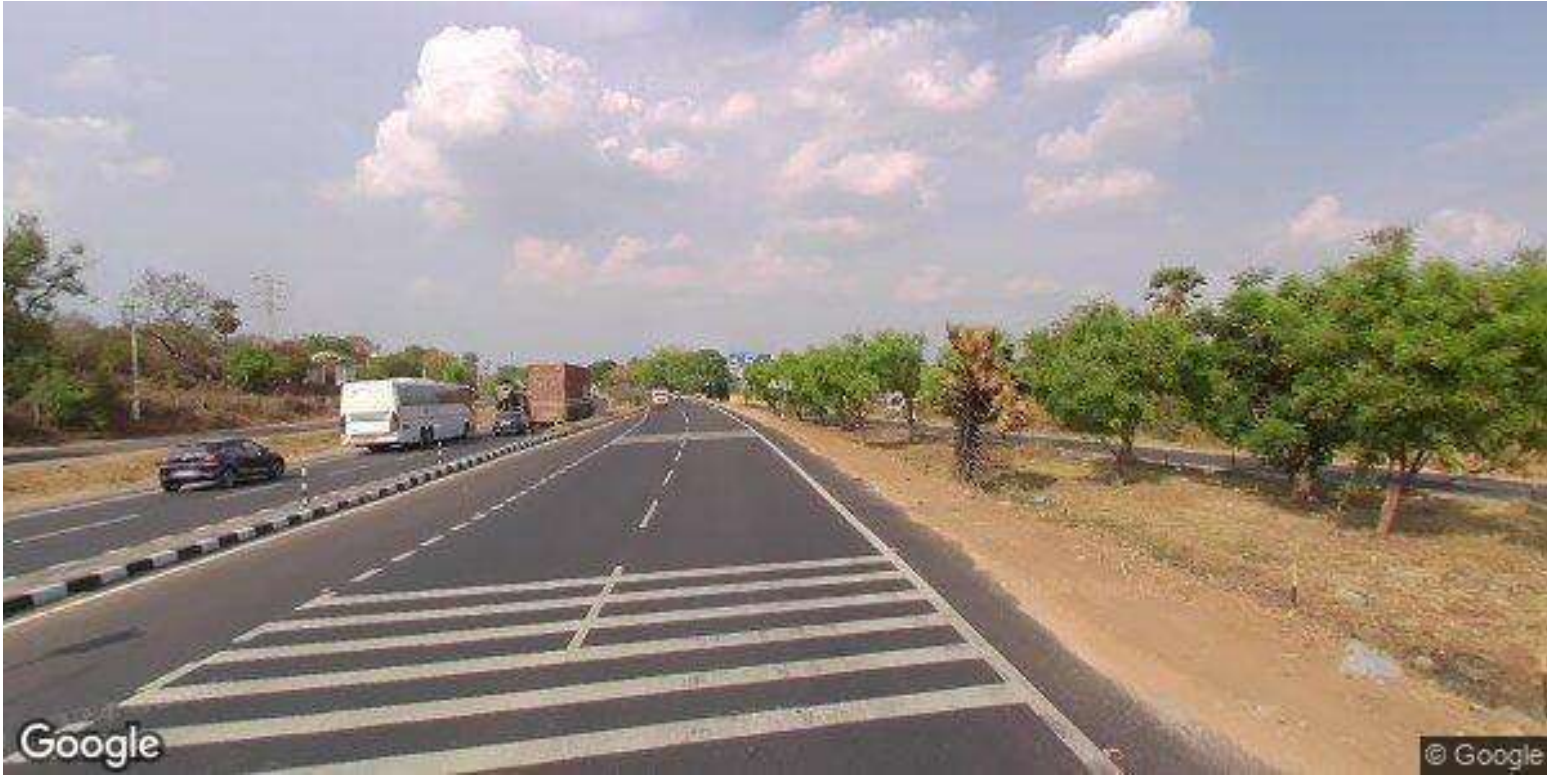
Risk Type: Turn
Risk Level: Medium
Speed Limit: 30 KM/Hr
Coordinates: 11.41353, 77.67453

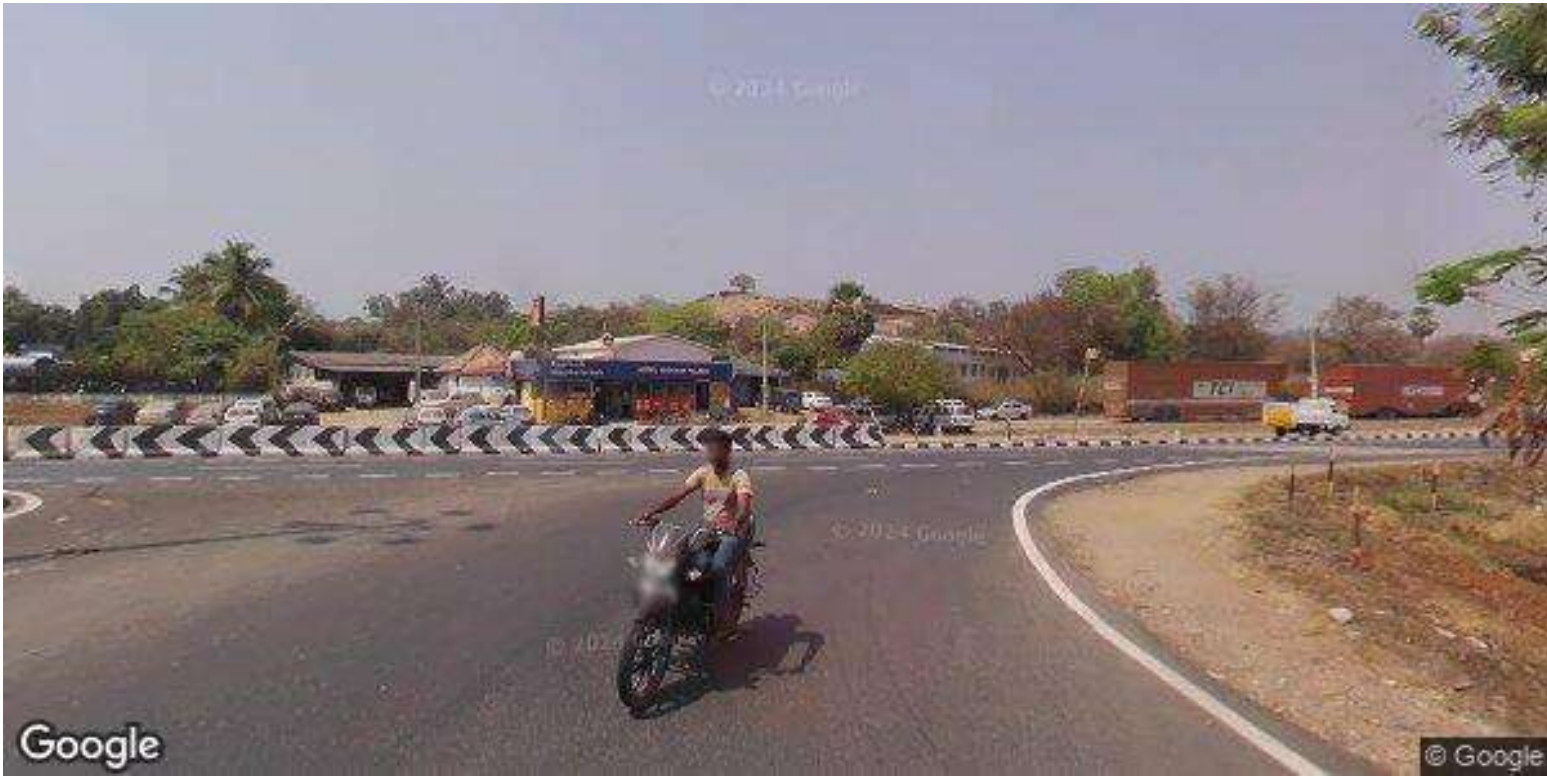
Risk Type: Turn
Risk Level: Medium
Speed Limit: 30 KM/Hr
Coordinates: 11.41333, 77.67450

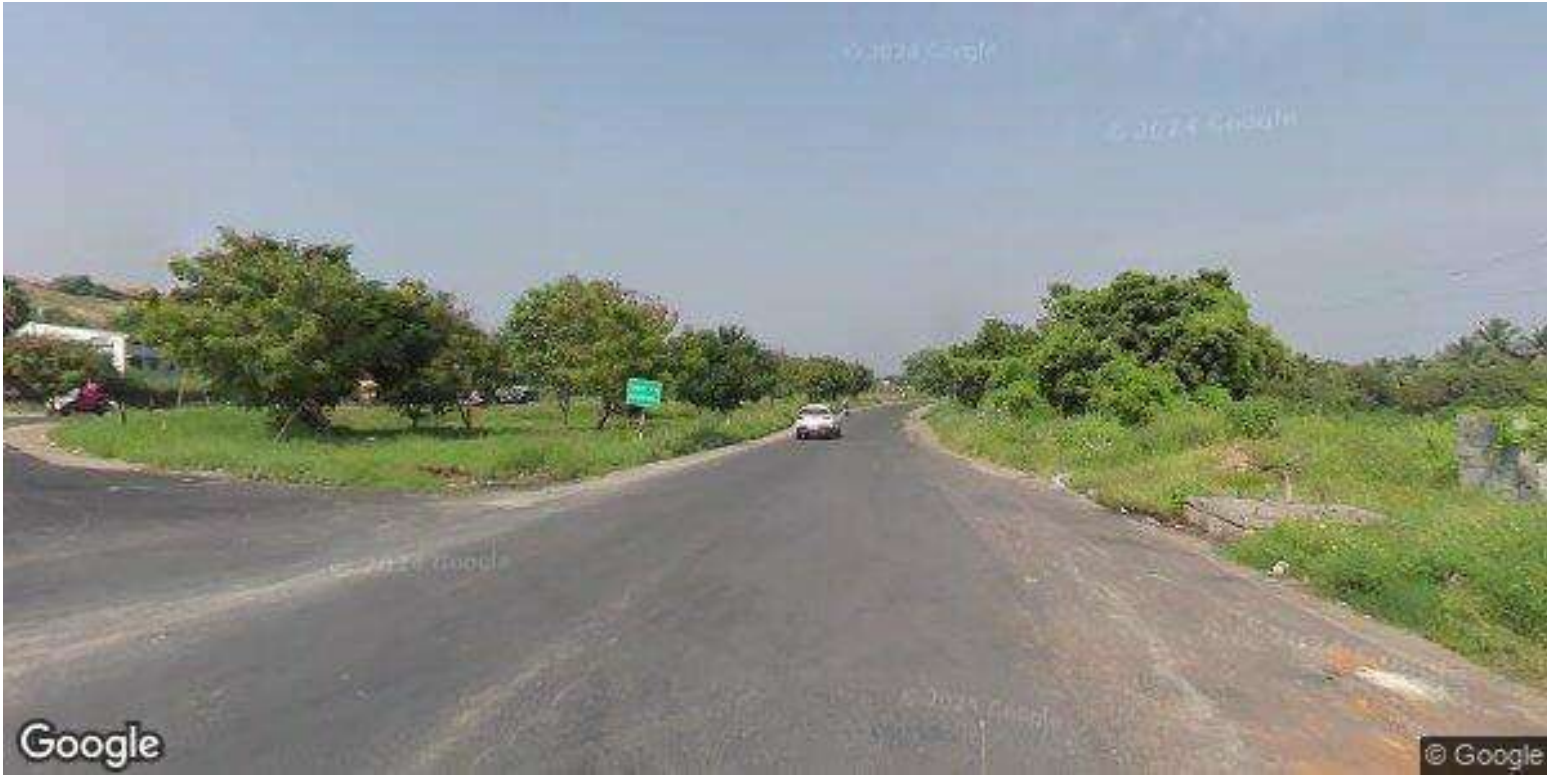
Risk Type: Turn
Risk Level: High
Speed Limit: 15 KM/Hr
Coordinates: 11.41313, 77.67466

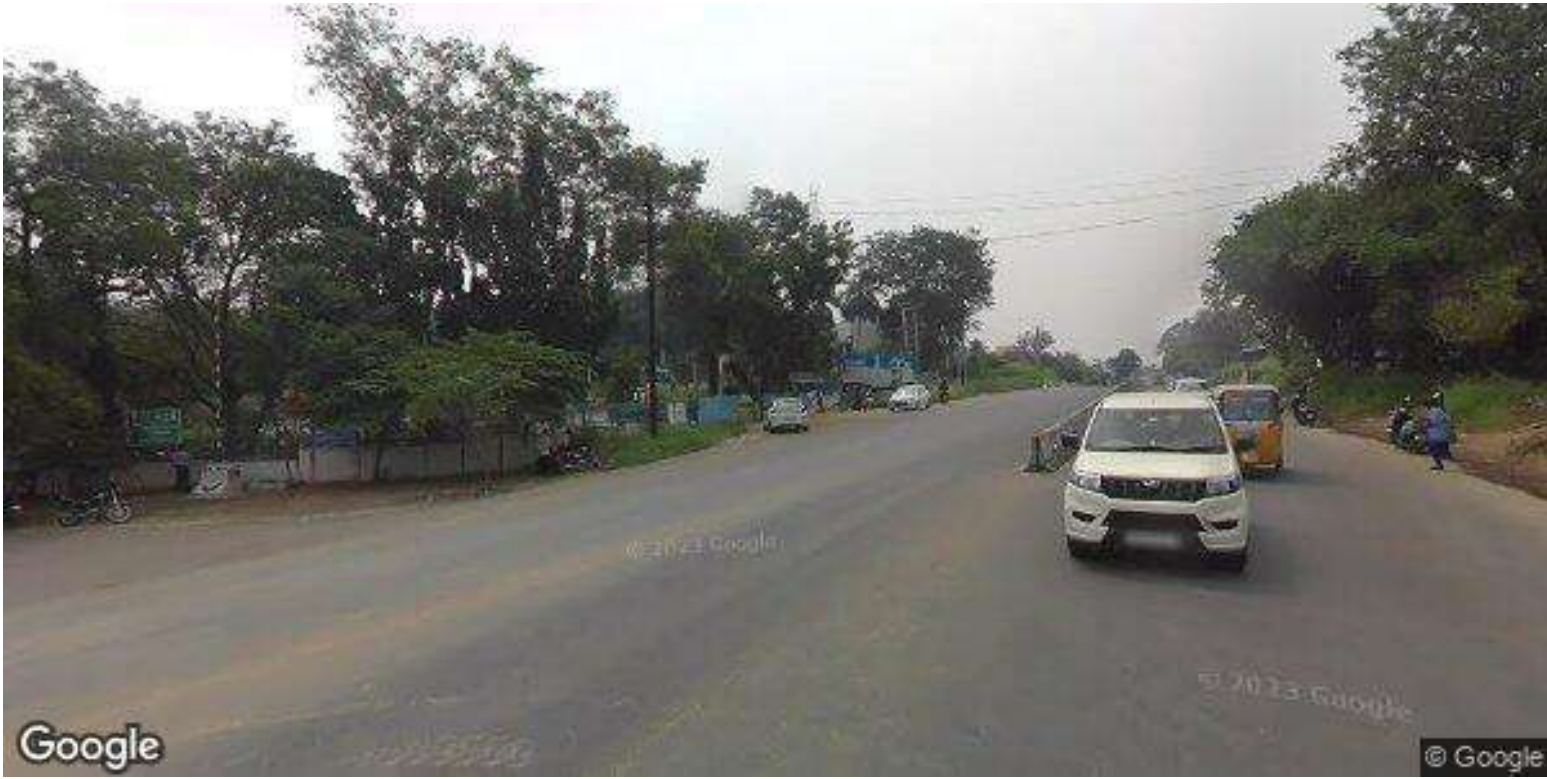
Risk Type: Turn
Risk Level: Medium
Speed Limit: 30 KM/Hr
Coordinates: 11.40833, 77.67154

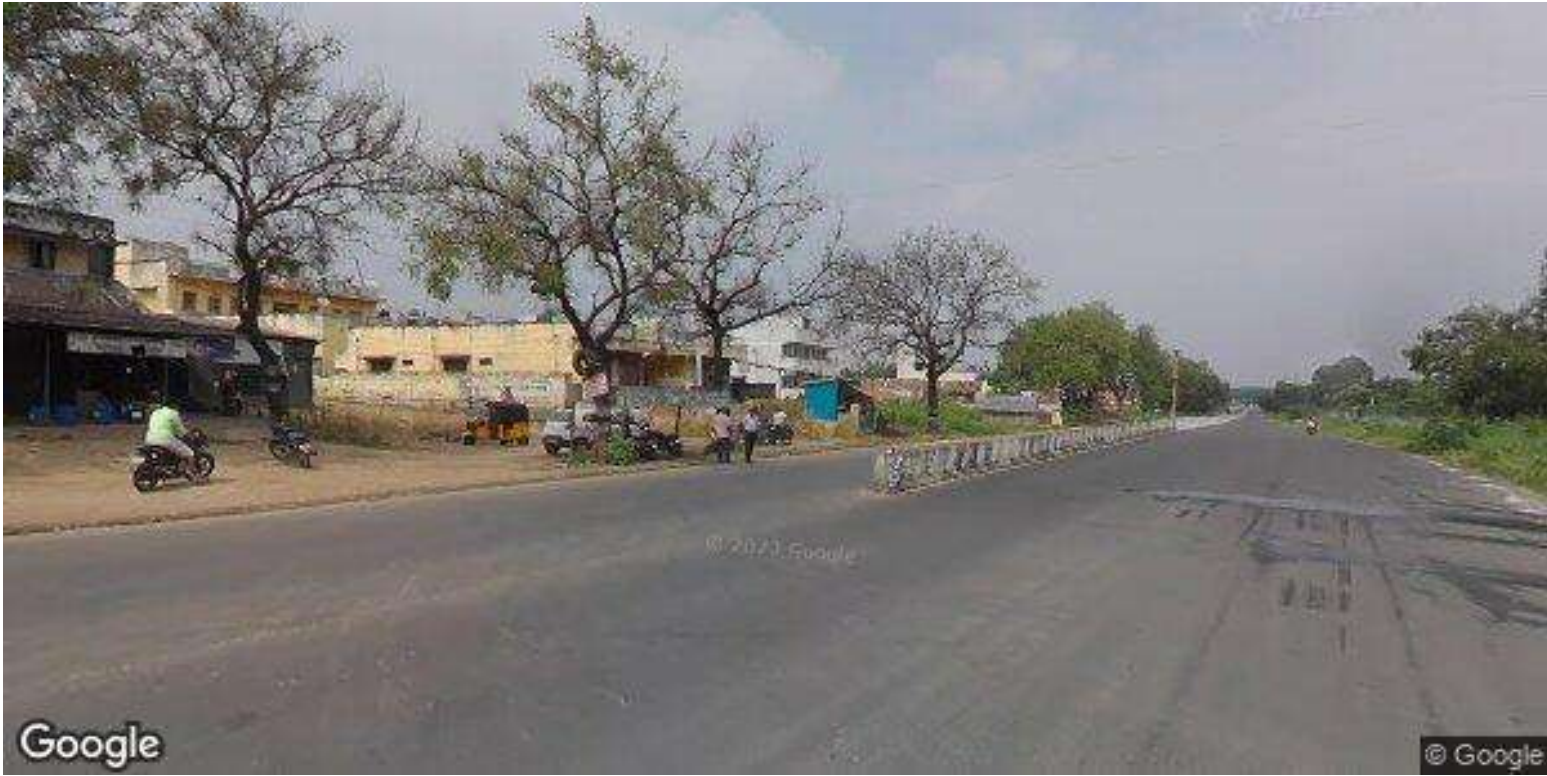
Risk Type: Turn
Risk Level: Medium
Speed Limit: 30 KM/Hr
Coordinates: 11.40826, 77.67154

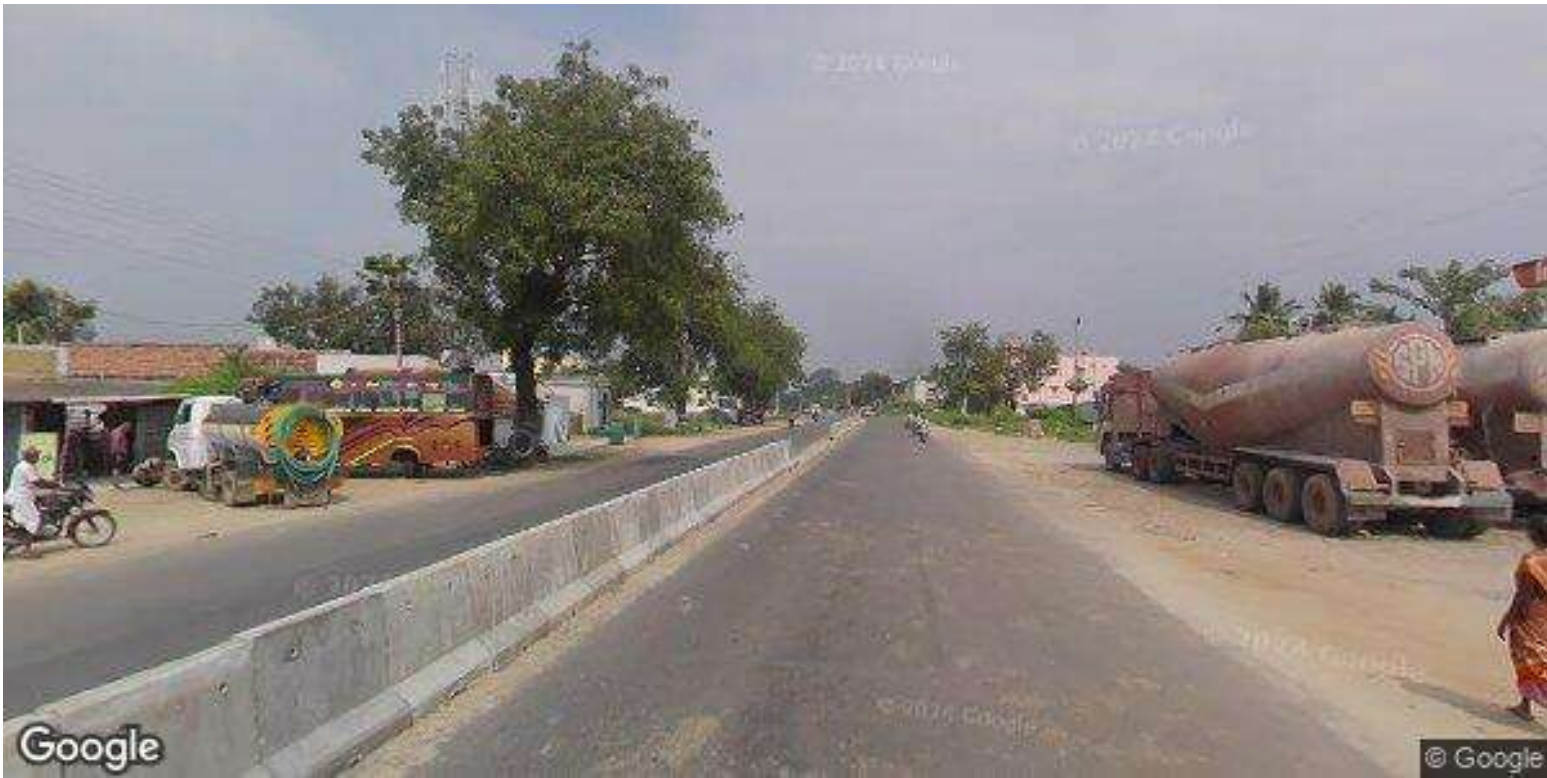
Risk Type: Blind Spot

Risk Level: Blind Spot

Speed Limit: 10 KM/Hr

Coordinates: 11.40316, 77.66733
