JOURNEY RISK MANAGEMENT (JRM) STUDY

IOCL Coimbatore Terminal to ASST. Materials Manager

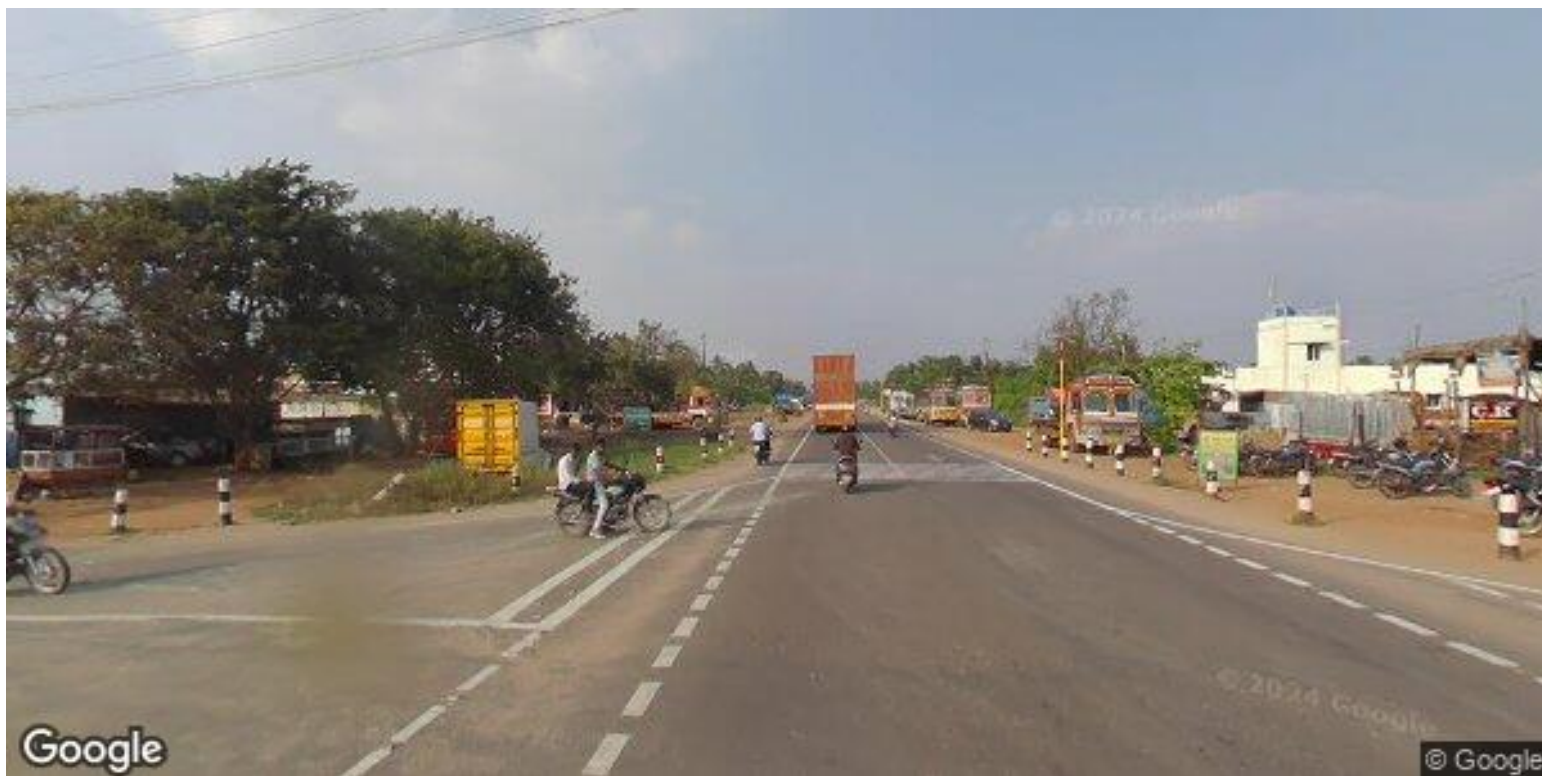
Coordinates: 11.03211, 77.07640

Risk Type: Blind Spot

Risk Level: Blind Spot

Speed Limit: 10 KM/Hr

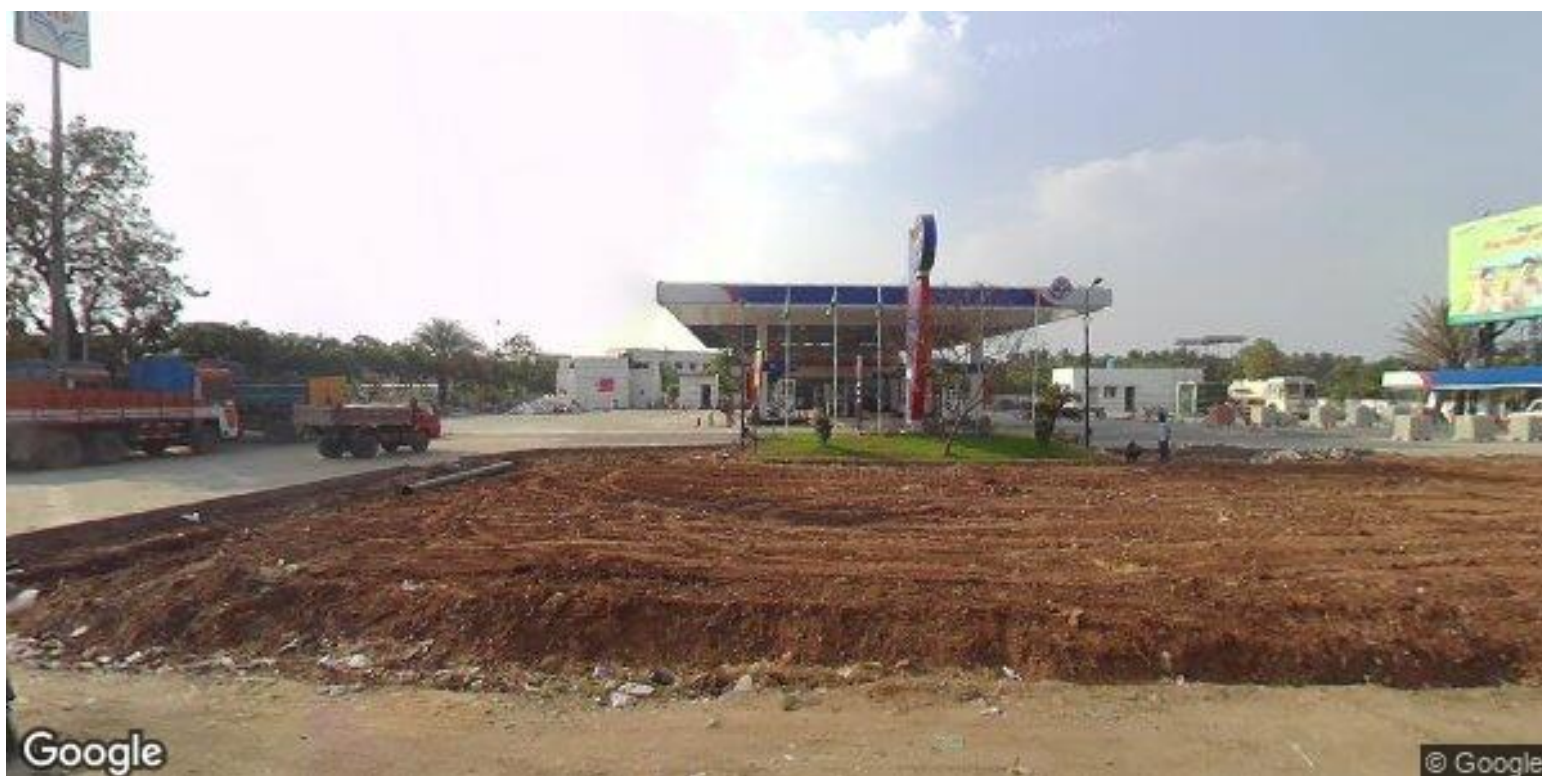
Coordinates: 11.00873, 77.07114

Risk Type: Turn

Risk Level: Medium

Speed Limit: 30 KM/Hr

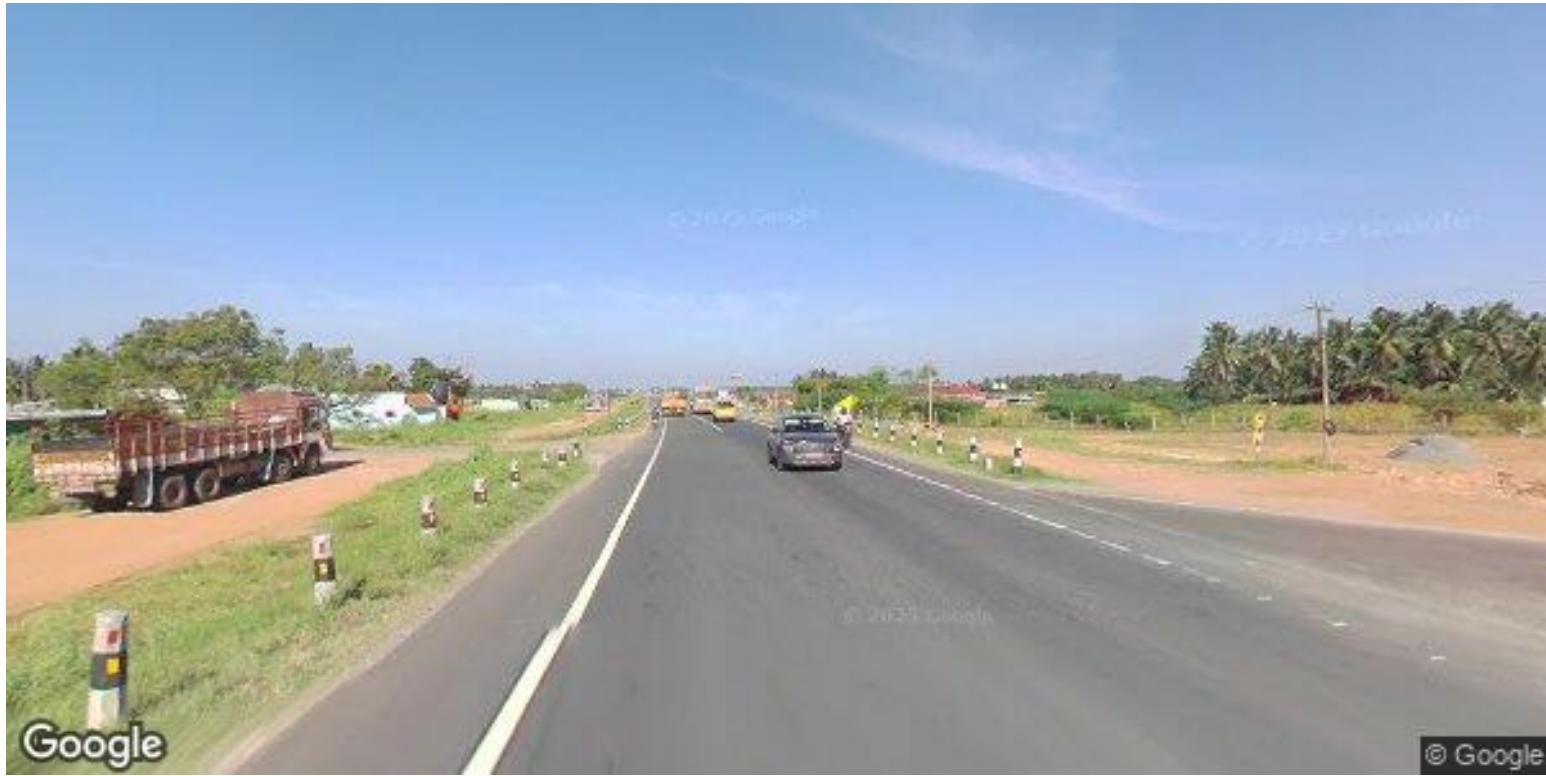
Coordinates: 10.94724, 77.01460

Risk Type: Turn

Risk Level: High

Speed Limit: 15 KM/Hr

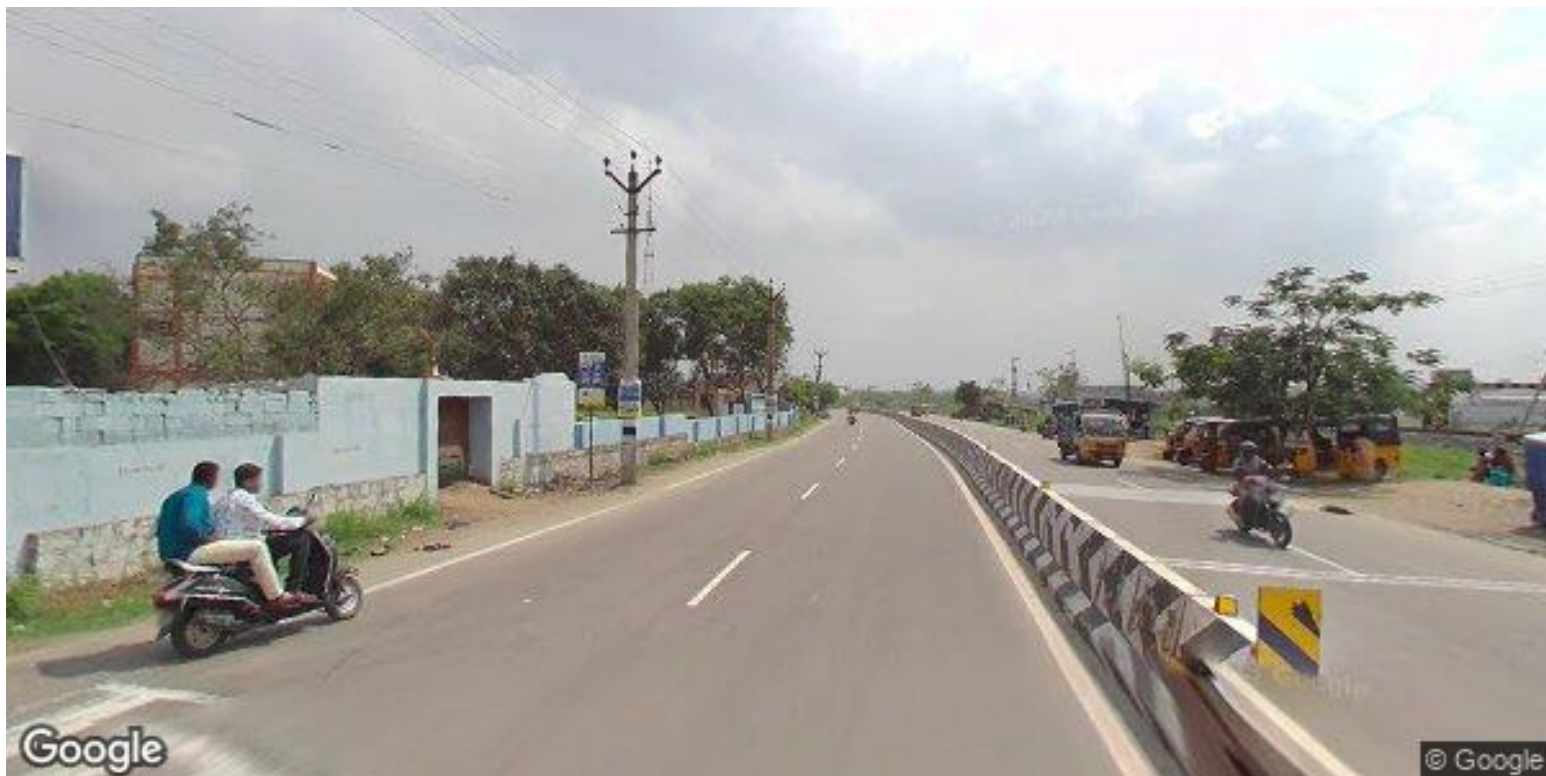
Coordinates: 10.94097, 77.01435

Risk Type: Turn

Risk Level: Medium

Speed Limit: 30 KM/Hr

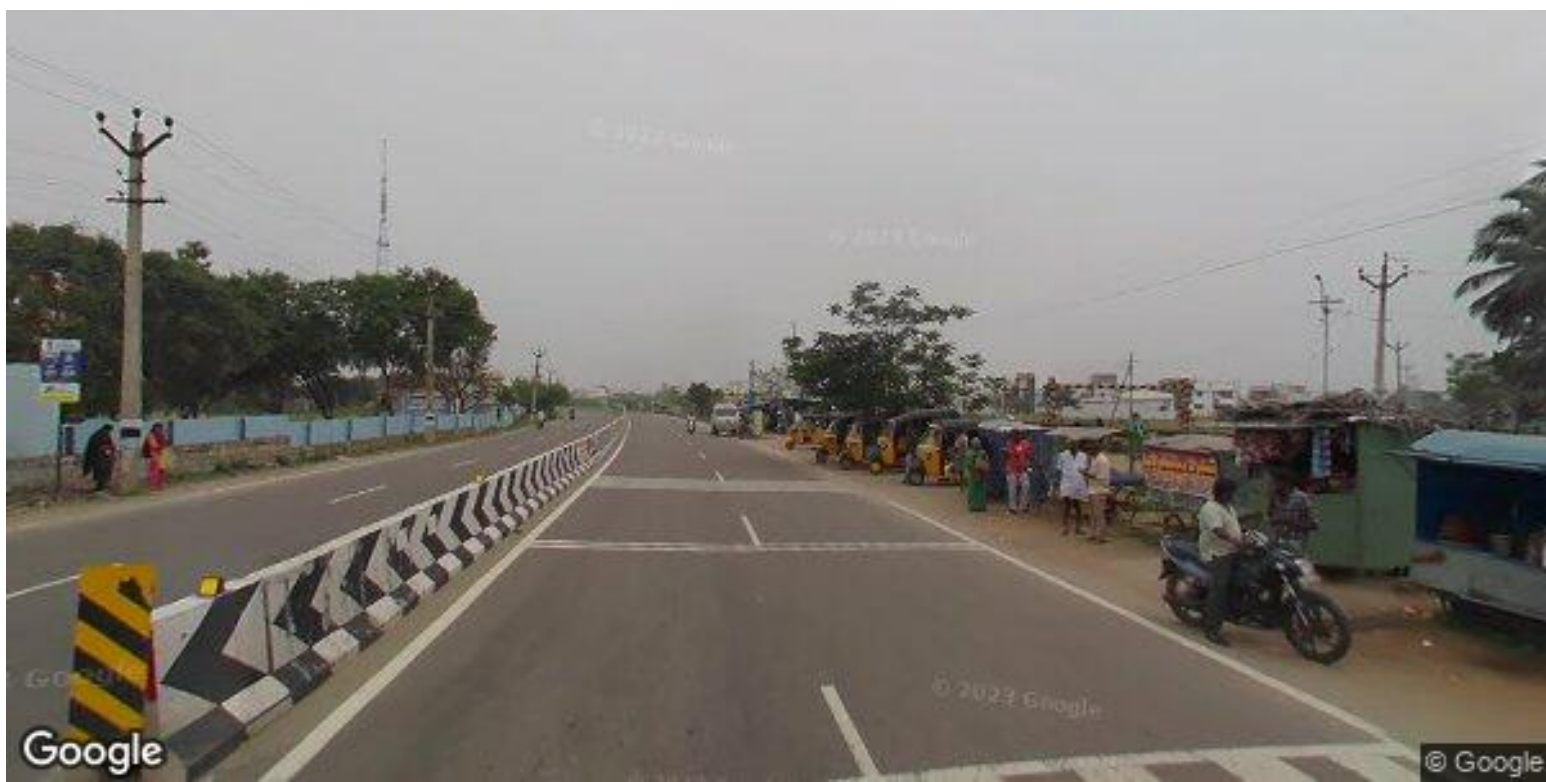
Coordinates: 10.94090, 77.01428

Risk Type: Blind Spot

Risk Level: Blind Spot

Speed Limit: 10 KM/Hr

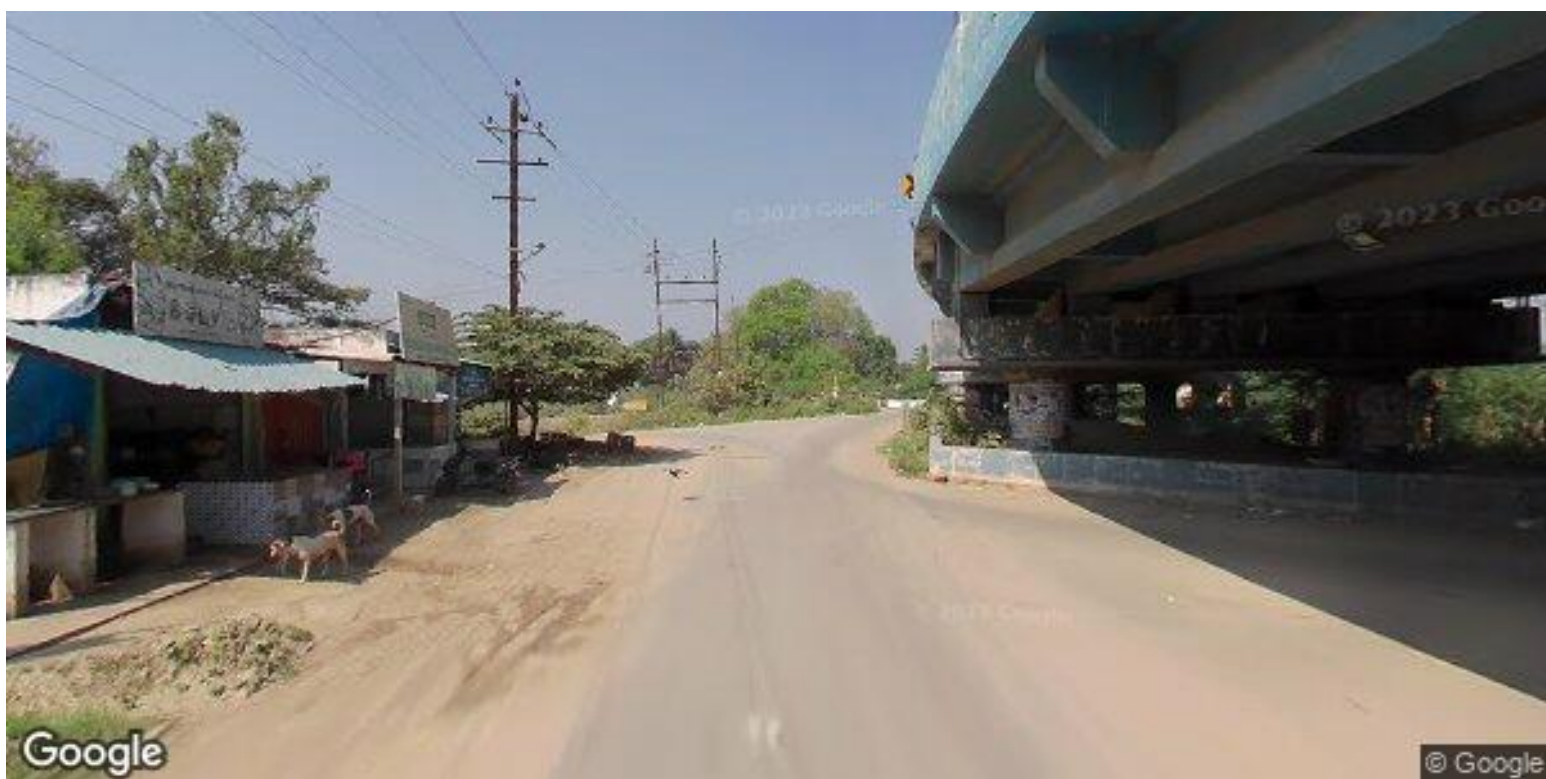
Coordinates: 10.95715, 76.98589

Risk Type: Blind Spot

Risk Level: Blind Spot

Speed Limit: 10 KM/Hr

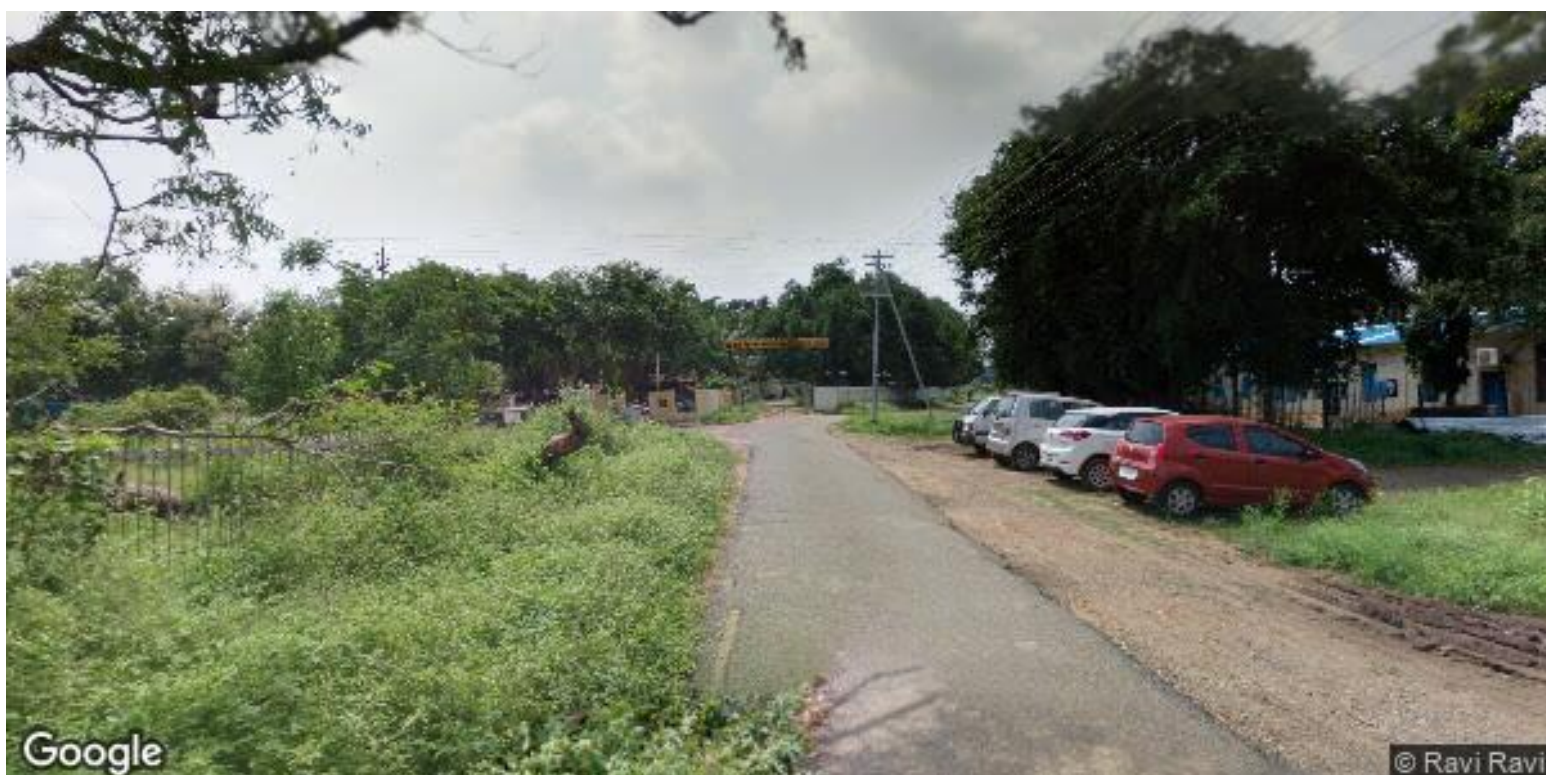
Coordinates: 10.95970, 76.98731

Risk Type: Turn

Risk Level: Medium

Speed Limit: 30 KM/Hr
