DTC	B1273/73	Sliding roof ECU communication stop (w/ Sliding roof vehicle only)
-----	----------	--

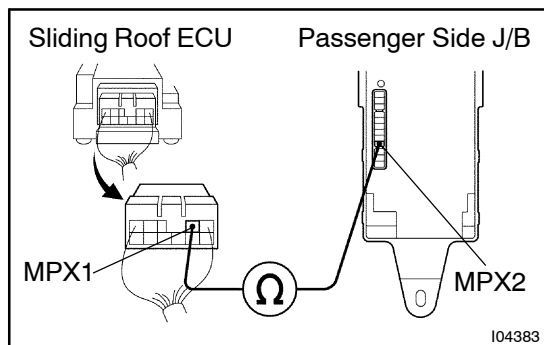
2 Check wireharness

Disconnect connector sliding roof ECU and body No.1 ECU.

Connector is disconnected by removing Body No.1 ECU from passenger side junction block.

Check continuity between terminals MPX2 of body No.1 ECU and MPX1 of sliding roof ECU.

Continuity exists in wireharness.

NG**Repair or replace wireharness.****OK****Replace the sliding roof ECU.**
