There have been numerous discussions concerning the RF characteristics of Stratux namely antenna input impedance and supposition concerning interference issues . Measurements were made on a typical dual dongle Stratux build to evaluate these concerns.

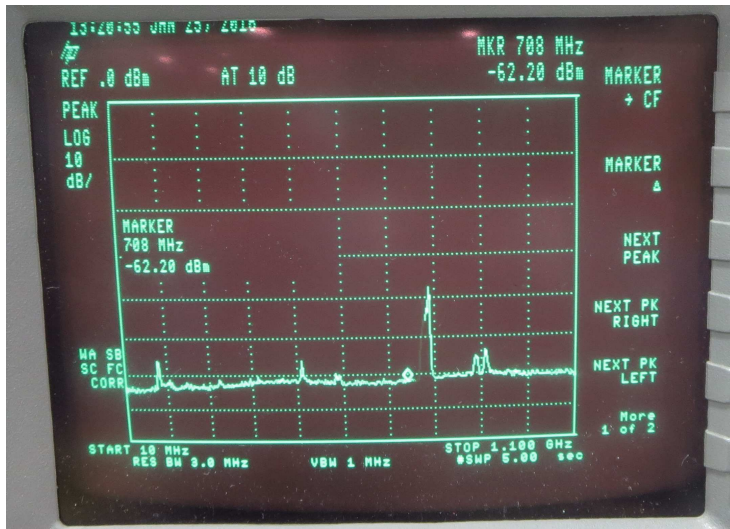
Image 1 (Stratux Off):

Baseline measurement of noise in the lab. The predominant noise spikes at 97 Mhz, 760, MHz, 870 MHz, and 890 MHz were consistent. Other noise spikes appeared intermittently. Any noise above this level were sourced by Stratux.

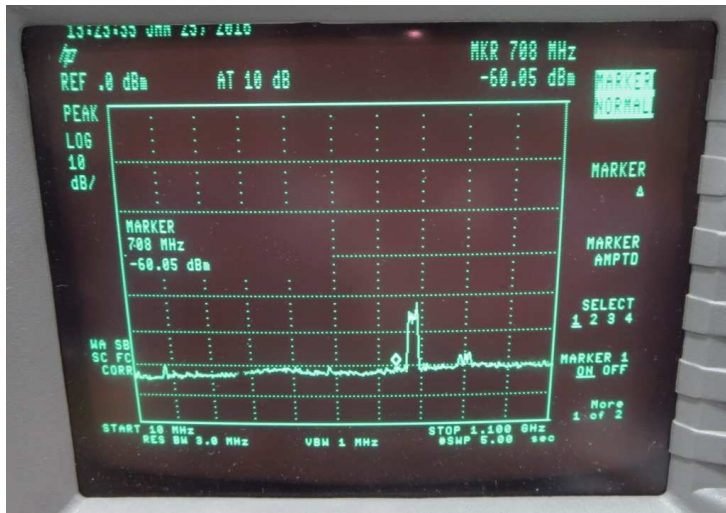
Image 2 (Stratux On):

Sweep of Statux with loop probe over the Raspberry Pi. There were no additional noise spikes or shift in the noise floor with the loop probe positioned over or in the vicinity of the Raspberry Pi.

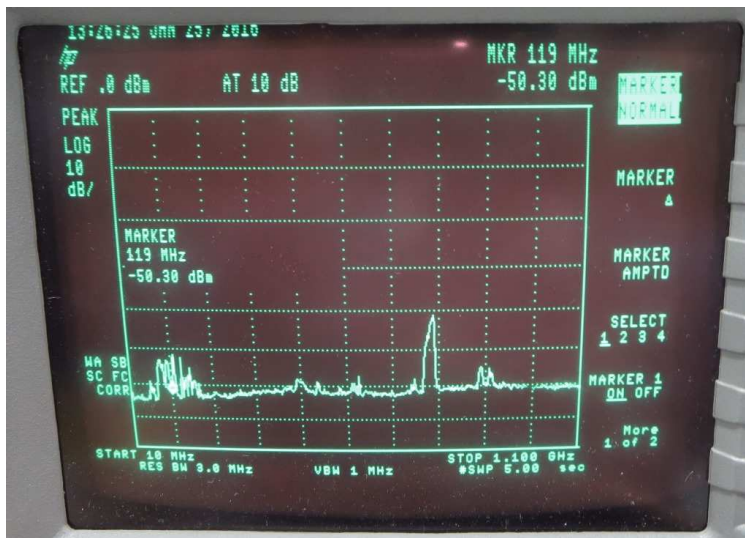
Image 3 (Stratux On):

Sweep of Stratux with the loop over the RY835AI module. Notice the noise centered around 100 MHz. The top of the Stratux case was removed placing the RY835 away from the Stratux. This showed noise is associated with the RY835. When power is removed from the noise at 100 MHz drops into the noise floor. While the top was removed the loop was scanned around the SDR Dongles. There was no appreciable noise detected in the vicinity of the dongles.

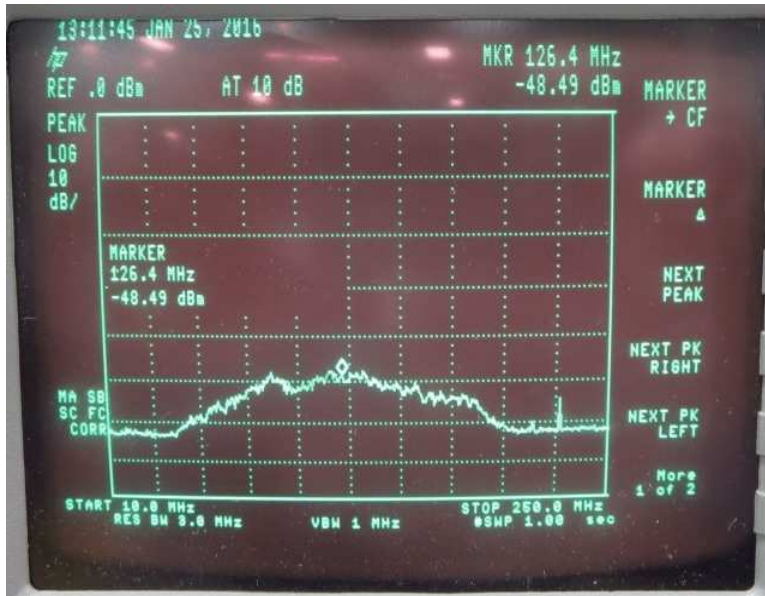
Image 4 (Stratux On):

Expanded view of image 3. The bandwidth of the noise is 162 MHz with a peak at 136 MHz measuring -47.4 dBm. This is the source of the "birdie" that was detected at 135.325 MHz.

The measurements taken in the area of the Raspberry Pi coincide with the FCC type acceptance report located on the FCC website. There does not appear to be an EMI issue with Startux when built with the Vilros R-Pi, NooElec 820T2 dongles, and the Edimax Wi-Fi. However, there appears to be a radiation issue when the RY835 is added to the build. More testing will need to be performed to determine if it is the RY835 itself or the GPIO wiring between the R-Pi and the RY835 causing the RF noise. It also is not know if any other GPS / AHRS solutions or add on peripherals to the GPIO will generate RF noise like seen with the RY835.
