Arlo Pro 3 Floodlight Camera

Troubleshooting

FB1001 – Arlo Pro 3 Floodlight

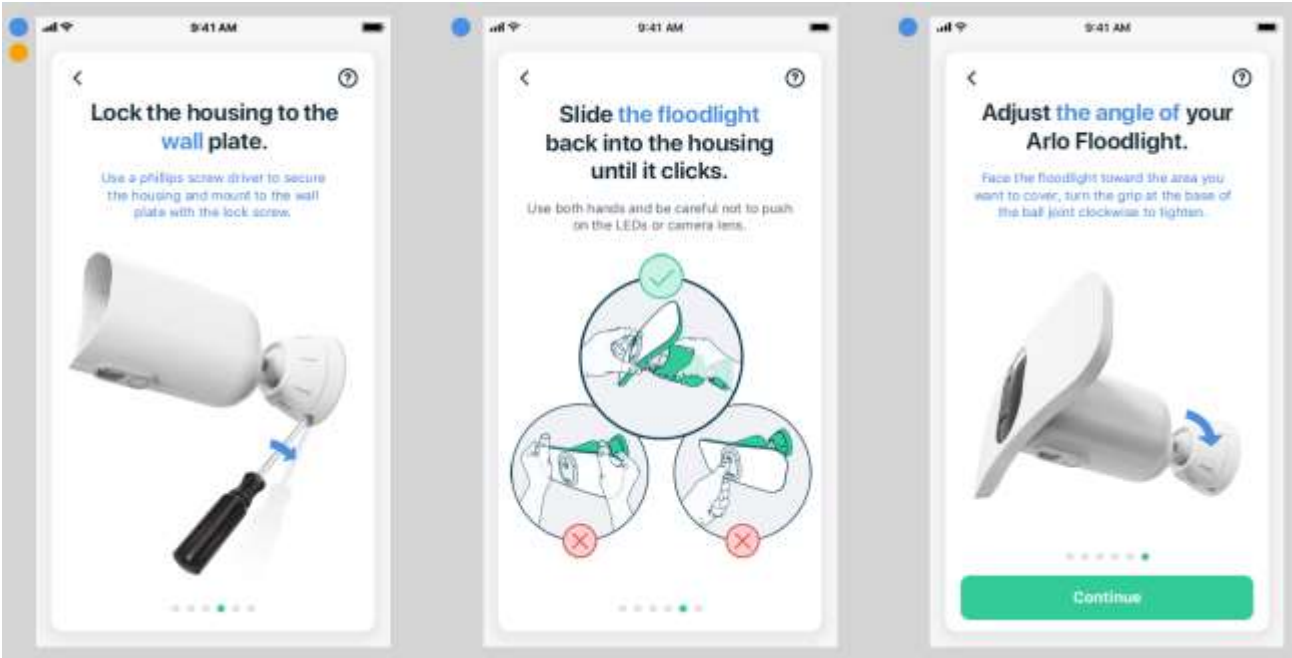
Arlo Pro 3 Floodlight – Push until Click

The Arlo Pro 3 Floodlight is heavier than all of our previous cameras. As a result, there is a higher risk of the camera falling out of the housing when removing for charging. Users are recommended to keep at least one hand on the Floodlight when pressing the release button.

The Pro 3 Floodlight can also appear to be in place when the latch is not fully engaged. Users must ensure to slide the floodlight into the housing until it clicks. When working with customers, make sure to emphasize to ensure it clicks to prevent the floodlight from unexpectedly falling out of the housing.

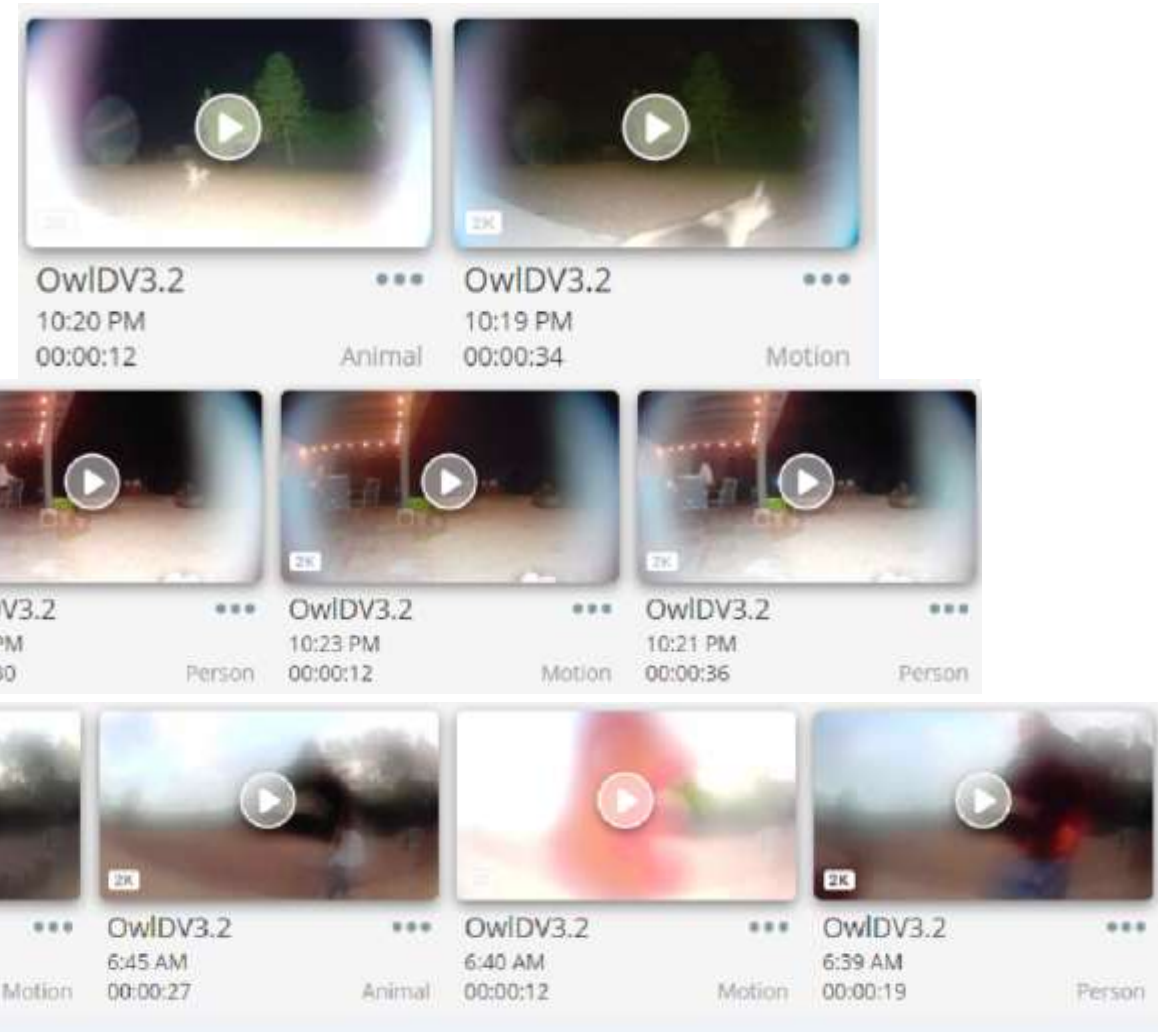
Arlo Pro 3 Floodlight – Blue Haze/Condensation

Like any other camera, condensation on the lens can result in blurring or other unwanted effects on the image quality.

With the addition of the ultra-bright floodlight to the camera, there is a possibility of additional effects.

The “Blue Haze” effect occurs when condensation is on or near the lens and the floodlight is active, drawing light into the lens. A blue “halo” or “aura” can occur as a result.

Condensation, in general, will also cause blurring of the picture, as seen in the bottom example pictures.

- When installing the camera, make sure the camera is pointed at least 10 degrees down from horizontal. This helps to allow water to drip off of the camera itself
- Ensure the lens is kept clean. Debris can attract additional condensation
- Install the Floodlight under an eave or overhang to reduce direct effect from rain weather
- Reduce the brightness of the Floodlight
- Install the Floodlight away from exhaust or vents

Future hardware revisions are expected to have adjustments to help reduce the potential for the blue haze effect. Condensation effects, however, cannot be fully resolved, as if there is water on the lens, the image will always be affected.

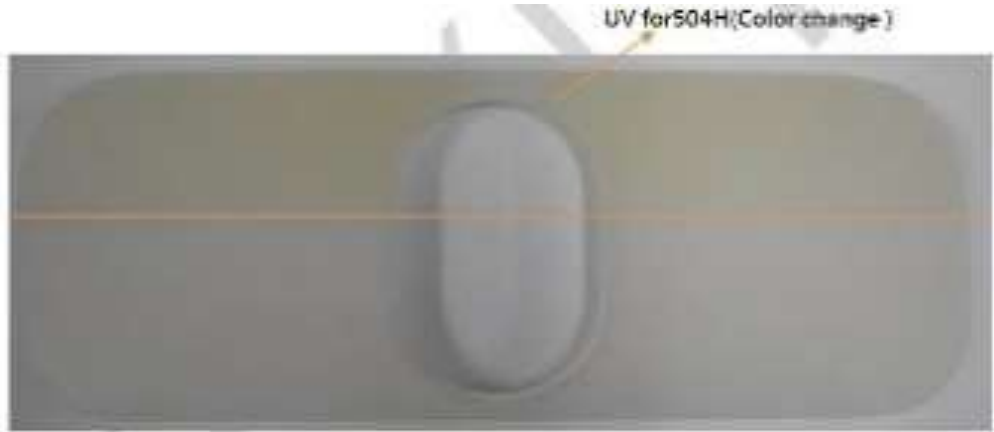
No.9-1	Pre-test Check	No.9-2	Post-test Check

During testing of the hardware, it was found that the plastics of the Pro 3 Floodlight were subject to yellowing when exposed to UV during testing.

The testing found that in the equivalent of one year of sun exposure, the plastic housing and floodlight diffuser can begin to yellow with age.

While the color of the floodlight is slightly affected, the brightness output remains near the same.

Engineering is investigating other possible materials for use.

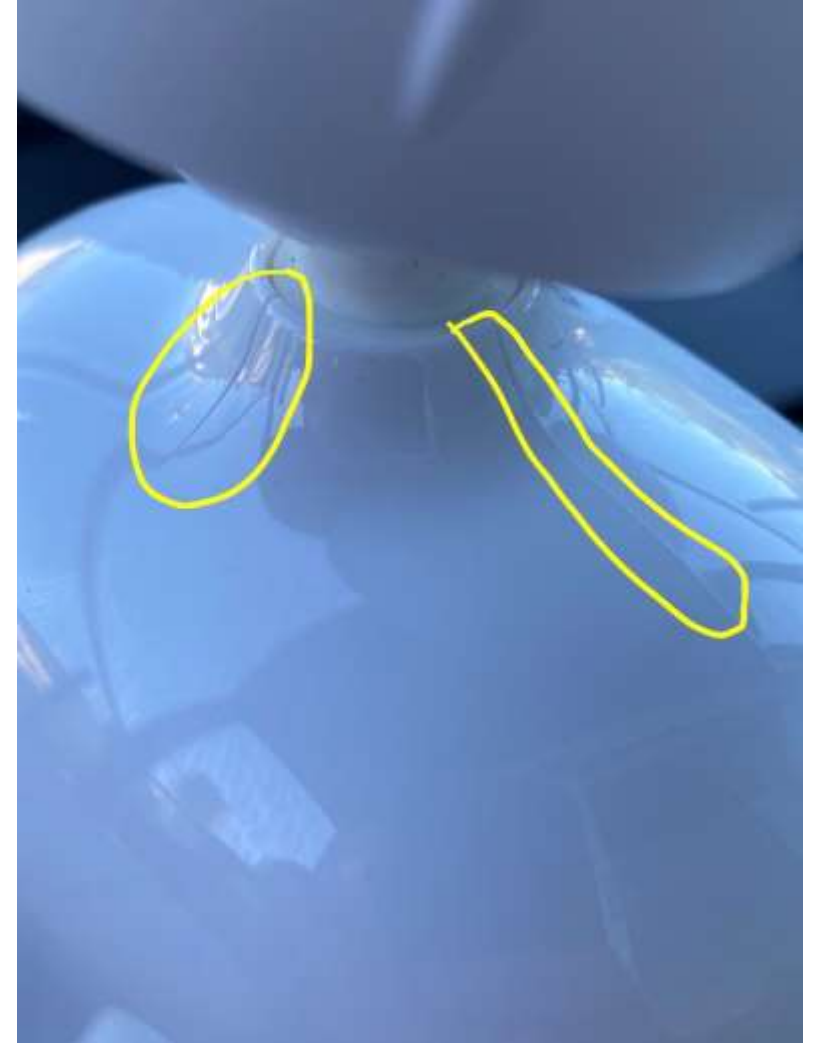
Arlo Pro 3 Floodlight – Cracked Housing

In Beta, we had a couple of cases where users experienced cracks in the housing of their Pro 3 Floodlight Camera.

The cracks were at the interface point where the camera meets the ball joint. One of the users admitted that they used a lot of force that may have caused the cracks. The other was suspected to have been a result of overtightening during assembly.

In the case that users have a cracked housing, the **Pro 3 Floodlight Camera Housing will be available as a separate part for Part Replacement**. Follow the normal Part Replacement process.

If we receive cases, we will request the housing be returned for engineering evaluation

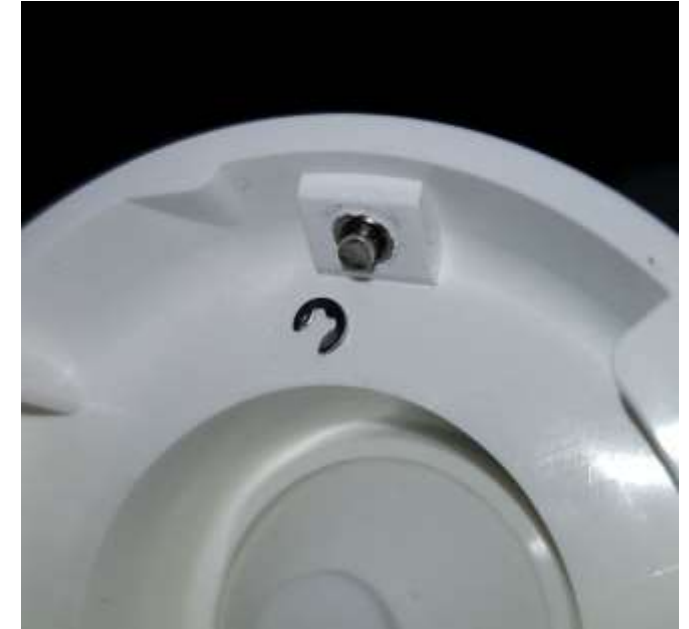
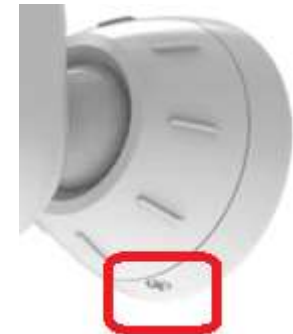
Arlo Pro 3 Floodlight – E-Ring Clamp Pop-out

Inside of the housing, there is an “E” shaped ring clamp that is intended to prevent users from unscrewing the locking screw. This E-ring clamp can fall out when loosening or tightening the screw.

This piece is not essential to the function or locking of the device in any way, it simply helps to prevent users from losing the screw.

If the E-ring clamp pops out, let the customer know that the piece is not essential.

No replacements are to be given for E-ring clamp issues. Do not replace the housing part if the E-ring clamp pops out.

An improved clamp will be used in a future hardware revision.
