# AXC F 2152 – CHANGE NOTES

## Change notes for the AXC F 2152 controller

Application note  
108427\_en\_18

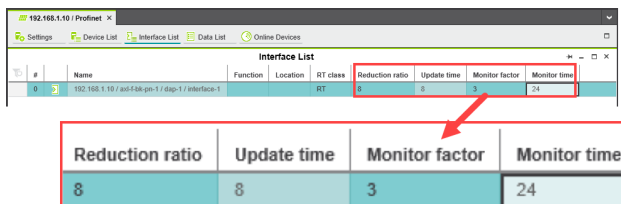
Figure 1 Monitor time

- Static\_String array in C++ programs  
The array sizes are incorrectly calculated in Static\_String-type arrays (C++), meaning that access to the second element contained in the array and to those following is incorrect.  
String arrays in IEC 61131 programs are not affected by this.
- AXC F 2152 as a PROFINET device  
The AXC F 2152 cannot be operated as a PROFINET device under PROFINET controllers from third-party manufacturers.
- Monitor time of PROFINET data  
The PROFINET data monitor time must be at least 24 ms. The monitor time is the product of „Reduction ratio“ and „Monitor factor“ (in PLCnext Engineer: „Profinet“ editor group, „Interface list“ editor).
