AXC F 2152 – CHANGE NOTES

Change notes for the AXC F 2152 controller

Application note
108427_en_06

Current firmware version: 2019.0 LTS

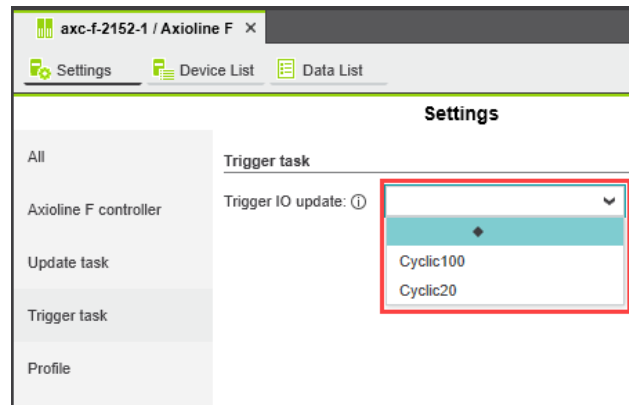
Figure 1 Select Trigger task

You can now specify the refresh interval for Axioline F I/O data. This is done by selecting which task triggers the Axioline F I/O data update in the PLCnext Engineer project.

If you do not select a task, the update will occur by default every 50 ms.

To do this, proceed as follows:

- Double-click on the “Axioline F (x)” node in the “PLANT” area.

The “/ Axioline F” controller editor group opens.

- Select the “Trigger task” view in the “Settings” editor.
- In the drop-down list, select the task that is to trigger the Axioline F I/O data update.
