AXC F 2152 – CHANGE NOTES

Change notes for the AXC F 2152 controller

Application note
108427_en_08

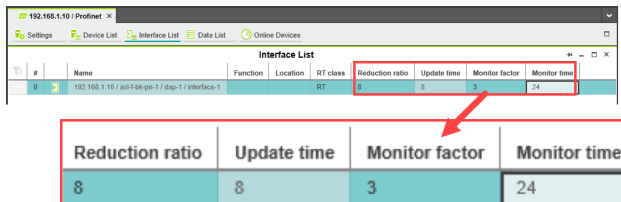
Figure 1 Monitor time

- Static_String array in C++ programs
The variable sizes are incorrectly calculated in Static_String-type arrays (C++), meaning that access to the second element contained in the array and to those following is incorrect.
String arrays in IEC 61131 programs are not affected by this.
- AXC F 2152 as a PROFINET device
The AXC F 2152 cannot be operated as a PROFINET device under PROFINET controllers from third-party manufacturers.
- Monitor time of PROFINET data
The PROFINET data monitor time must be at least 24 ms. The monitor time is the product of „Reduction ratio“ and „Monitor factor“ (in PLCnext Engineer: „Profinet“ editor group, „Interface list“ editor).
