MOP of VSWR Alarm for Huawei Site

This activity is for E2E troubleshooting and alarm clearance of VSWR of the antenna feeder abnormal.

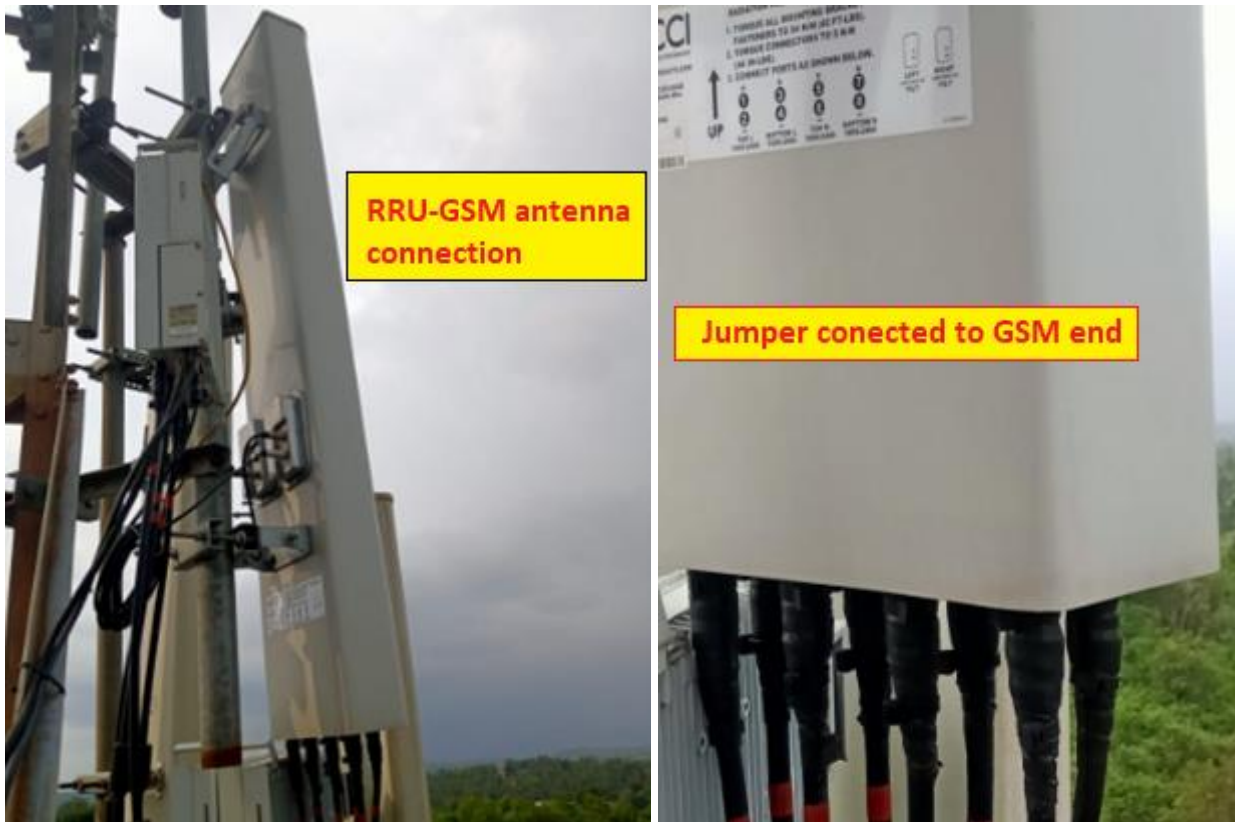
3. Check number of jumpers between RRU and Antenna and found it is correct as per plan.

4. No of cable are connected as per Plan so we are going to next step.
5. we checked all connector are tight or not and found that connectors are loose as well as band.
