TITLE: Sheet_1		REV: 1.0
	Company: Your Company	Sheet: 1/1
	Date: 2023-11-09	Drawn By: Denjhang

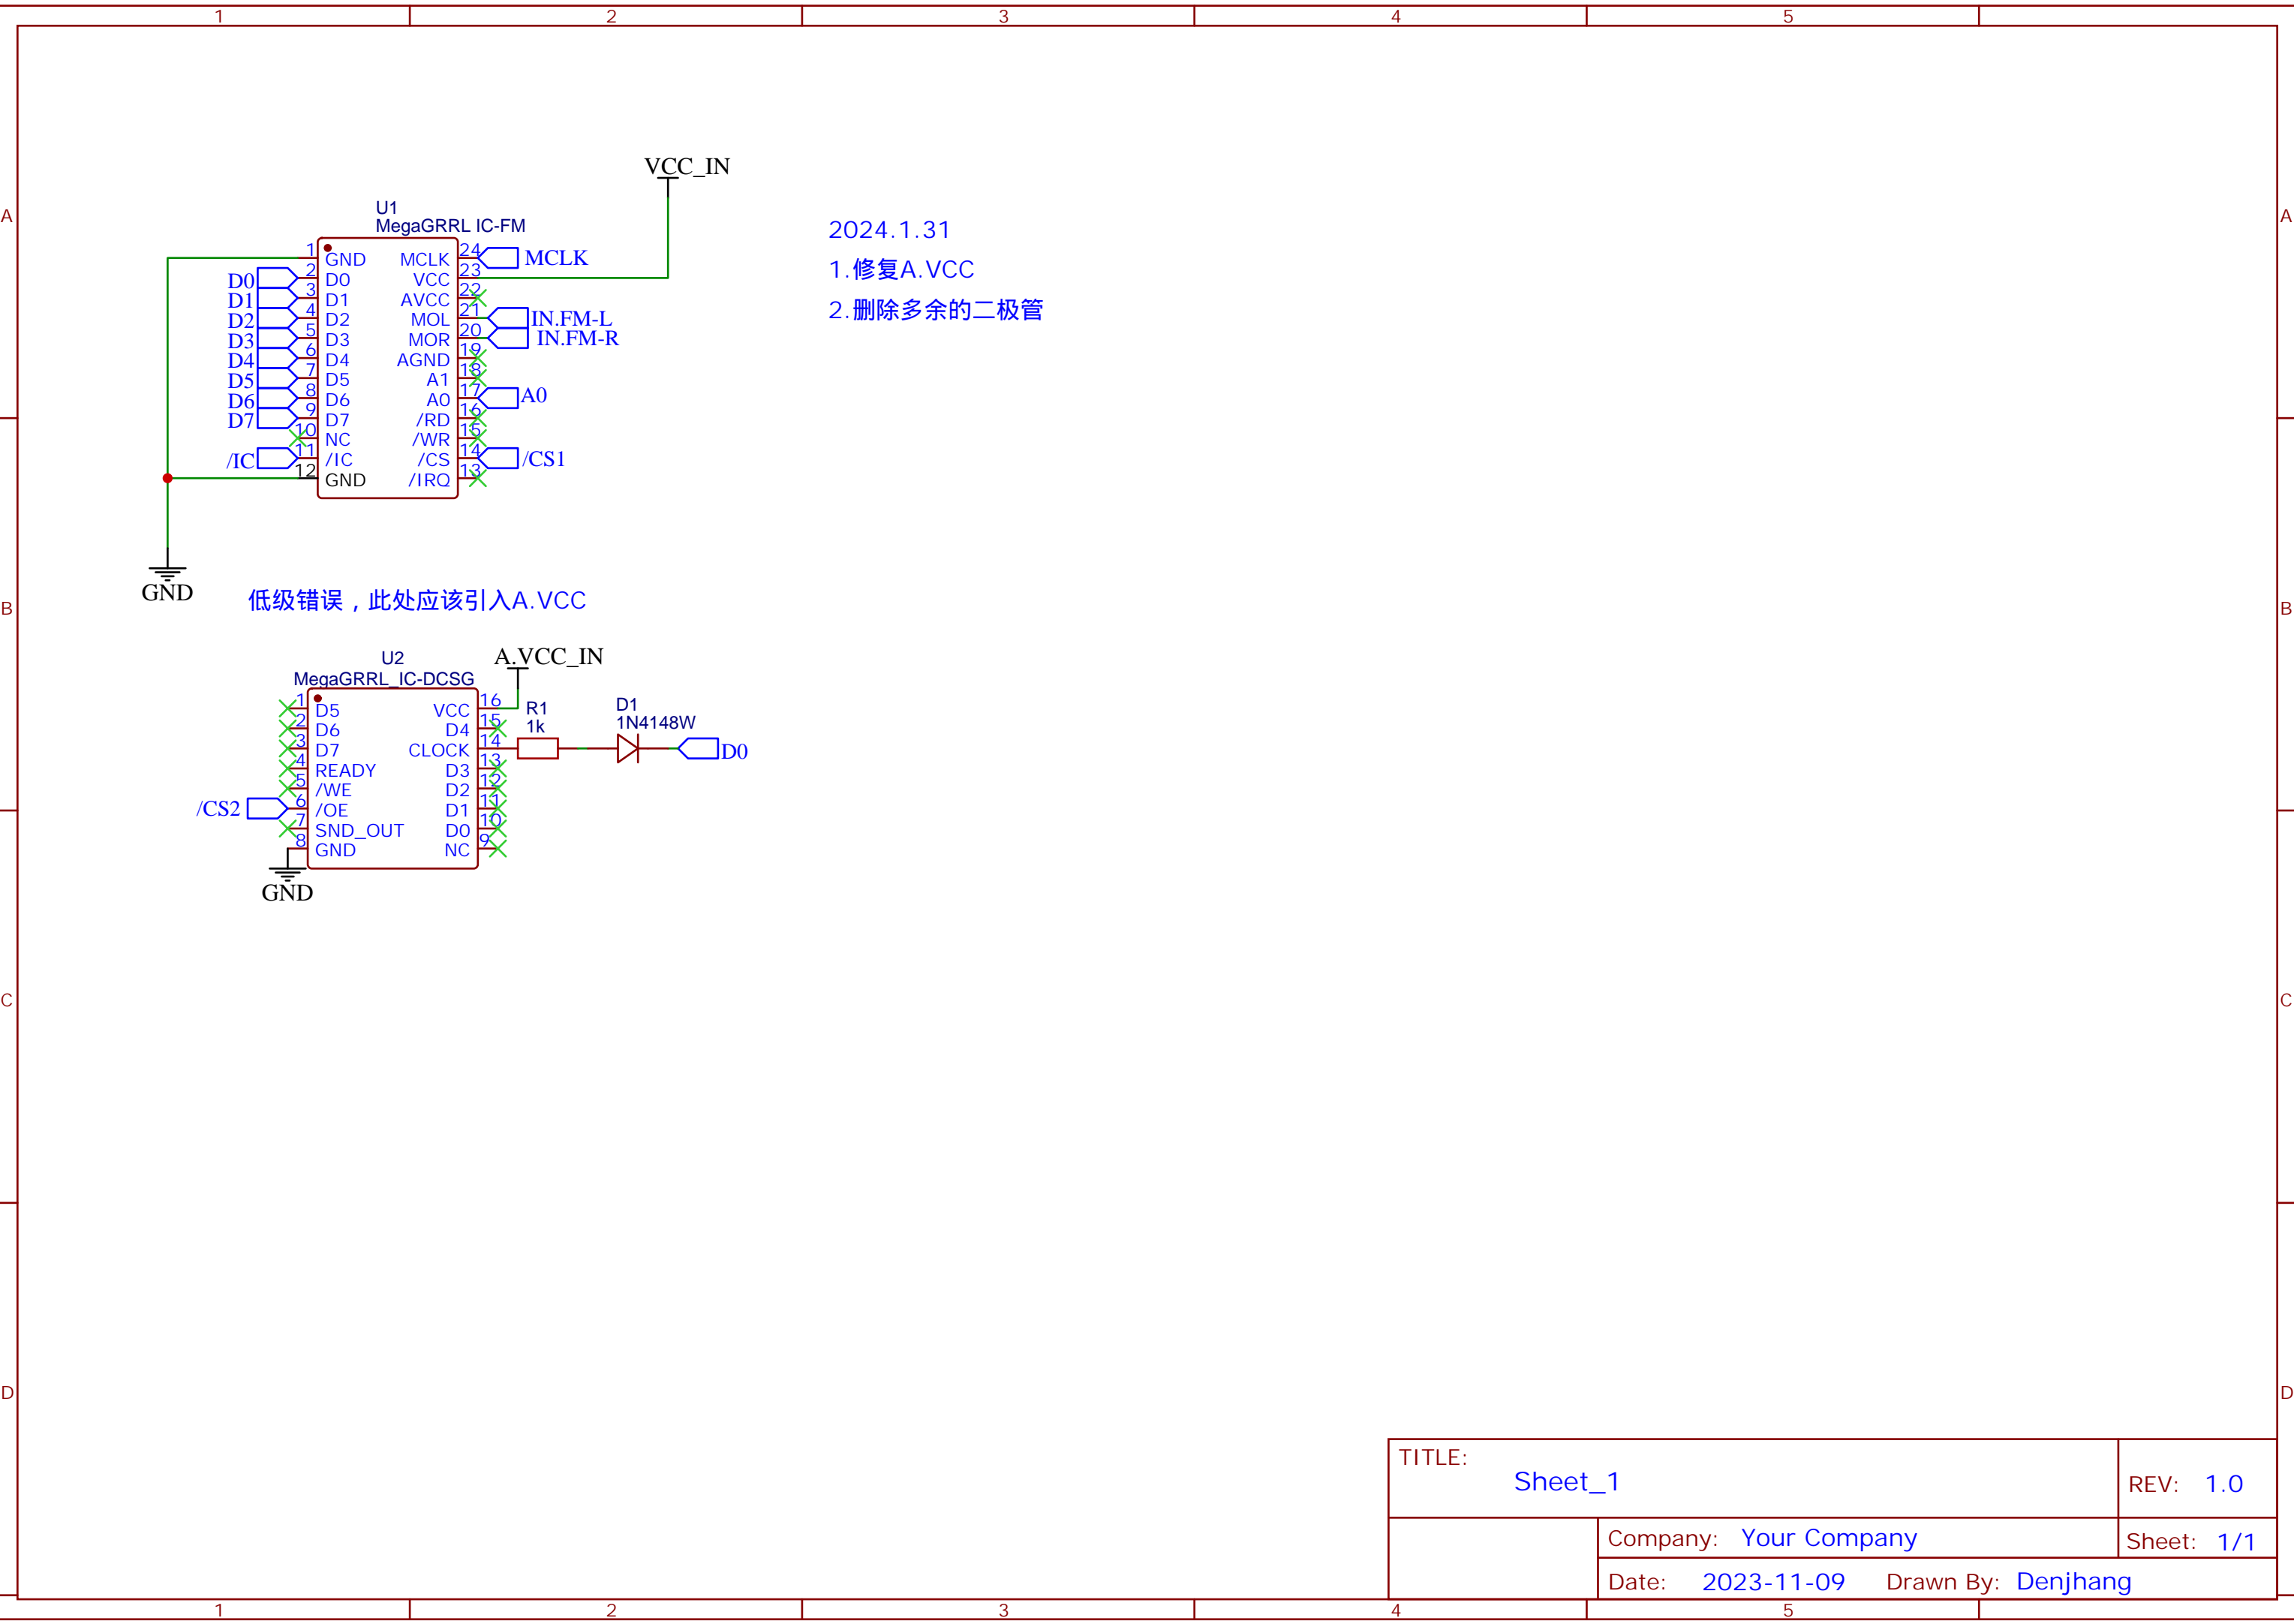
低级错误，此处应该引入A.VCC

2024.1.31

1.修复A.VCC

2.删除多余的二极管

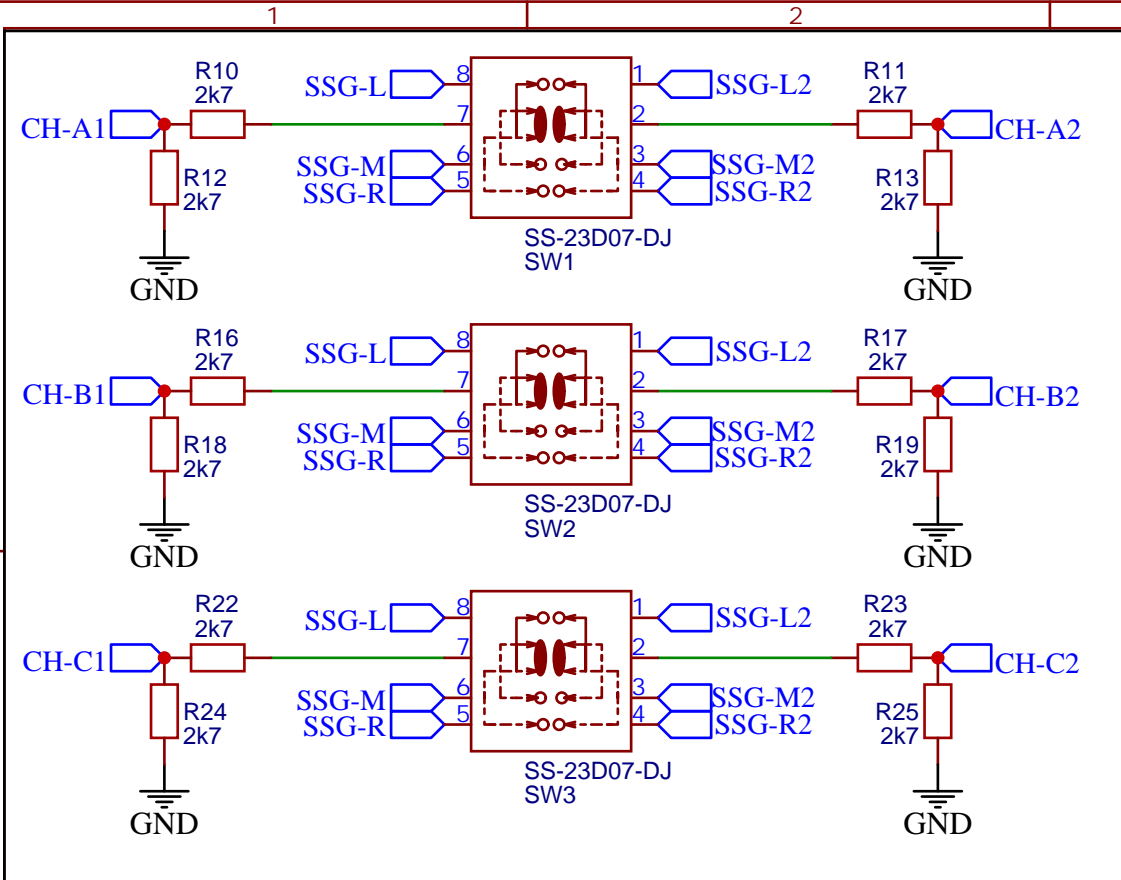
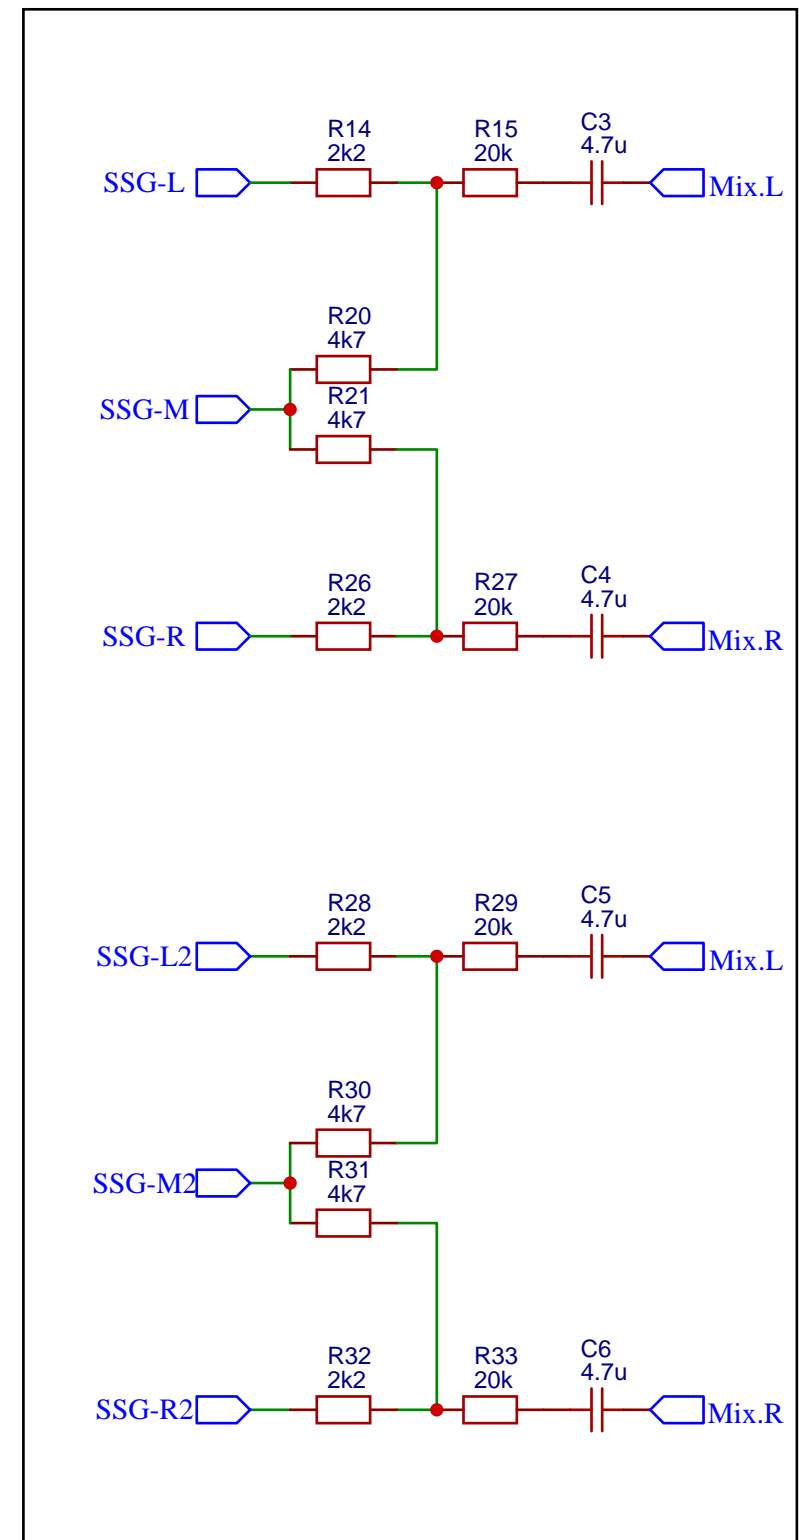
SSG在过下拉电阻之前，禁止接电容
此处参考RC2014-YM2149的黄金比例立体声混音
