MPW 2 Silicon Bring Up Status

SWT Frame Location	SLOT	PROJECT	ID	Git Repo
B1	7	yiFive	20007	Link

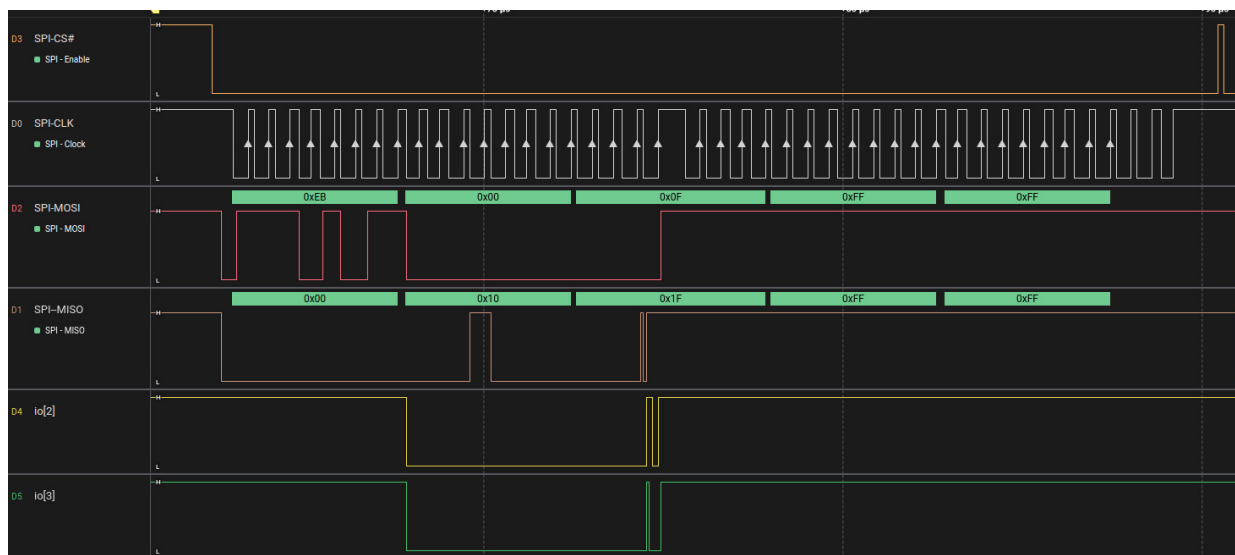
Baby Step-4: At user SPI interface after initial SPI init sequence, there should be RISC boot access with SPI Opcode : 0xEB followed by 0x200 address, which was not appearing at external interface.

After little adjustments on the clock_skew adjust at RISC core interface, I have notice that Quad SPI access Opcode: 0xEB followed with 0x200 address and it matches with expected simulation step.

- 1> RISC To Wb-Interconnect Write access good
- 2> Wb-Interconnect to SPI Write access is good
