# Sensor Fusion Toolbox

## communications problems

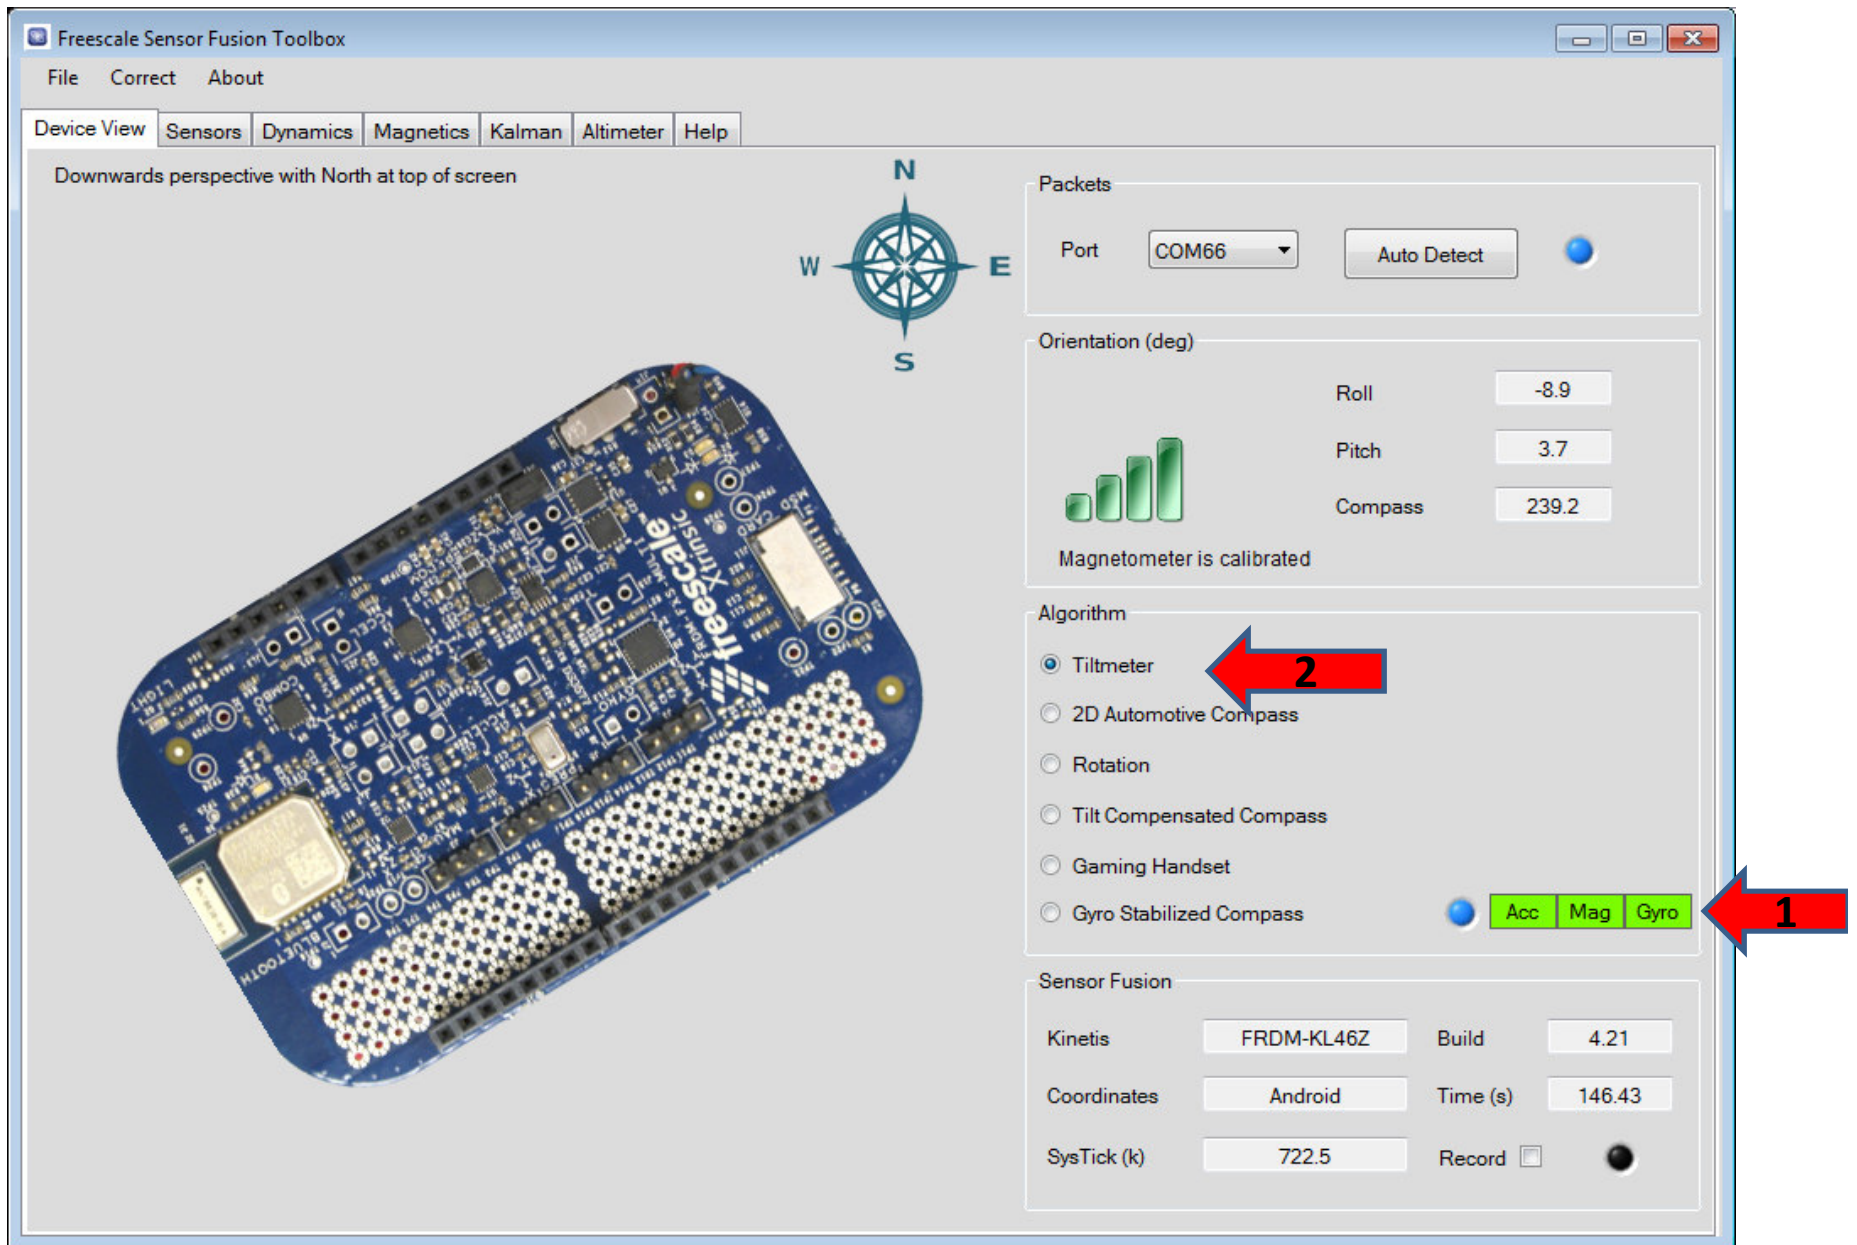
Root cause is that command packets from PC or Android device are never seen by the embedded software. This can be caused by a number of things, which are listed in the final page of this file.

When (1) and (2) do not agree, it indicates that the application and board disagree as to which algorithm is active.

- The GUI asked for an option not included in the embedded firmware build
- Command sent from GUI not recognized by embedded firmware
  1. Did you remove J7 when using wired mode?
  2. Did you forget J7 when using Bluetooth?
  3. Is the battery on your board low?
  4. Do you have more than one copy of the fusion toolbox running, or some other conflict for the serial port?
  5. Drag-and-drop of .s19 file can leave the Open SDA CDC serial port in a non-compatible state. Disconnect your USB cable, completely power cycle the Freedom board and reconnect.
  6. Download from the CW IDE followed by unplug/plug of the USB cable can have the same effect. You must cycle the power of the board completely.

Numbers 5 and 6 are believe resolved by changes to the embedded command interpreter in build 4.22.

Numbers 1 and 2 have been resolved in build 5.00 via the addition of redundant UART support.

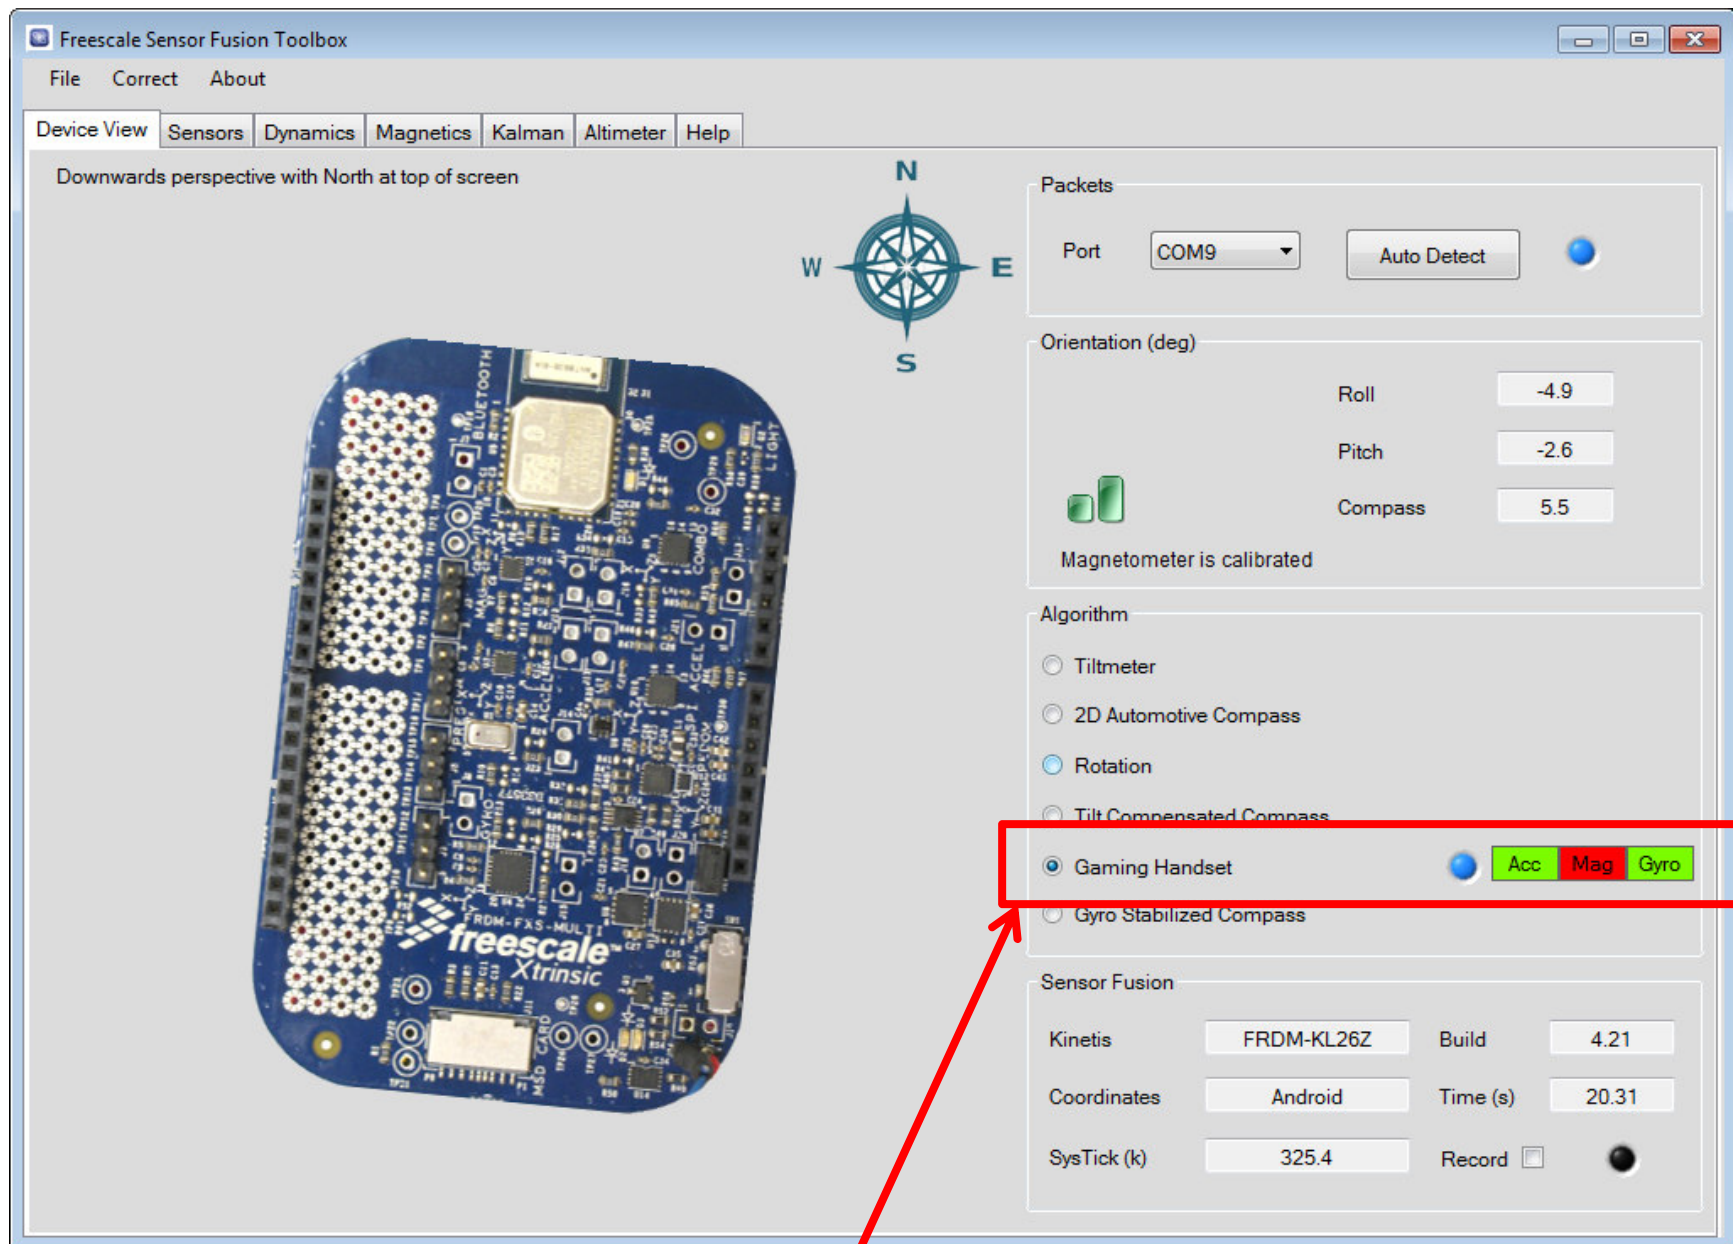
You want to see them agree
