TITLE: LogBoard

AUTHOR: Renan R. Duarte

DATE: 15/10/2019 11:32

v1

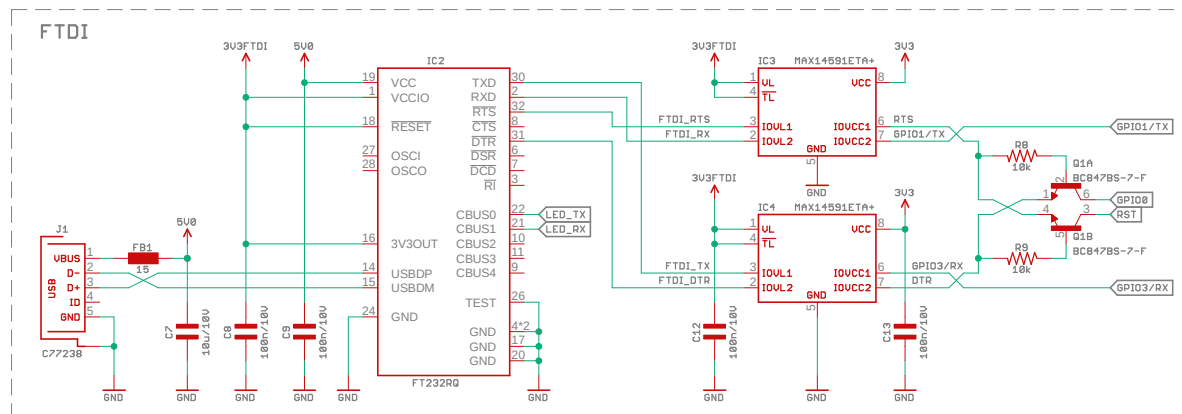
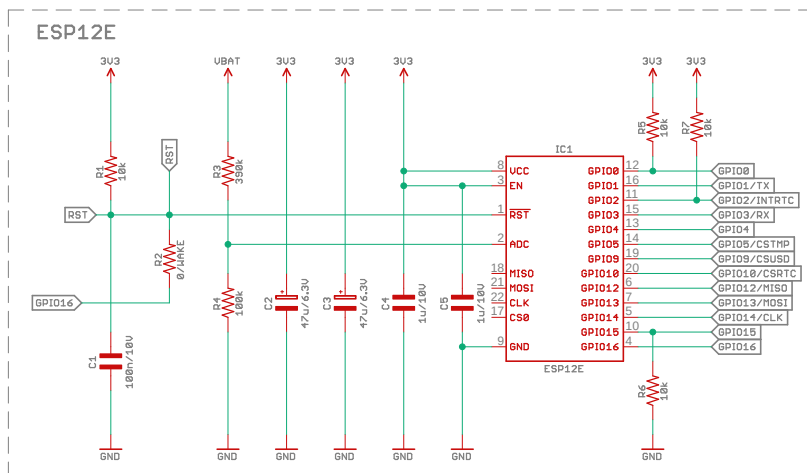
MISTAKES OF v1:

- USD CD was not connected
- RTC RST (DS1391) causes ESP not to boot. Disconnect this signal or use DS1390
- S2 footprint is wrong
