Borehole: BH070

## Field Log - Cored Borehole

Client: INCLINATION - 61° DIRECTION 339°	COORDS: 33378.3 M E	Job No.
Project: LUNA PARK FAULT ZONE CORE	6252116.3 M	Date started: / /
Borehole Location: LUNA PARK CORE	BARANGAROO -	Date completed: / /
(40.16 - 40.43) STICK 1	CROSS OVER CAVERN	logged by: EMILY BENJAMIN

Project: LUNA PARK FAULT ZONE

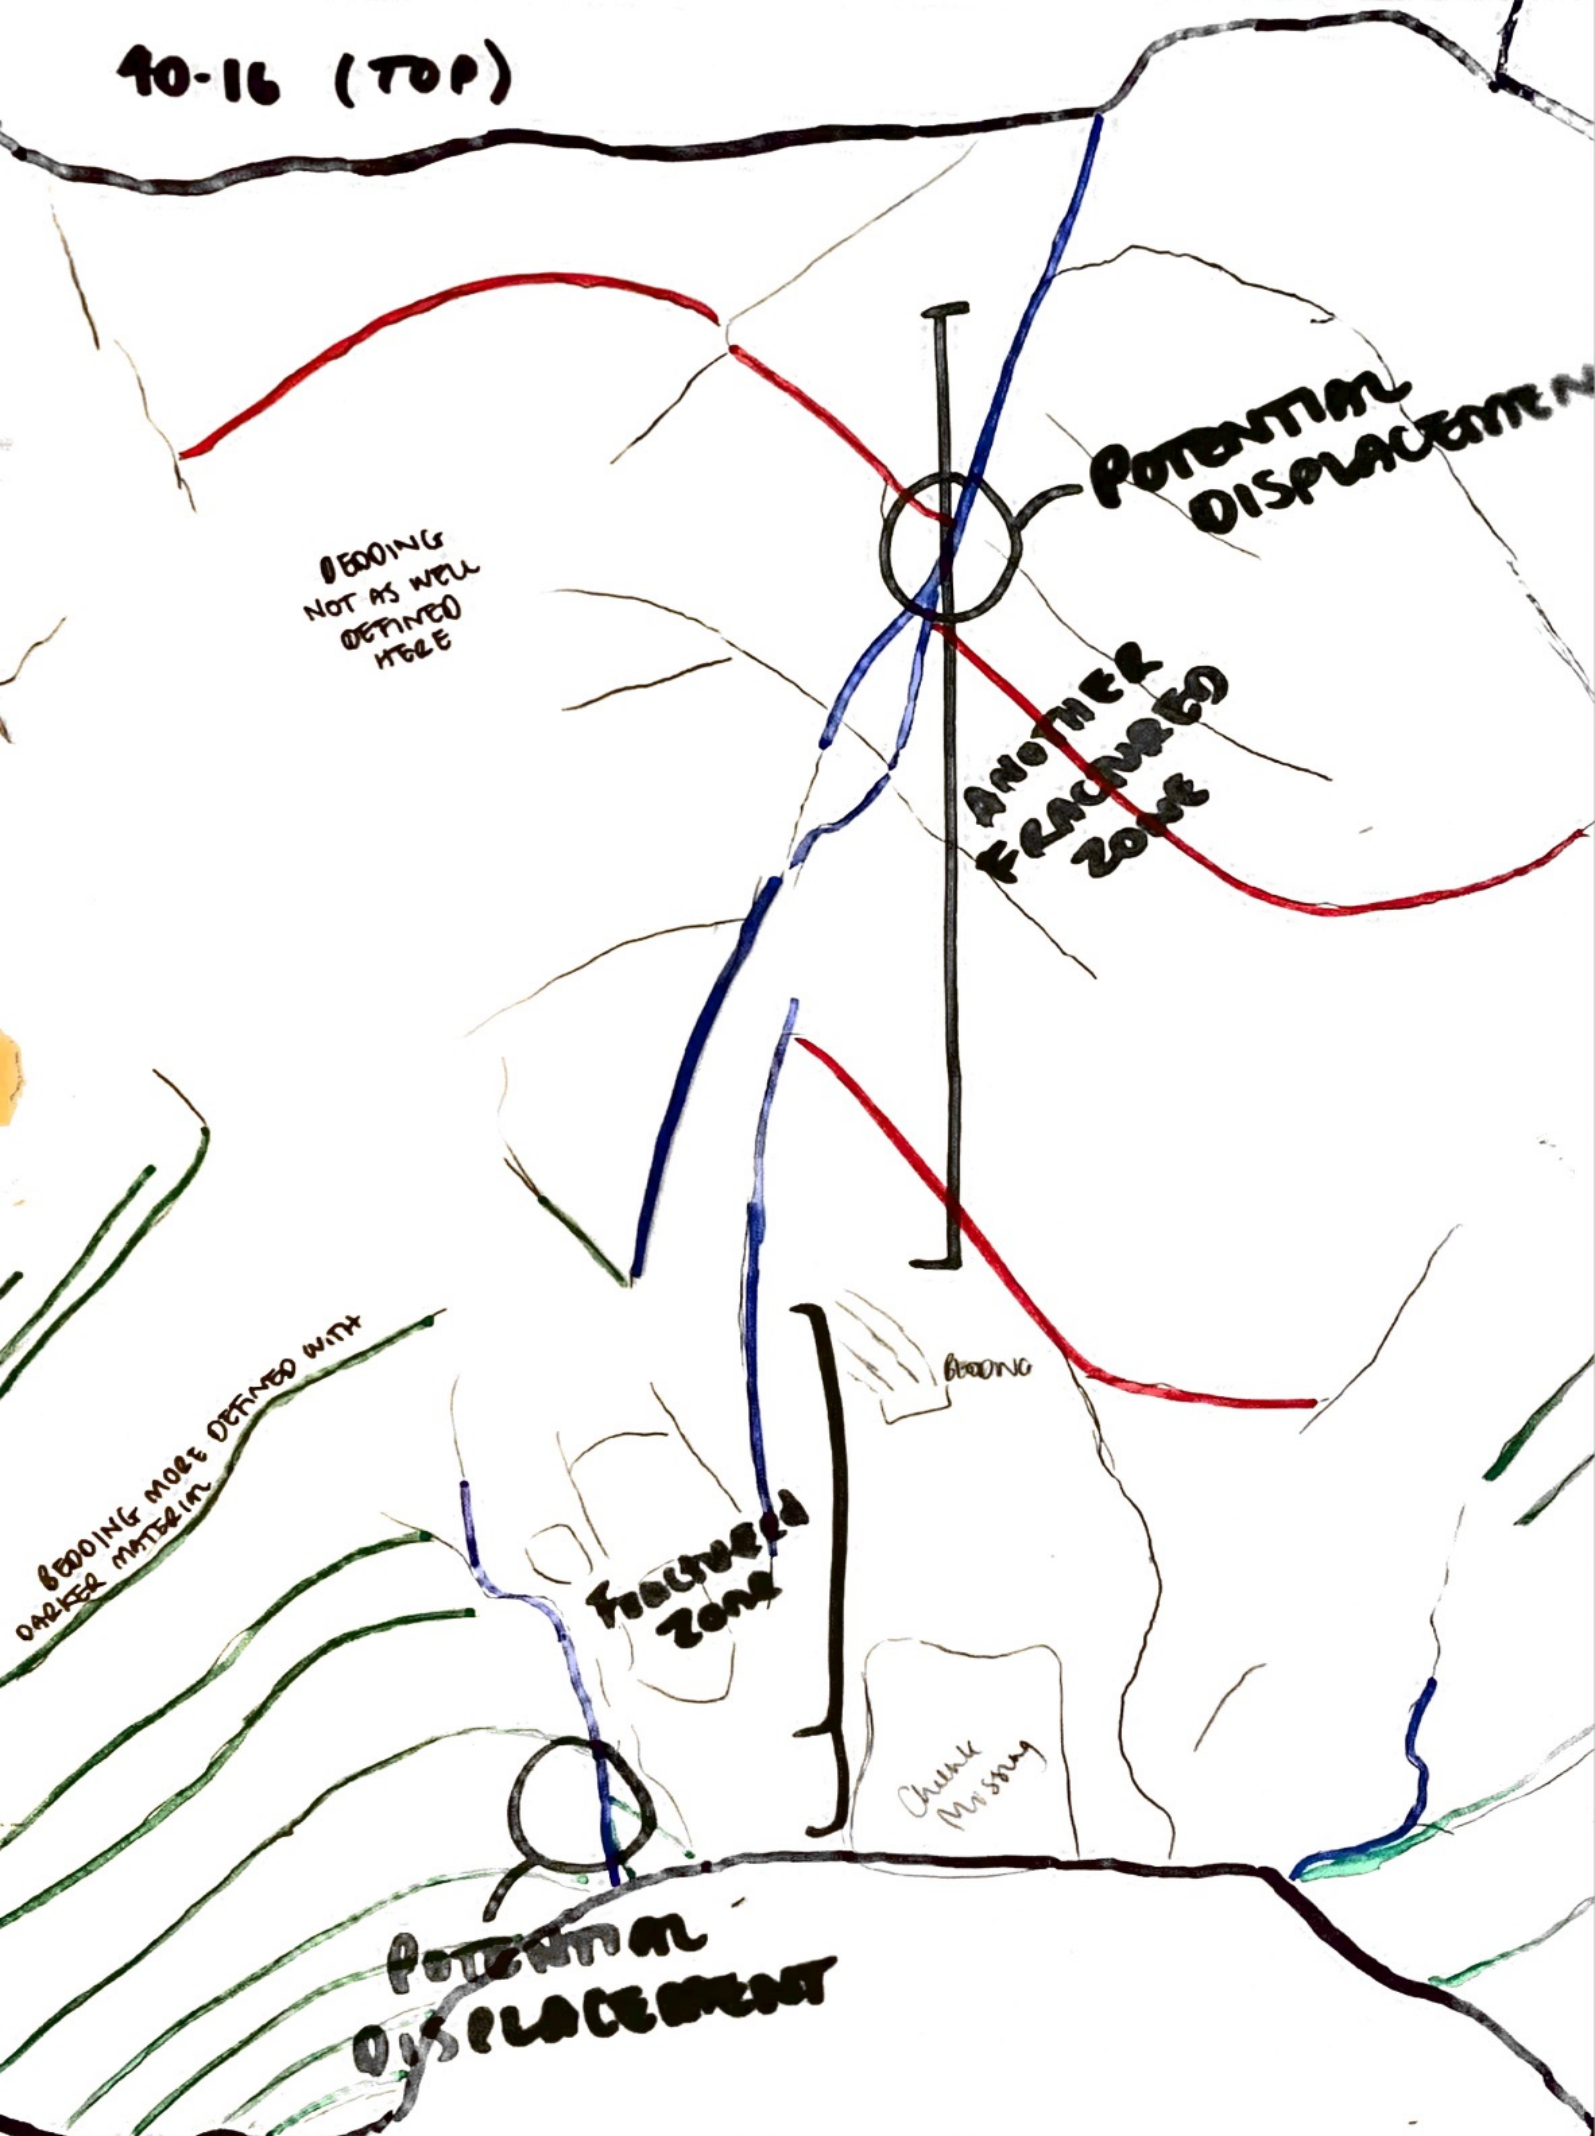
40-16 (TOP)

POTENTIAL  
DISPLACEMENT

**PARTING AT BEDDING PLANE**

**DARK MATERIAL**

**FRACTURES - FAULT ZONES**

BOTTOM FAULT DIPPING @  $75^{\circ}$ ?

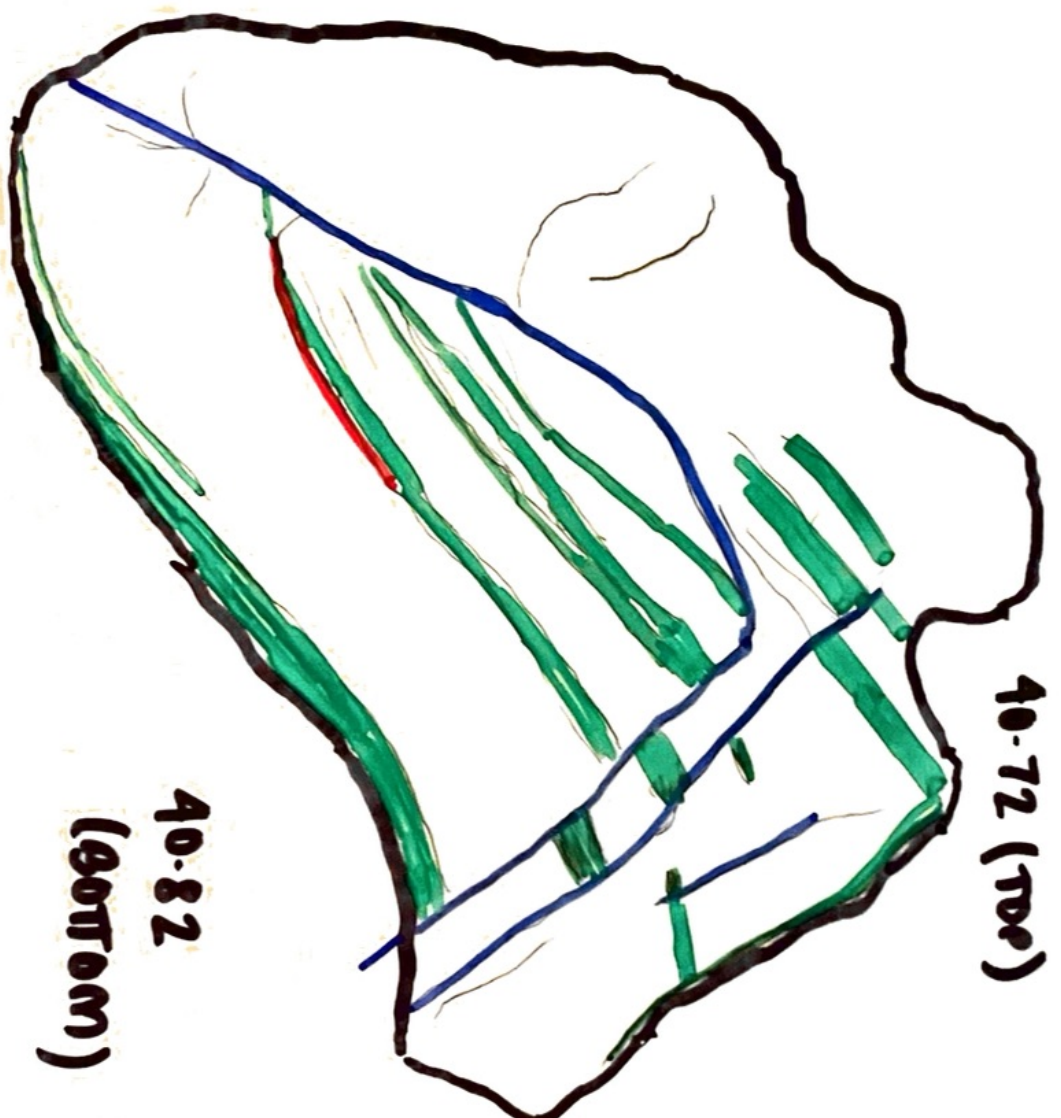
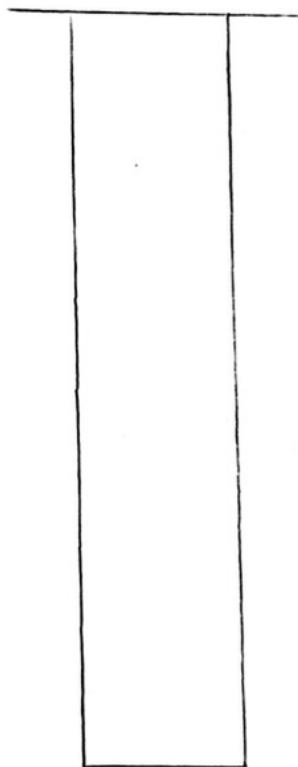
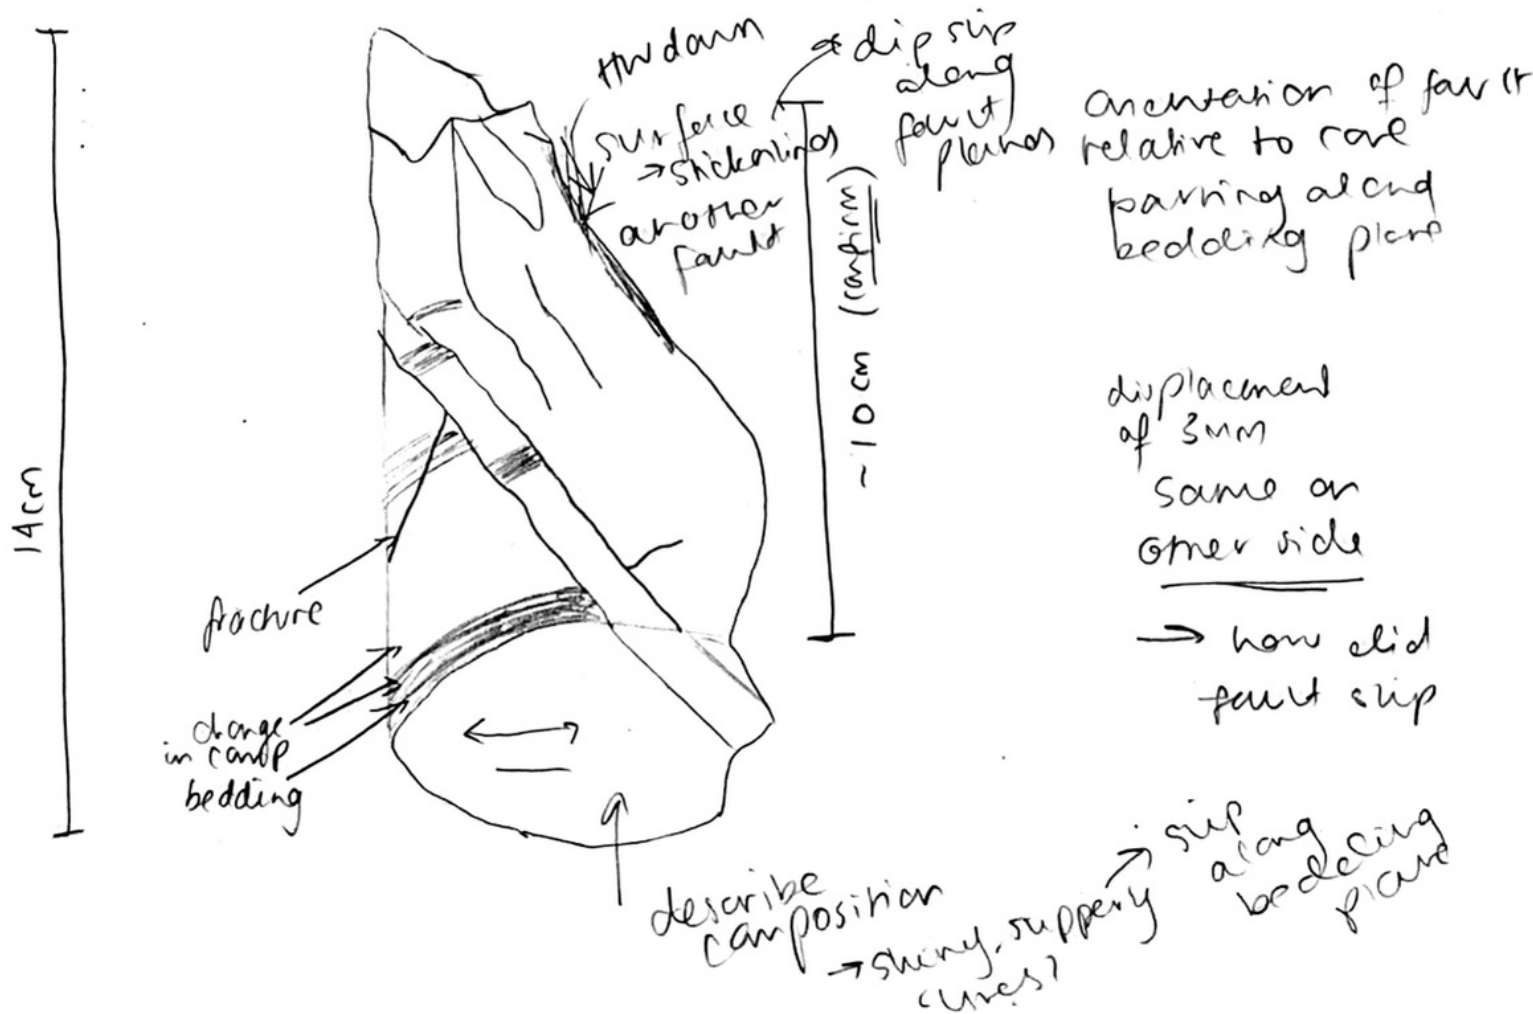
$$(40.72 - 40.82)$$

**PARTING AT BEDDING PLANE**

**FRACTURES - FAULT**

**DARK MATERIALS**

Two planes act.  
w/ different slip  
slip events on different  
surfaces  
→ different time

Tubing says 40.72 to 40.82 - 1 measure  
(10cm) longest at 14cm

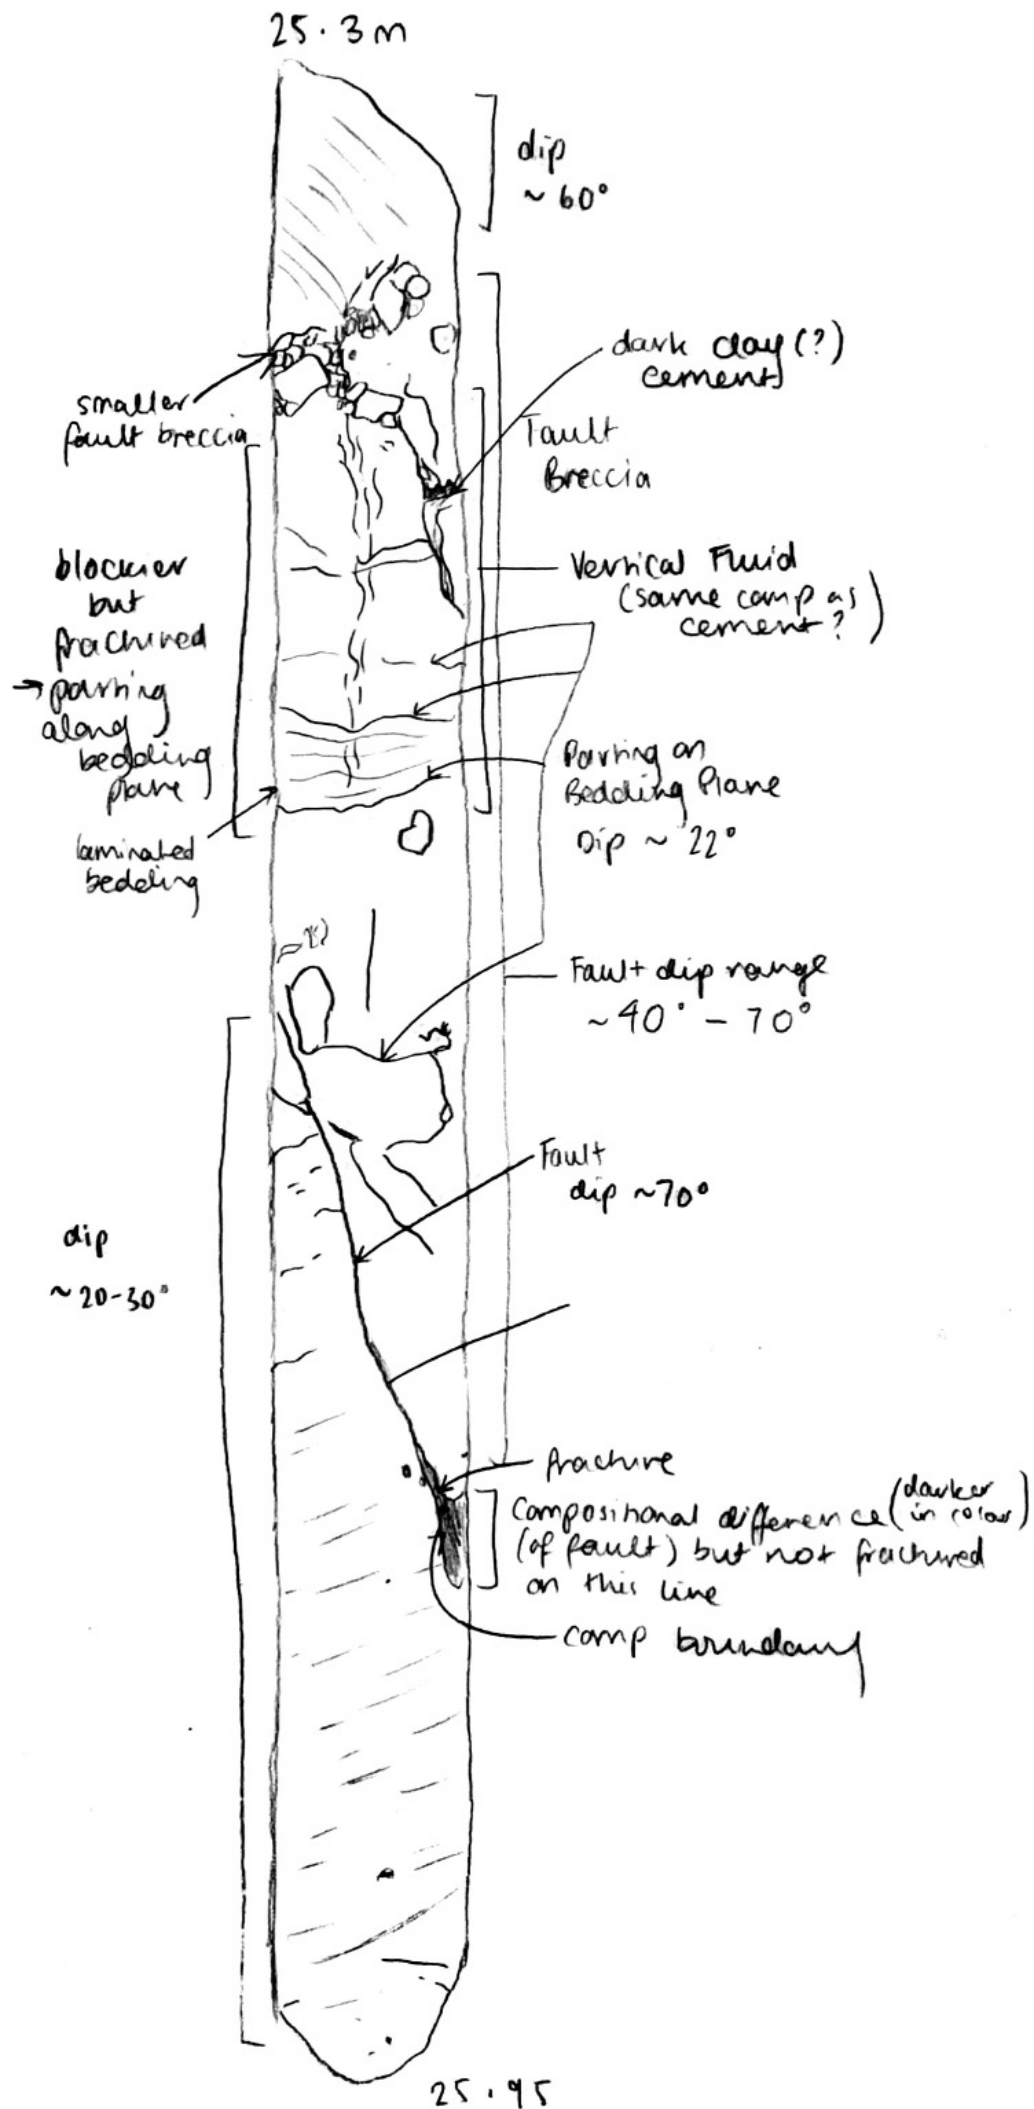
5cm from top  
(25.35 m)

Bedding plane

25.44m

black material  
↳ mud?

25.53m  
looks like breaks  
along bedding plane  
(different orientation)

dark material in  
fault zone

surface channels  
missing

material. ↳ because  
not bedding highly brecciated

fault fracture ↳ weaker  
clay precipitate

fault

little black  
marks  
↳ bedding plane

42cm long

(25.77m) BOTTOM

largely the  
brecciated  
zone

corrosion
