(wafer2,2,0,-1,-1,0,1) Characteristics

- **Cell Size:** 15um
- **Times Accessed:** 6
- **Last Measurement:** 2022/March/23 at 04:09:35PM

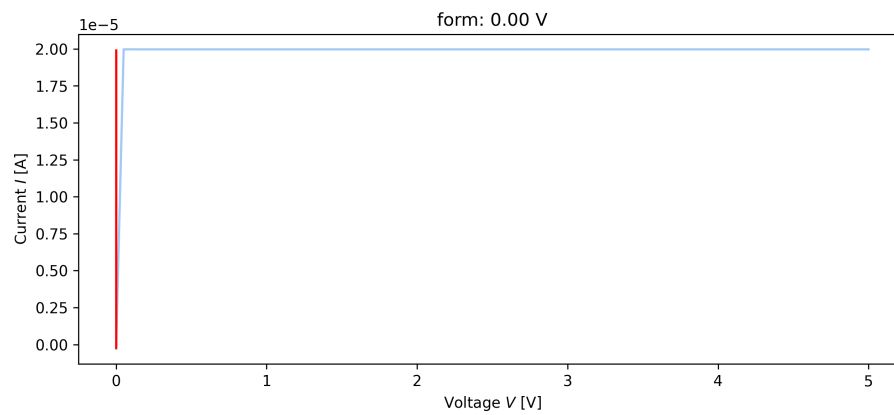
form

- **Time:** 04:01:03PM
- **Icc:** 20.0uA
- **Voltage Range:** 0V \rightarrow 5V
- **Target Ramp Rate:** 1V/s
- **True Ramp Rate:** 1.836 V/s*
- **Cycle:** 1
- **Error:** Set failed

Probe A on copper, B on platinum. Already set. Possibly due to minor layer short in wafer, around countour edge of bottom platinum layer.

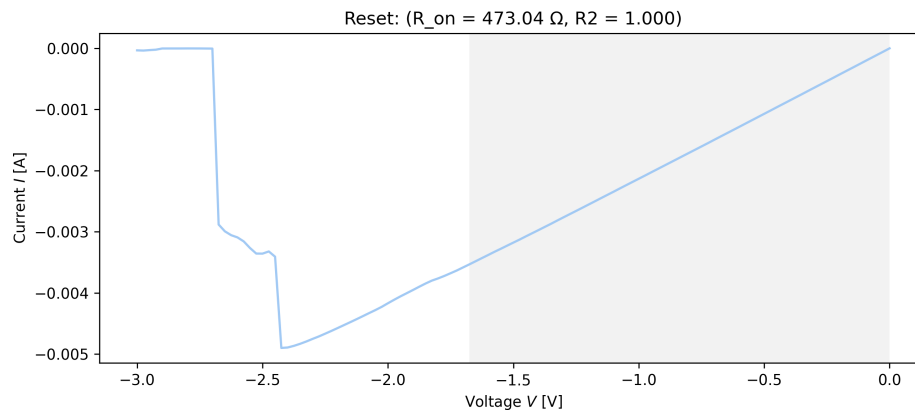
- **Time:** 04:03:36PM
- **I_{cc}:** 6.0mA
- **Voltage Range:** 0V → -3V
- **Target Ramp Rate:** 1V/s
- **True Ramp Rate:** -0.765 V/s*
- **Cycle:** 1
- **Resistance:** 473.04 Ω
- **Linear Fit R²:** 1.000

reset success

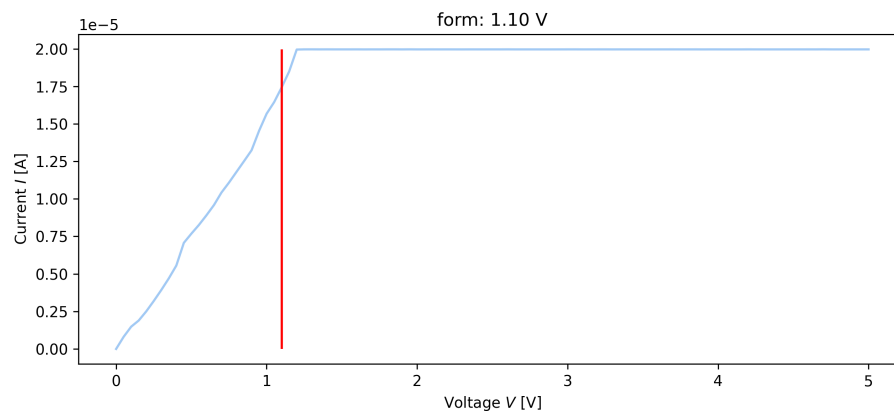
form

- **Time:** 04:04:26PM
- **Icc:** 20.0uA
- **Voltage Range:** 0V \rightarrow 5V
- **Target Ramp Rate:** 1V/s
- **True Ramp Rate:** 1.353 V/s*
- **Cycle:** 1
- **Set Voltage:** 1.10 V

Set success, but at v low voltage of 1.2V. Therefore weak filament.

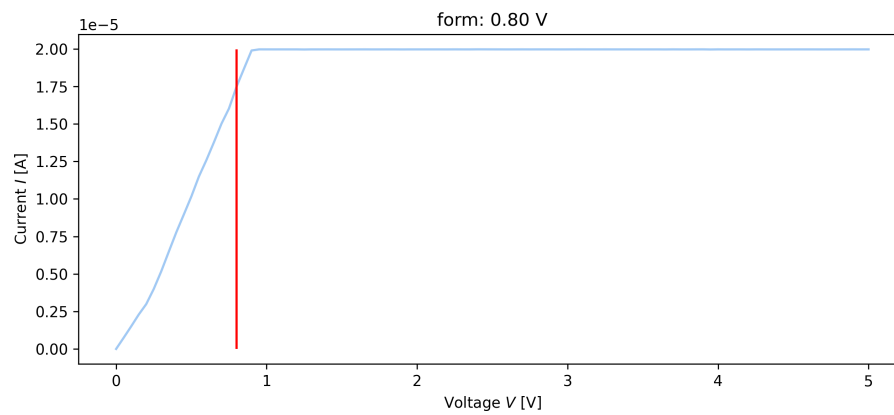
form

- **Time:** 04:06:40PM
- **Icc:** 20.0uA
- **Voltage Range:** 0V \rightarrow 5V
- **Target Ramp Rate:** 1V/s
- **True Ramp Rate:** 1.429 V/s*
- **Cycle:** 2
- **Set Voltage:** 0.80 V

shows ohmic pattern. Short maybe present.
