Personal Project – Design & Build Log

Part Name: Prototyping Motor Controller Perfboard mount

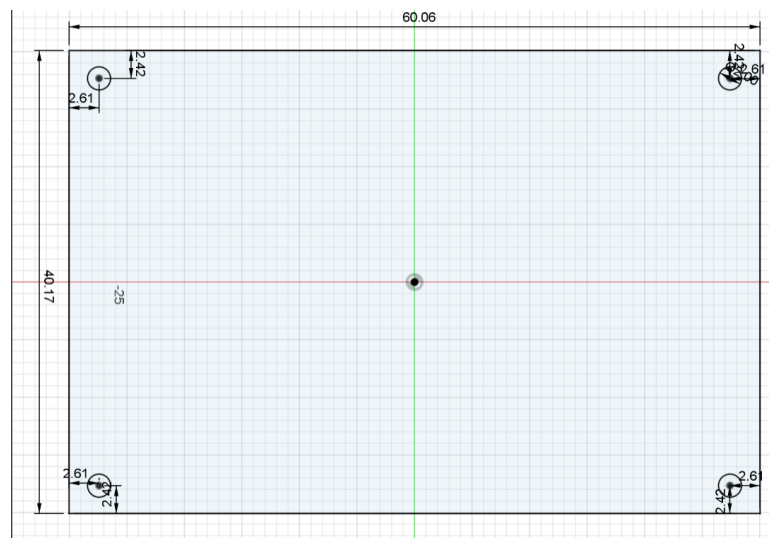
- Decided that rather than adjusting and reprinting the L-bracket several times to get the hole spacing right for the perfboard, it would make more sense to print a temporary mount to the chassis and adjust the hole spacing when the final PCB dimensioning has been confirmed.
- Changed the hole spacing of the perfboard in the CAD because when remeasuring, I found errors in the measurements in the CAD, here is the new diagram for reference:

- Adjusted the holes in the mount to slot in with M5 and added correction for perfboard screw mounting.

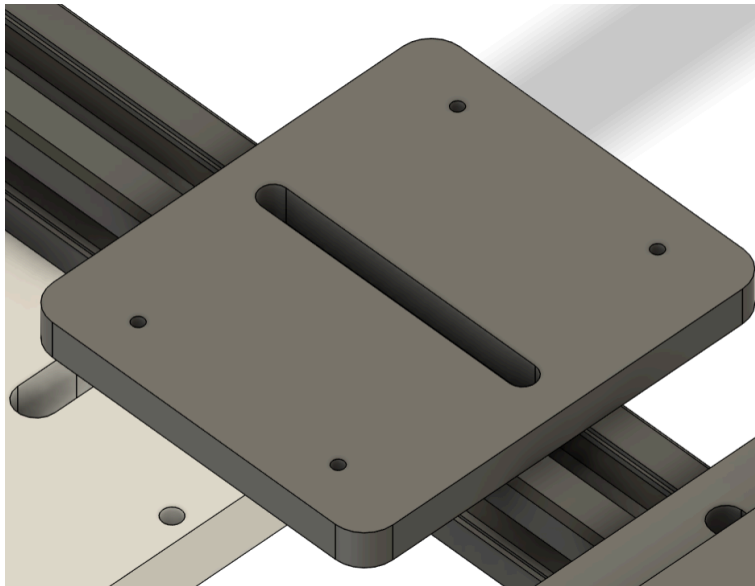
-> Assembly Photo

- Test the part against the motor controller perfboard

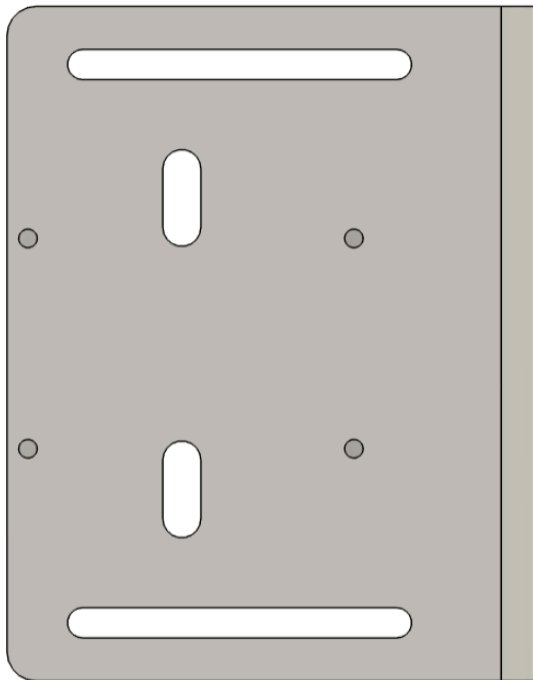
- On 1/9/26 when the M2 threaded inserts were added to the bottom face of the L bracket via solder, the holes did not line up accurately to the perfboard. Due to it being difficult to measure the exact spacing, this likely resulted in the error.

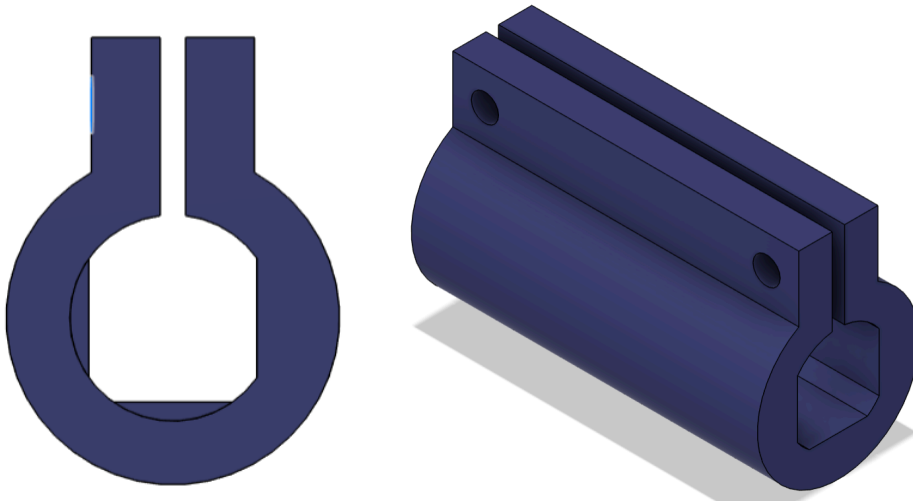
- Changed the shape on the motor end to be D-shaped according to the shape of the motor itself.

- Adjust wheel shaft tolerances to make a better fit with the wheel shaft -> adjusting by 0.2 mm
- Change screw holes to M3

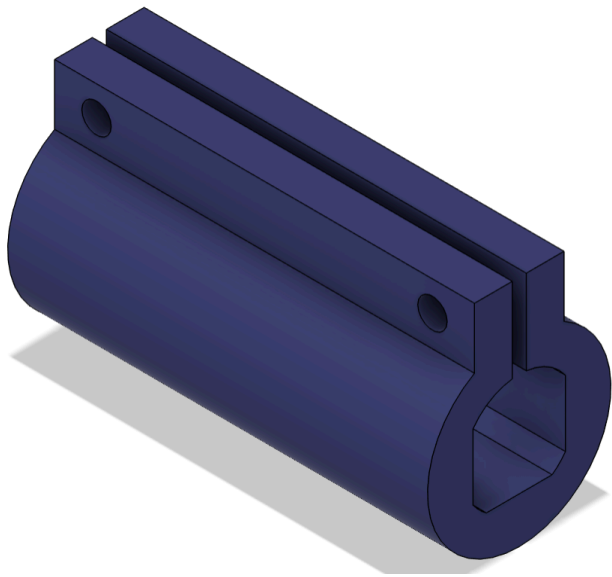
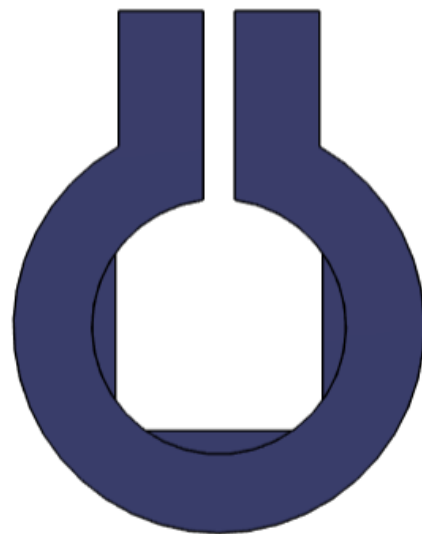
- Note this part was printed on 1/1/25, this is a review of the part overall done at a later date.
- Overall, the print quality was pretty good and didn't show signs of warping.

- Make screw hole larger than 2.1 mm -> try 2.2 mm for the M2 screw
- Fix the shaft length for the motor shaft and make the coupler more D shaped on the motor end

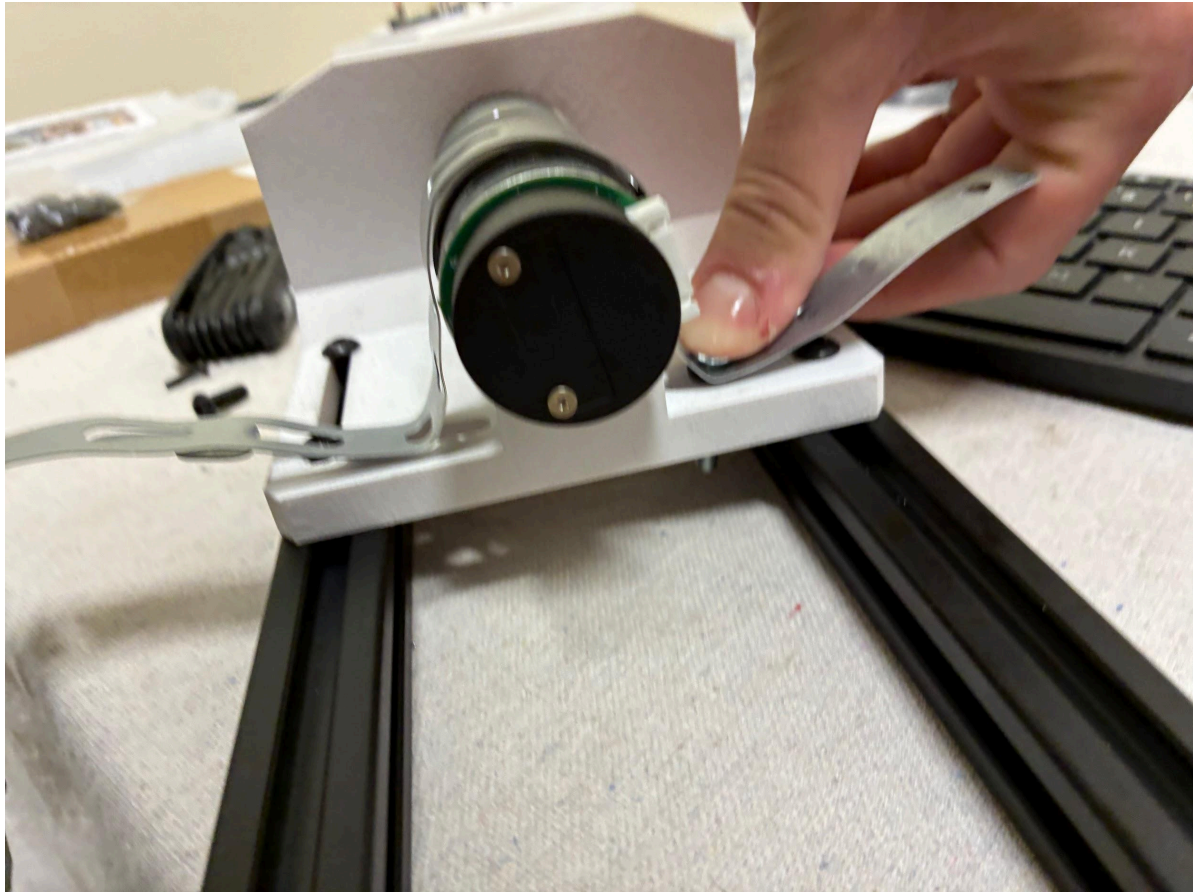
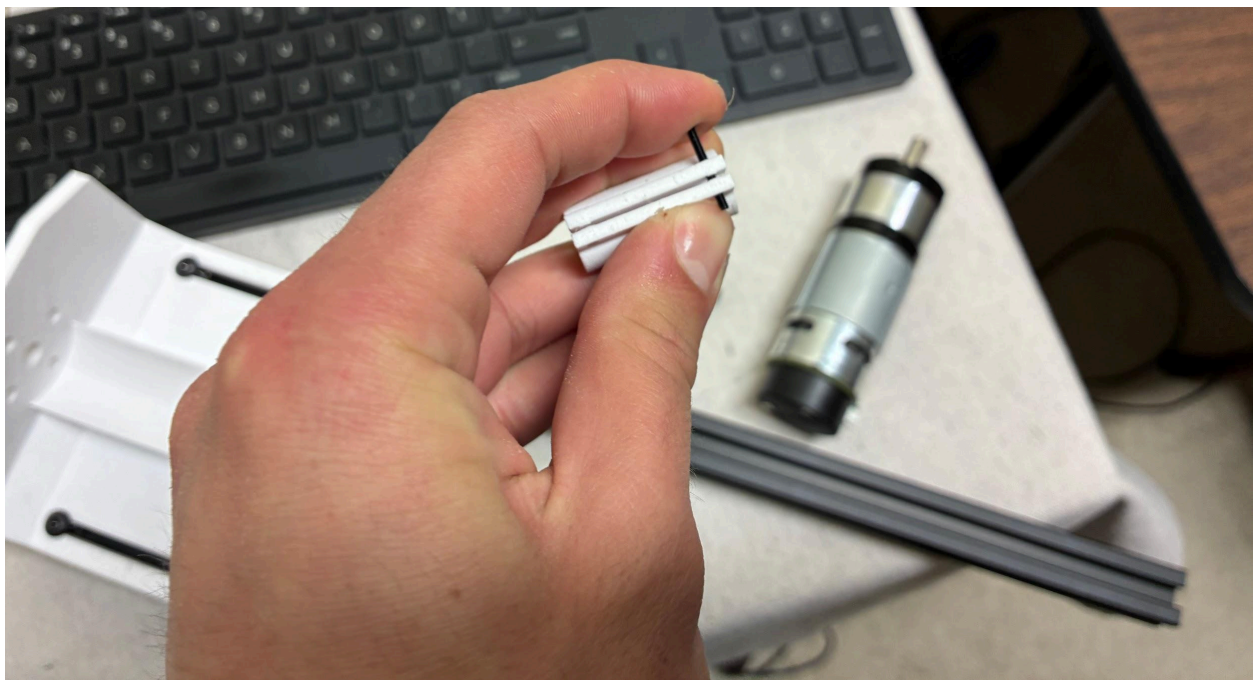
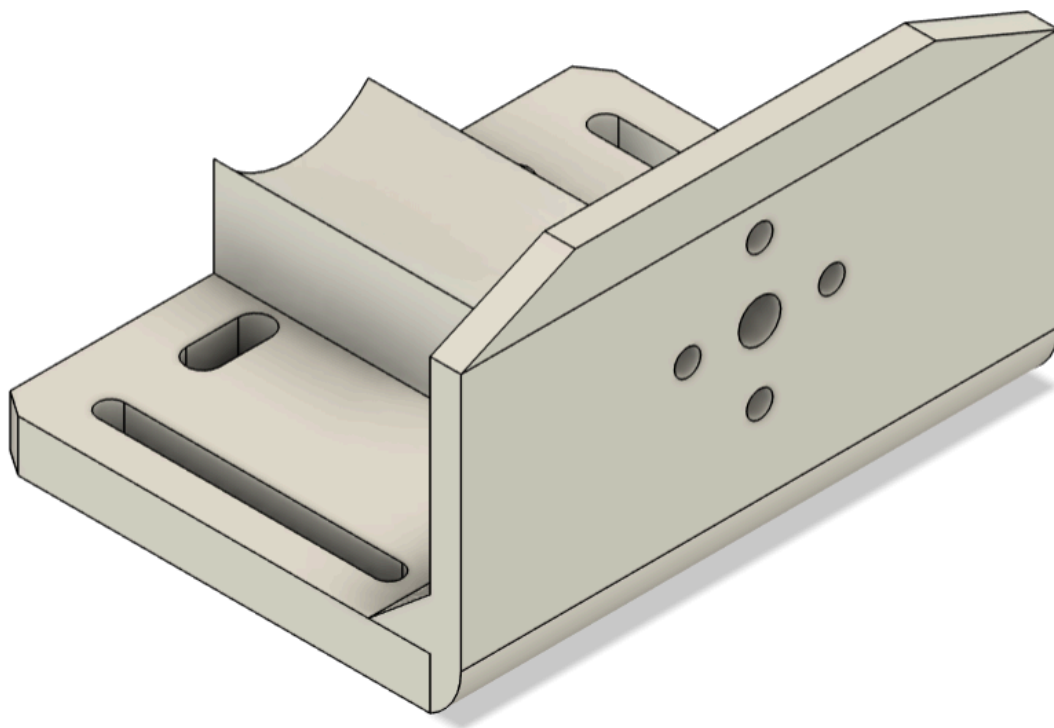
- Note this part was printed on 1/1/25, this is a review of the part overall done at a later date.
- Overall, the print quality was pretty good and didn't show signs of warping.

- Wrong screw hole, should be M3
- 0.7239 mm band around the motor for 1.3415" -> add proper adjustment for band
- Counter sink motor screw holes
- Move saddle tabs over to make better contact with the band
 - Add tape around saddle band
 - Cut the saddle band strip
- Consider thickness of the part in relation to the motor shaft (if that is causing problem -> not enough shaft coming out)
- Tolerances:
 - 5.1 mm for M5 is too small -> 5.2 is better
 - 5.45mm is the diameter of the M3 screw head
 - 9mm too short for the shaft hole
 - 15.875 usable shaft

- Consider reducing the thickness of the top plate on the bracket to have more shaft extending out of the bracket.
- Consider rearranging chassis bar structure to sit connecting rails on top of the motor rails for better clearance with the shaft.
