# SunetC 200G blogg

## SunetC 200G

[Magnus Bergroth](#) posted on May 25, 2020

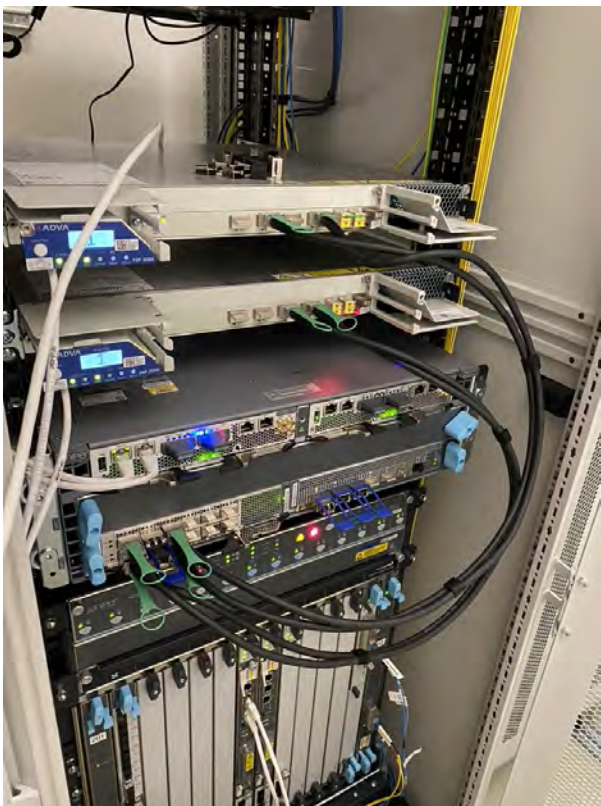
There were plenty of space in the rack in Linköping:

The small issue is that the Juniper MX960 and the MX10003 has different distance between the front and the back rack post. And the installed equipment made it impossible to move the posts.

A trip to the local company Biltema were some M16 long nuts and long m6 bolts over bridged the 75mm gap.

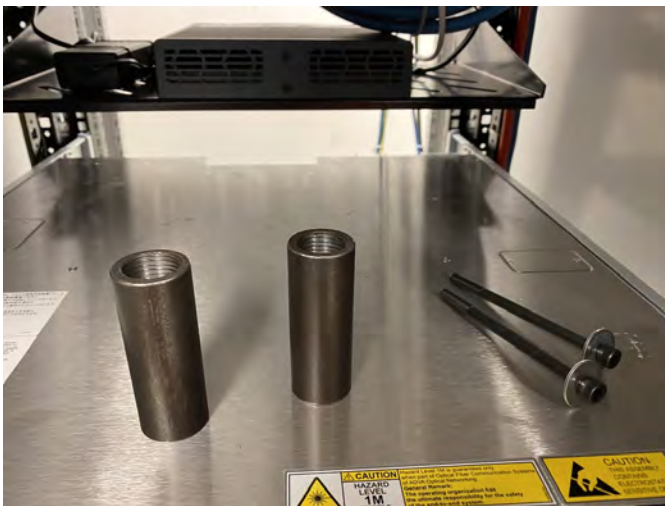
The rack had the same problem as the rack in Linköping, the posts were to close together. The "shims" were upgraded to m15 black iron pipe nuts. But I forgot to clean them, they are rust prevented with oil, so it got a bit messy.

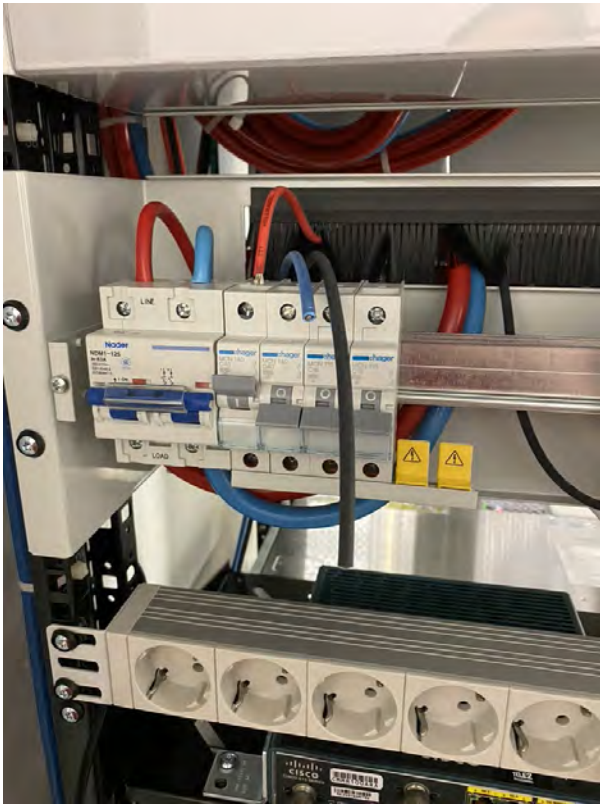
The blue and black cable from the ADVA DCI box are dual insulated cables as required by local installation laws. It means that the insulation is rather thick and that the end protection sleeves that we use on the cable will not fit over the isolation. To fix that you have to cut the insulation twice.

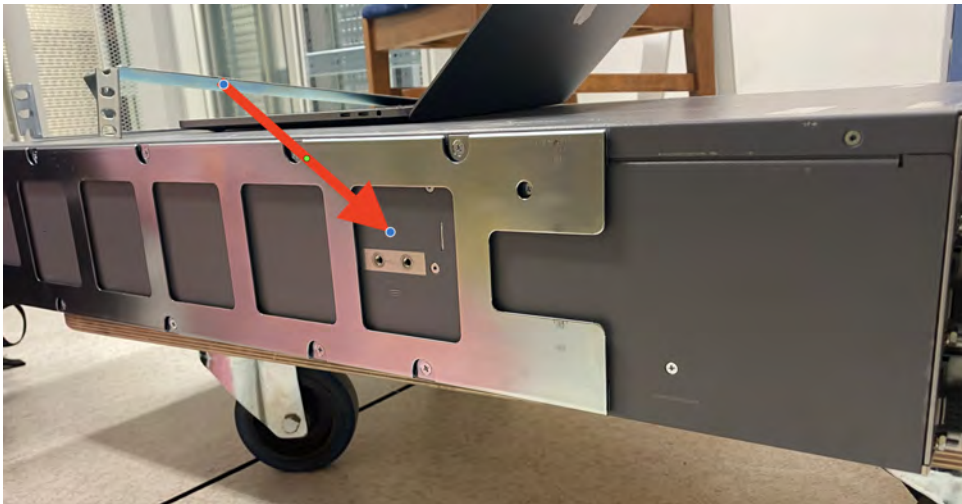
The Mx10003 has a separate grounding point on the side of the box that needs to be used when you run the router on DC power.

But as you can see it's inside the rack rails, so you can't mount the cable until you have mounted the router in the rack and if you have a rack with closed side you will not fit normal a screwdriver. Stupid design.

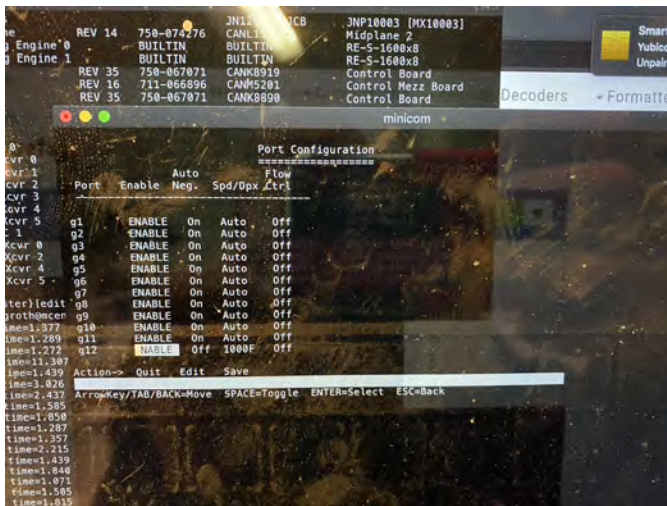
A 24 port linksys switch was used as a media converter. The fibre port flashed as one could expect. Connected my laptop to the switch and I could ping their FW but not our router.

Restarted the switch, swapped ports, no luck. Found a DB9 connector and logged into the switch.

Turns out that the Linksys switch wasn't able to get the logical port up if the other side didn't talk auto-negotiation. Disabled auto-neg and we had connection,

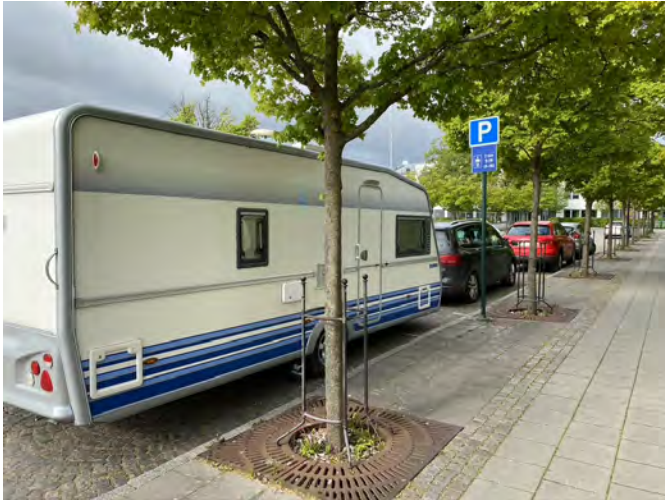
Heading towards Borås, stopped at Lund to fit and a missing coverplate for the DC PEM, the stupid the designed plastic thing.

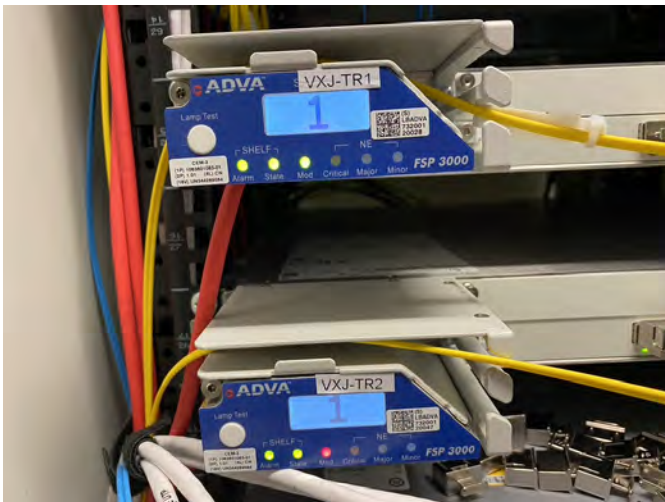
and Växjö to correct an error that was found on the DCI boxes.

VXJ-TR2 has alarms on the frontplate but not in the admin interface, odd.

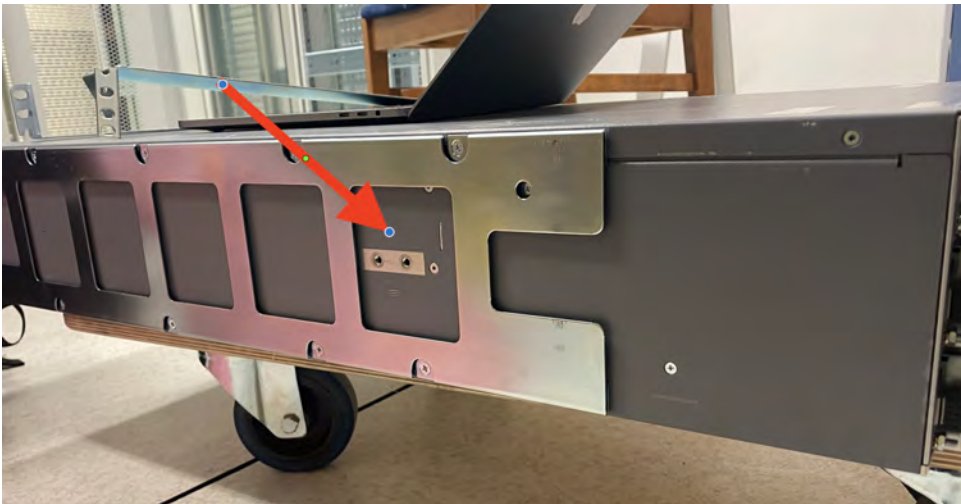
The Mx10003 has a separate grounding point on the side of the box that needs to be used when you run the router on DC power.

But as you can see it's inside the rack rails, so you can't mount the cable until you have mounted the router in the rack and if you have a rack with closed side you will not fit normal a screwdriver. Stupid design.

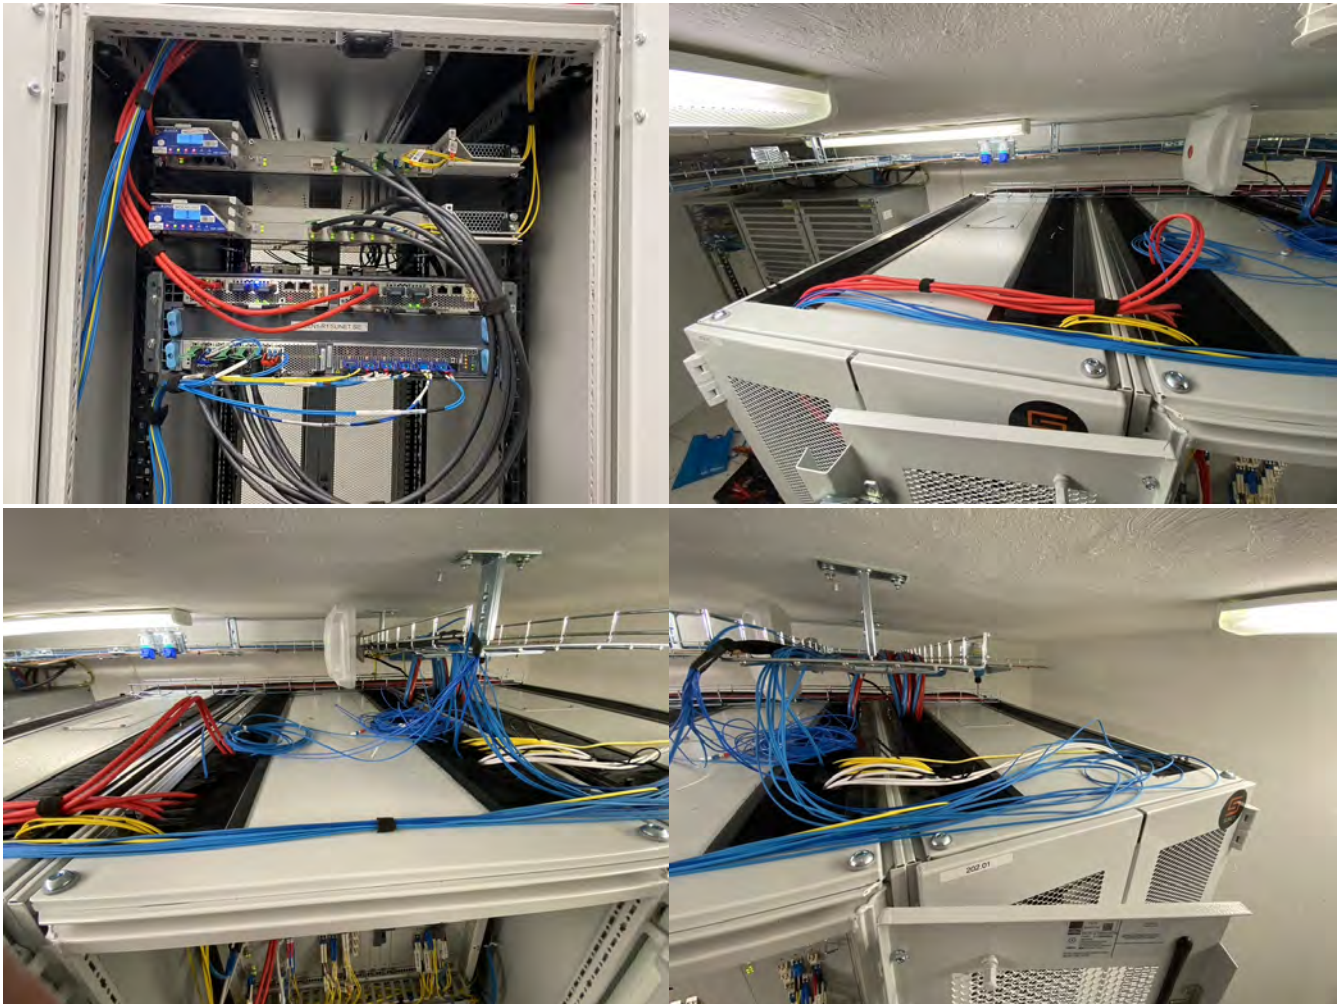
The delivery of the fibers could have been done better but, I guess it works.

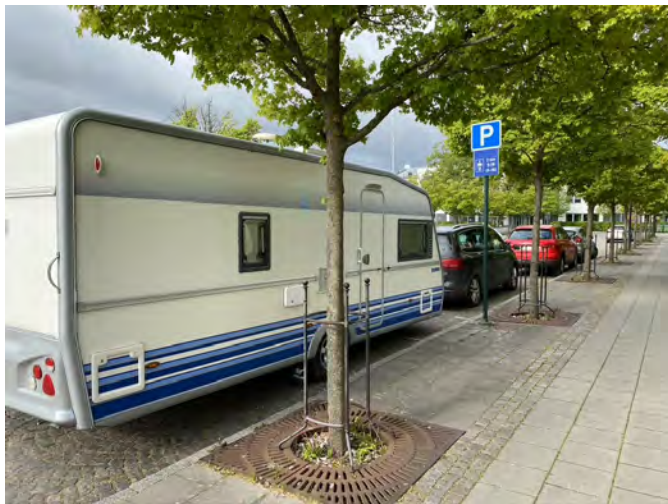
Heading towards Borås, stopped at Lund to fit and a missing coverplate for the DC PEM, the stupid the designed plastic thing.

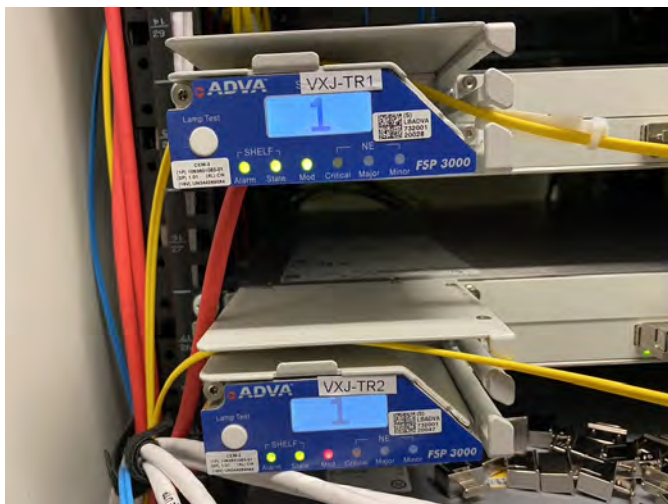
and Växjö to correct an error that was found on the DCI boxes.

VXJ-TR2 has alarms on the frontplate but not in the admin interface, odd.
