DURAFLEX™

Troubleshooting Guide

Rev #: 4.05

Date: 30 May 2022

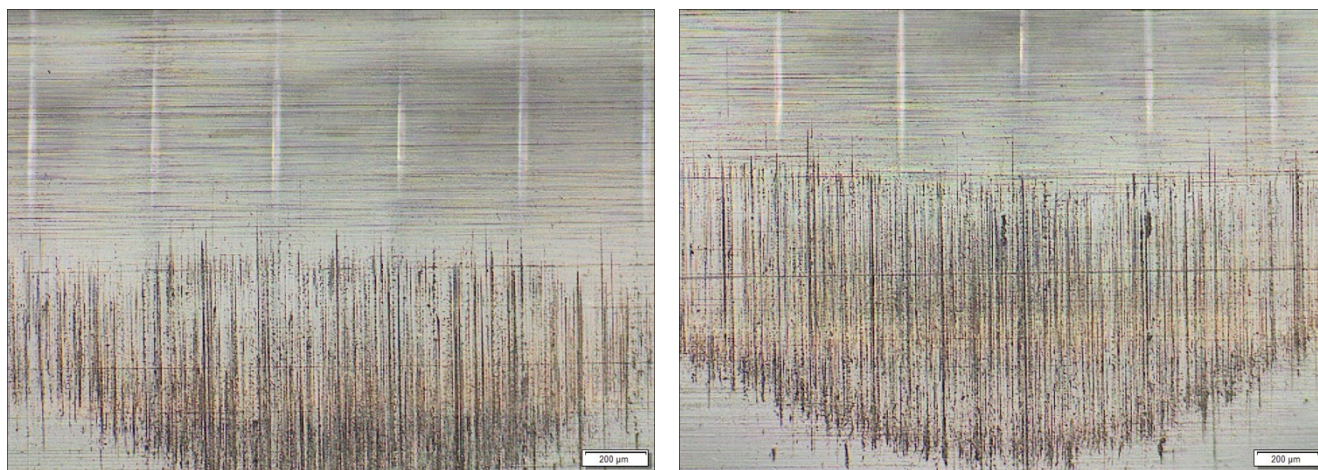
Figure 3 – Examples of Printhead Damage Caused by Media Contact

Figure 3 shows magnified images of printhead encap with repeated paper strikes.

2.22.1 Resolution

- Set PPS as specified in the Installation guide
- A 0.3 mm feeler gauge should easily fit between the paper and the encap all the way along the printhead.

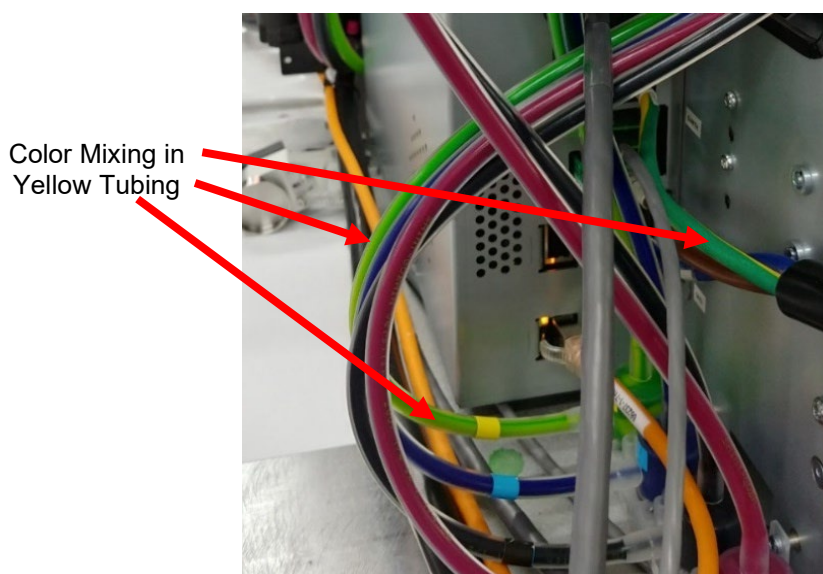
Figure 6 – Color Mixing in Ink Tubing

Color mixing is a serious problem and requires immediate attention to prevent ink contamination throughout the printer. Major color mixing is defined as any uncontrolled ink mixing inside the printer or ink tubing. If any color mixing has occurred, the OEM must drain the contaminated ink from the system and replace it with new ink using the instructions provided below.

[Figure 6](#) shows an extreme example of ink color mixing, where cyan ink is in the yellow ink return line.

To resolve the major color mixing issue, complete the following procedure.

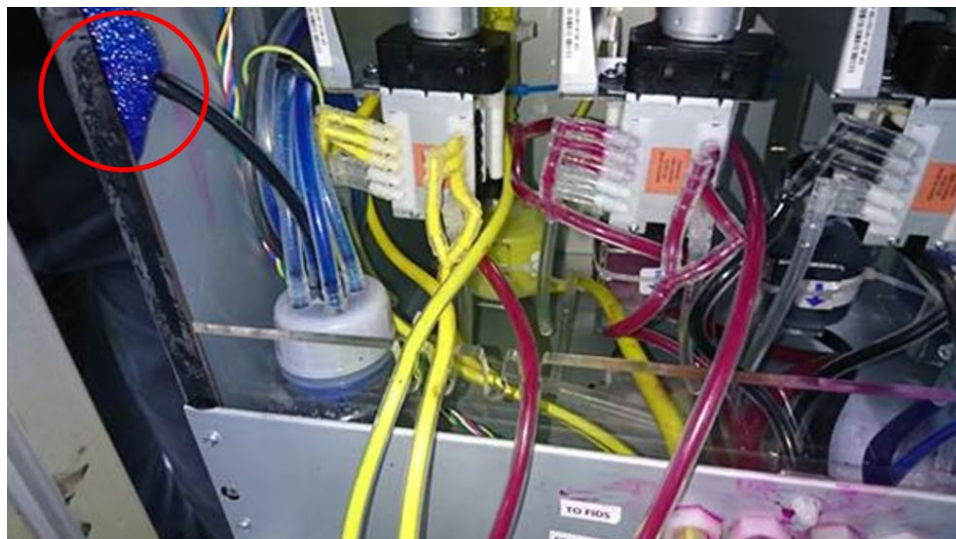
Figure 15 – Ink Foaming (Cyan)

Ink foaming is a rare issue that might occur in the DuraFlex printing system. Ink foam can travel down vent tubes, fill up the IDS vent reservoir, or travel up the vent lines of other colors. This might lead to a color mixing issue.

Multiple cycles of priming and depriming or a sustained refill pump running with an empty bulk ink supply may trigger the ink foaming issue.

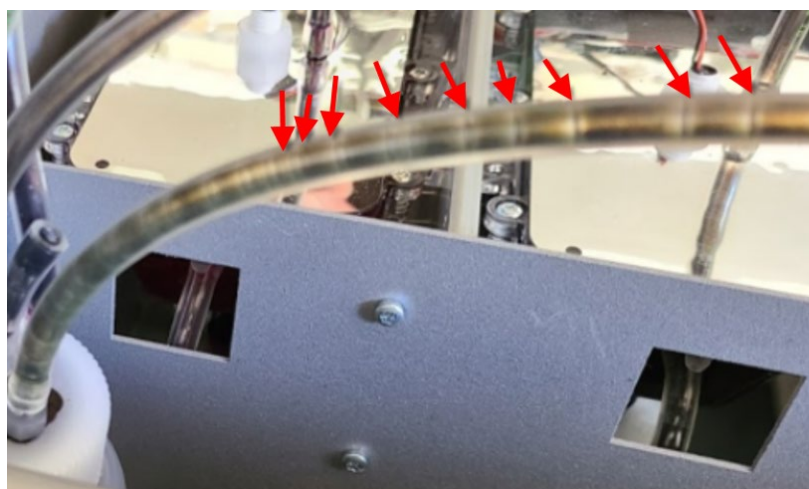
Figure 16 – Menisci in Vent Line

Ink foam can also leave multiple menisci in the vent line, which might build pressure deltas in the IR tank.

3. Be sure that the vent tube is 250-350 mm long (maximum), which will reduce the menisci buildup.
4. Leave 30 mm radius of open space at the bottom of tubes, which will prevent the ink foam from interacting.

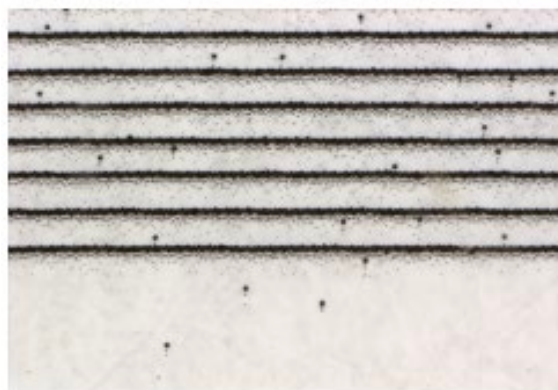
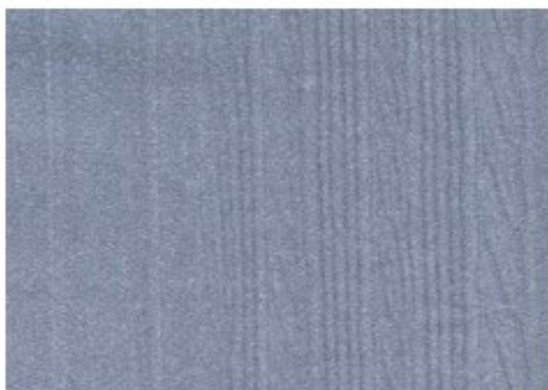
Figure 26 – Print Artifacts Due to Incorrect PPS Setting

Satellites and Ink Mist

Tiger Stripes and Sand Dunes

- 0.7 mm (+0.0 mm, -0.2 mm)

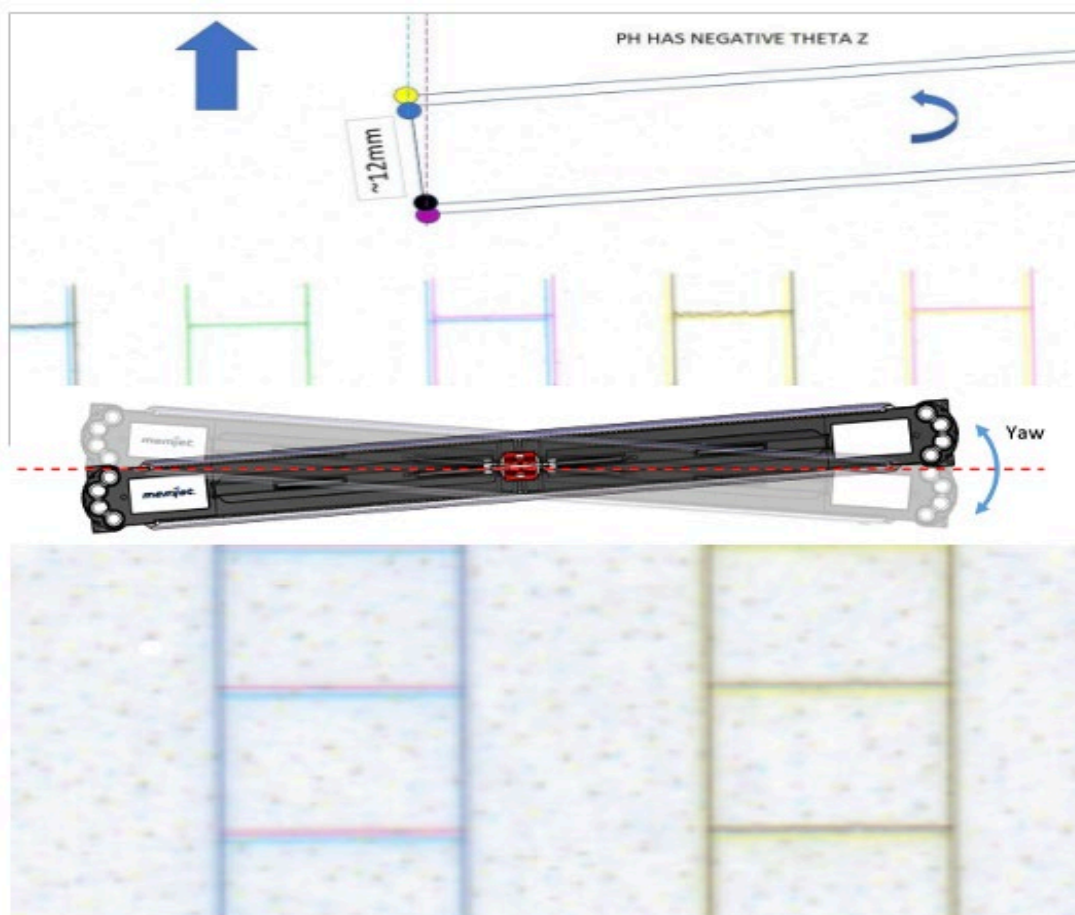
Figure 27 – Color Fringing

Color fringing occurs when the print bar mounting has exceeded specifications.

The print bar mounting is not within the following specifications:

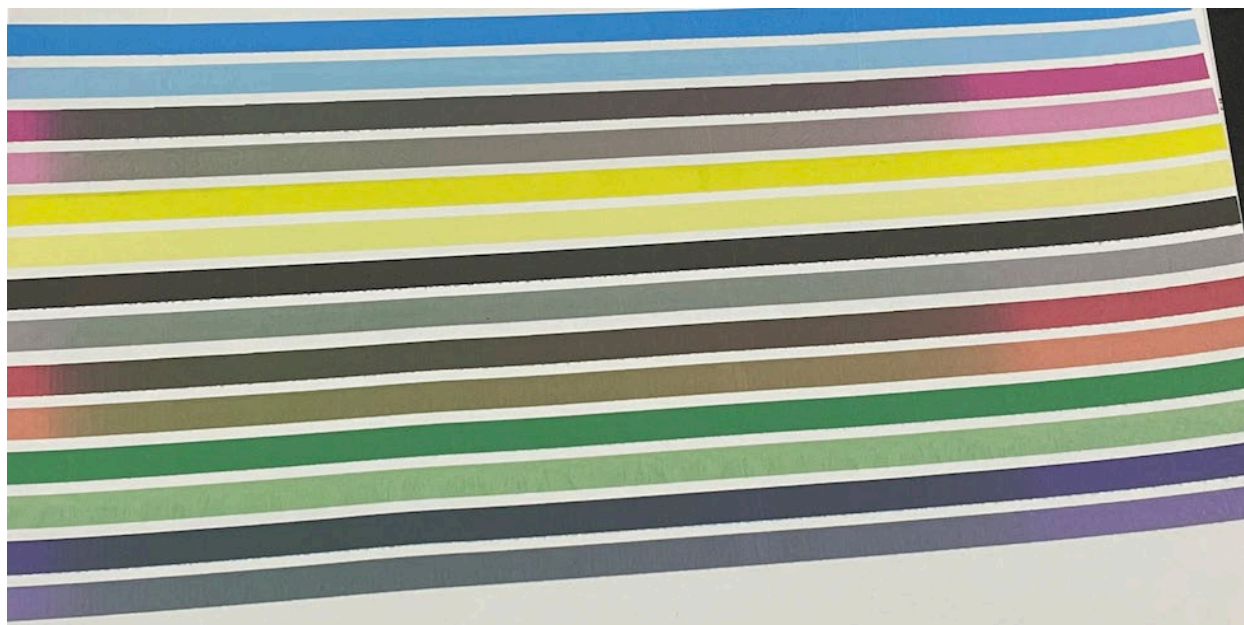
Figure 28 – Color Mixing on Printed Output

A small amount of ink mixing occurs on prints as shown in [Figure 28](#).

- Ink flooding on the surface of the printhead.
- A loose IR tank or Ink Blade can cause the IR tank to be at the wrong height and supply the incorrect ink pressure
- The printhead left in the print position could be hit by the media
- Media/paper fibers accumulating across the nozzle face and provide a bridge from one color channel to the next
- The cap wick touching the printhead face
- Printhead leak in the back end fluidic channel, caused by impact or manufacturing damage

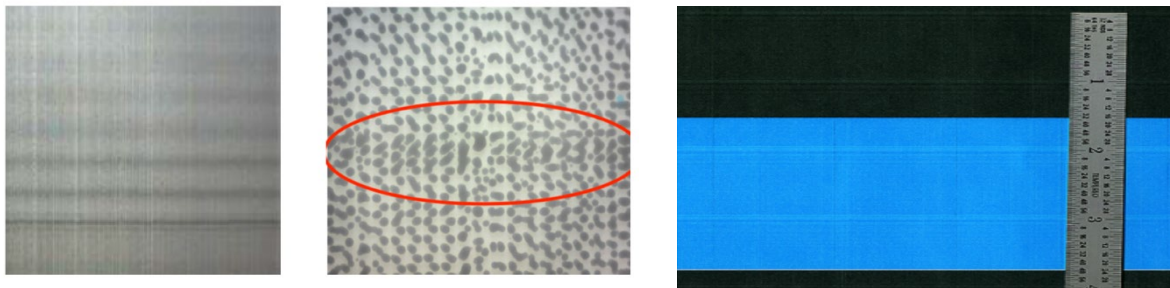
Figure 29 – Example Horizontal Banding

This defect is caused by a variation in dot placement due to instability within paper path, or the systems that feed in the paper or a combination of both.

Media Advance Banding

Dot Misplacement/Banding
