REV 0.3

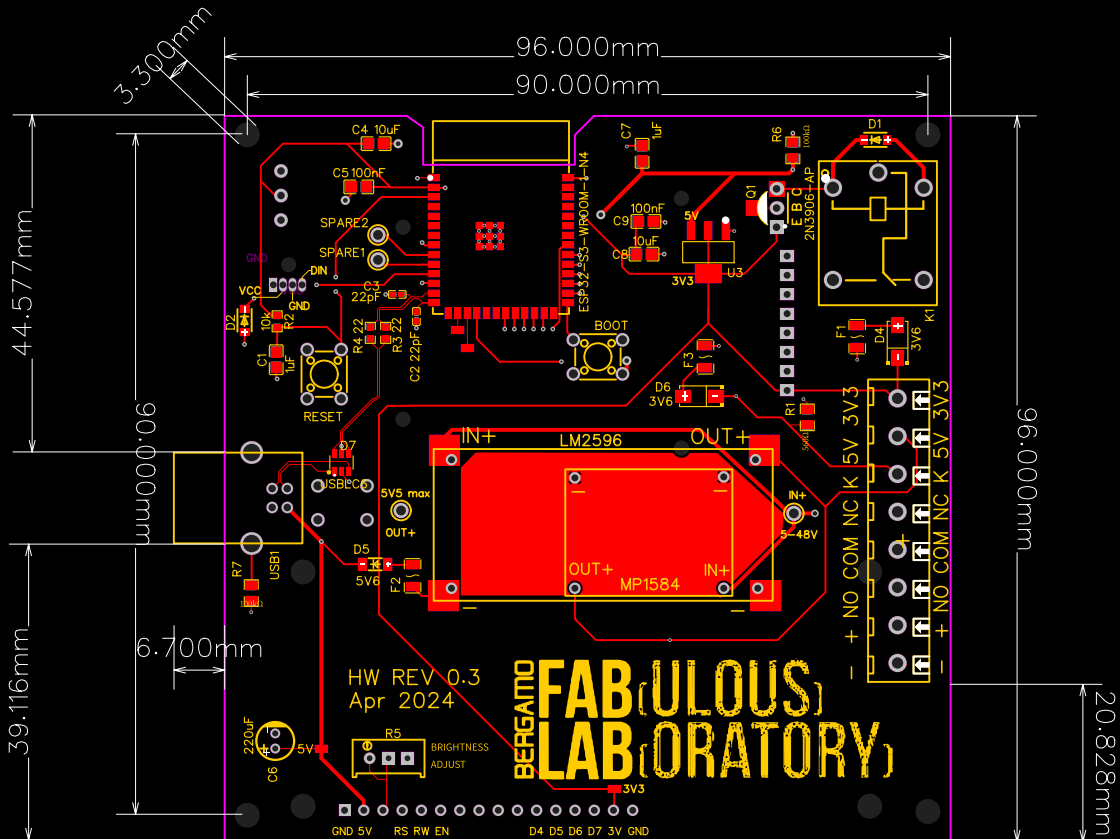
BUGFIX: LCD RW must be set to GND

BUGFIX: ESP32 cannot supply enough current for Relay, added Q1

Moved RFID card to the right to avoid overlap with DEFAULTS button

USB tracks rerouted to avoid pads breaking the data lines

Can't move LCD hole out of the terminal blocks

Changed large caps to 0805 footprints

Replaced variable resistor with more common footprint

Added components values

Added Input protections with fuses

Changed tactile switches model to through hole model

Add large cap for LCD power
